Zeitschrift: IABSE structures = Constructions AIPC = IVBH Bauwerke
Band: 12 (1988)
Heft: C-44: Structures in Finland

4. Kaitavesi Bridge, Tampere (Finland)

Owner:	<i>Finnish Roads and Waterways Administration (RWA)</i>
Design:	<i>RWA and Insinööritoimisto Pontek Ky</i>
Contractor:	<i>Perusyhtymä Oy</i>
Construction Work Duration:	<i>10.5 months</i>
Completion:	<i>1983</i>

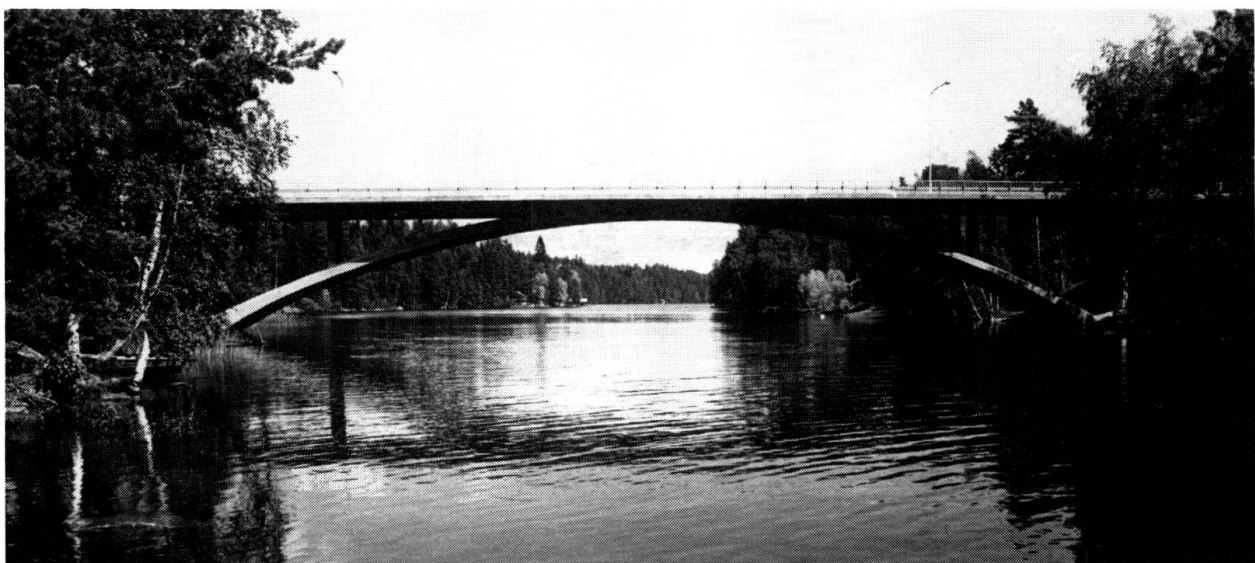
Fig. 1 Kaitavesi bridge

Since the bridge had to harmonize well with the landscape as well as with the old bridge, appearance requirements for the new bridge were high. Of several alternatives a reinforced concrete combined slab and open spandrel arch bridge was chosen. Its total length is 110.8 m and the arch spans 73.5 m. At one end the slab spans are 3×14.0 m and 3×13 m at the other. At midspan, the slab and arch join, forming a monolithic structure for a distance of 23.4 m. The horizontal clearance is 10.5 m. The rise-span ratio of the arch is only 1:7.3.
