**Zeitschrift:** IABSE reports = Rapports AIPC = IVBH Berichte

**Artikel:** Steel buildings with low annual energy consumption

**Autor:** Elmroth, Arne / Johannesson, Carl Michael

## Steel Buildings with Low Annual Energy Consumption

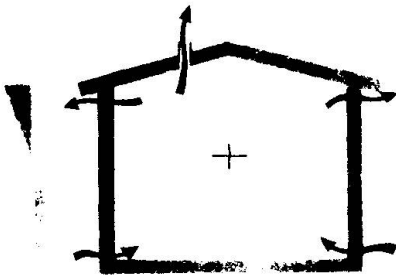
Air pressure on a calm day  
Air leakage  
Cold outside - warm inside

**Fig 1** An insufficiently air-tight building where cold air seeps in at floor level and warm air leaks out at roof level due to thermal forces, wintertime. The pressure gradient is for temperature related pressures on a calm day and fore evenly distributed air leakage.

The governing force for air-leakage and ventilation in buildings is the difference in pressure of the air inside and outside the building. The forces affecting the air adjacent to and inside the building (excluding ventilation fans) and setting it in motion are wind and temperature. On a calm winters day the air pressure in the lower part of a building is lower inside the building than outside, and in the upper part of the building the air pressure on the inside is higher than that outside. The result is that cold air will seep in at floor level and that warm air will leak through the upper walls and the roof, fig 1, giving rise to, apart from the increased energy consumption, uncomfortable draughts at floor level. Such draughts are unacceptable in a quality building. At floor level, and especially in the eaves area, warm air leaks out which, when cooled, may even give rise to condensation and moisture problems in the roof itself. In order to reduce the seepage of cold air at floor level and the leakage of warm air at roof level it is necessary that the climate shield of the building be air-tight.

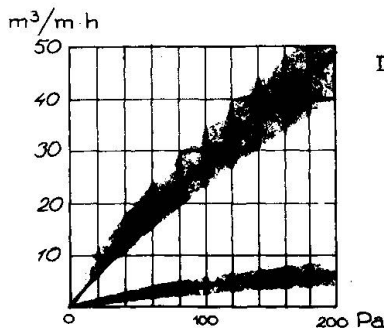
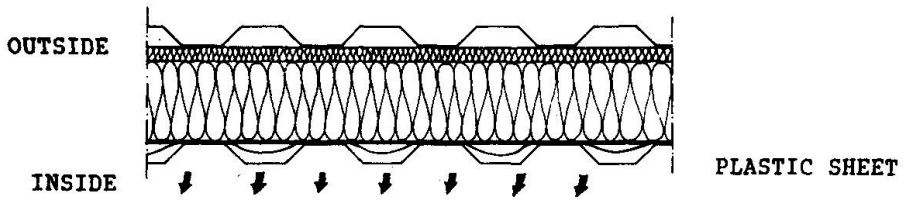
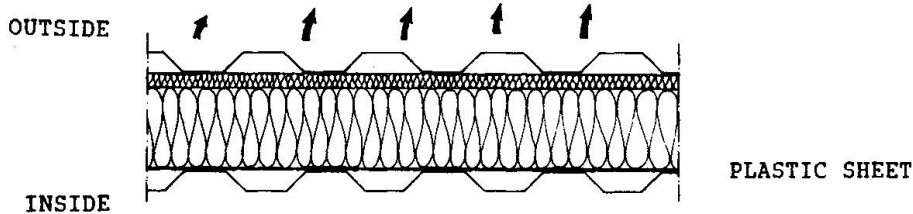
Lower pressure inside than outside

Higher pressure inside than outside.

Lower inside air pressure: the plastic sheet is pressed against the ground plate and against the thermal insulation.

Higher inside air pressure: the plastic sheet is pulled towards the profiled sheet wall causing leakage

**Fig 2** If the plastic sheet is fixed to the ground plate only by means of a profiled steel sheet the air pressure at floor level will pull the sheet away from the ground plate and allow air leakage. If the air pressure is higher inside than outside the sheet will be pressed against the ground plate and reduce leakage. The latter case is however not the most usual one.

The air-tight membrane in walls constructed with cold formed sheet steel studs and sheet steel cladding is a plastic sheet between the inside surface of the thermal insulation and the inside wall finish. This form of construction creates no problems on undisturbed walls. If the wall is punctured by vents, adjoining walls, joints, windows etc great care must be taken in the design of these details. For example where the bottom edge of the plastic sheet is free - when the plastic sheet is fixed in place with a profiled steel sheet - air will seep in easily if the inside air pressure is lower than that outside. If the air pressure inside is higher then that outside the plastic sheet is pressed against the ground plate, reducing air leakage. It is most common to find lower air pressure at floor level which makes it necessary to find a better method of construction to avoid the free edge of the plastic sheet which is found today. Figure 2.

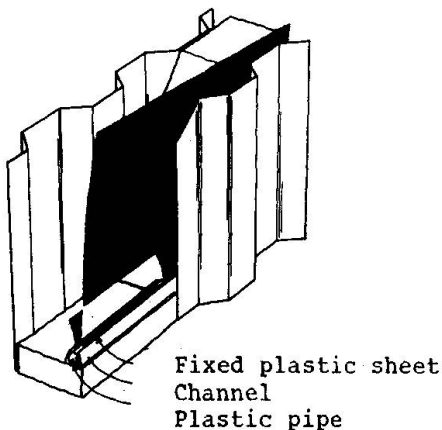
**Fig 3** If the plastic sheet is fixed in a channel with a plastic pipe, electric conduit for example, excellent air tightness is achieved.

There are several methods of ensuring good air-tightness in the ground plate detail, one of which is a sheet steel channel in which the plastic sheet is clamped by means of a plastic pipe as shown in fig 3. When tested, this detail gave 100 times less leakage than that of a free sheet edge. Another version of the same detail which also gives a low leakage value is to fasten the plastic sheet between a fixing strip and sealant as shown in fig 4. These details cost very little but are essential; the extra cost being very quickly repaid.

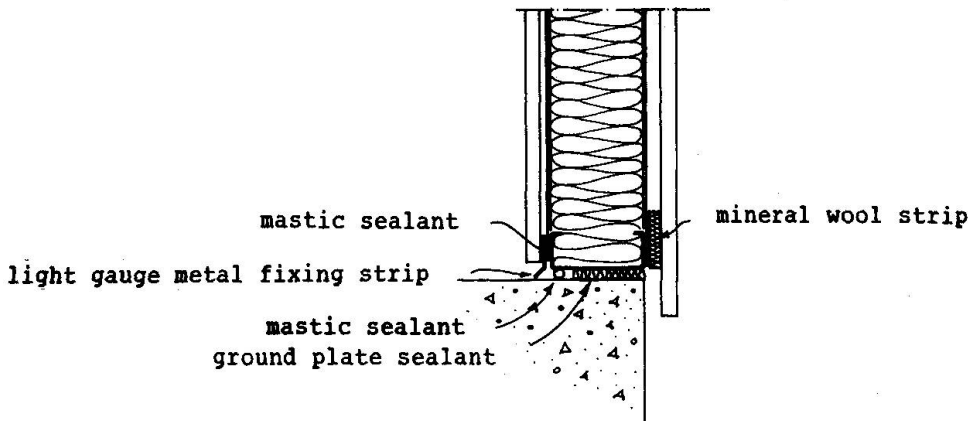
**Fig 4** An alternative method of achieving good air-tightness in the ground plate detail is to fasten the plastic sheet with a special light gauge metal fixing strip. A mastic sealant or sealing strip placed between the plate and the sheet will ensure air-tightness. The joint between the ground-plate and the concrete foundation slab must be well sealed; mineral wool with a joint sealant on the inside gives an acceptable result.

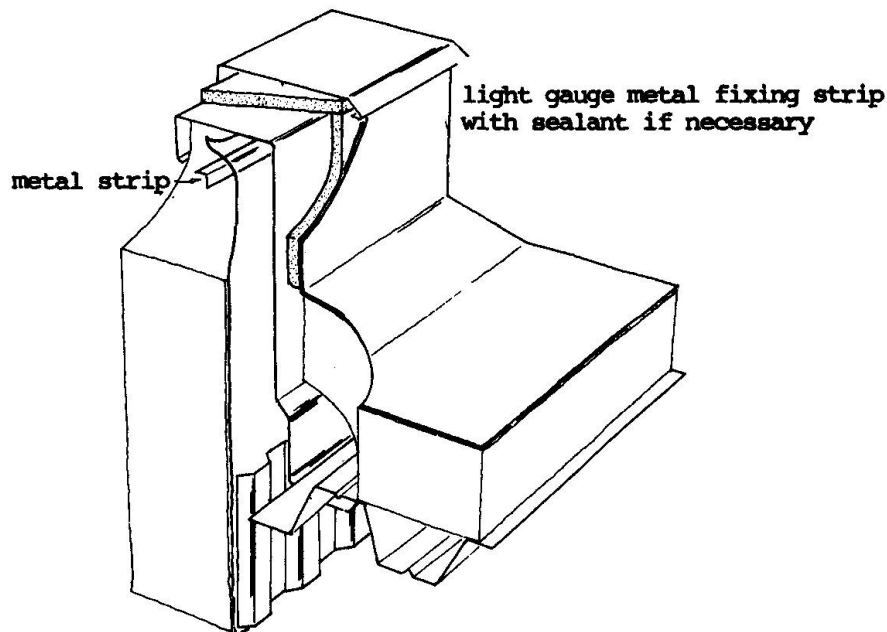
**Fig 5** If the plastic sheet at the roof eaves is placed round the outside of the eaves beam there is a risk for air leakage being as the air pressure is often higher inside the building than outside. The sheet is drawn away from the beam and leakage occurs. The sheet must therefore be fixed with, for example, a fixing strip and mastic sealant in order to obtain sufficient air-tightness.

There is normally some kind of special light gauge sheet steel eaves beam which causes the plastic sheet to be led round it in some way, usually on the outside. The internal excess air pressure presses the sheet away from the eaves beam creating a gap for leakage. This is an unsatisfactory detail which is simple to resolve. Here again all that is required is a light gauge metal fixing-strip which fixes the plastic sheet to the eaves beam, with a sealant between if necessary, as shown in fig 5. Again the cost per metre is very low. Minor adjustments in detailing can give greatly improved air tightness.

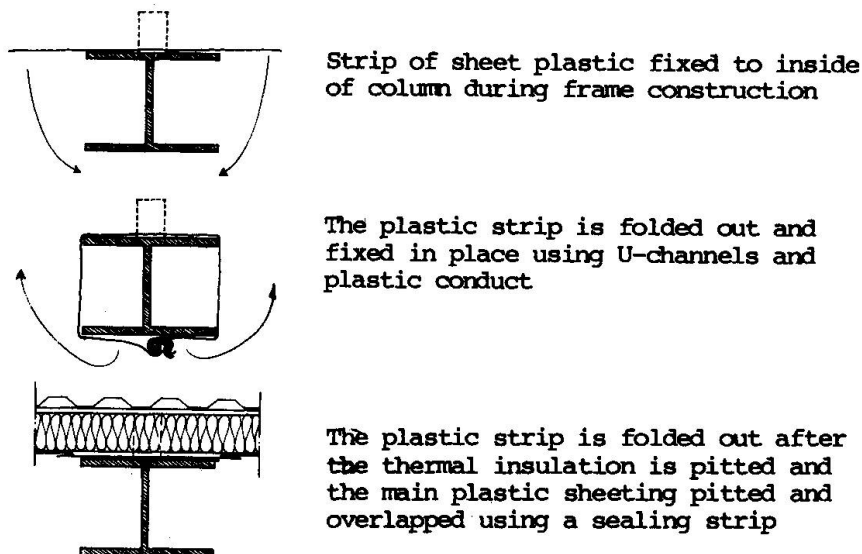
**Fig. 6** It can be difficult to place the plastic sheeting when steel columns are placed inside the facade. A strip of plastic sheet is therefore fitted directly after the completion of the frame and carefully fastened so as to avoid wind damage during construction. When the thermal insulation and the plastic vapour barrier are in place the strip is folded out to give a good overlap joint with the main plastic sheet.

The method of jointing the plastic sheet in the external walls is also of consequence to air-tightness. One method used which gives good joint tightness is to wrap a 0.5 m wide strip of plastic sheet round the column before the horizontal studs are fixed in place. Sealant is applied to the support details and the strip of sheet kept wrapped around the column. When the plastic sheet in the wall has been fitted in place after the completion of the thermal insulation, the wrapped around strip is folded out and sealed in the overlaps with a sealing strip as shown in fig 6. Overlapping edges in the plastic sheet without any form of sealing strip or the pressing together of the overlap will not give satisfactory air-tightness. This detail is not costly but does require thorough workmanship. The wrapped around strip of sheet must be carefully fastened during construction to avoid wind damage.

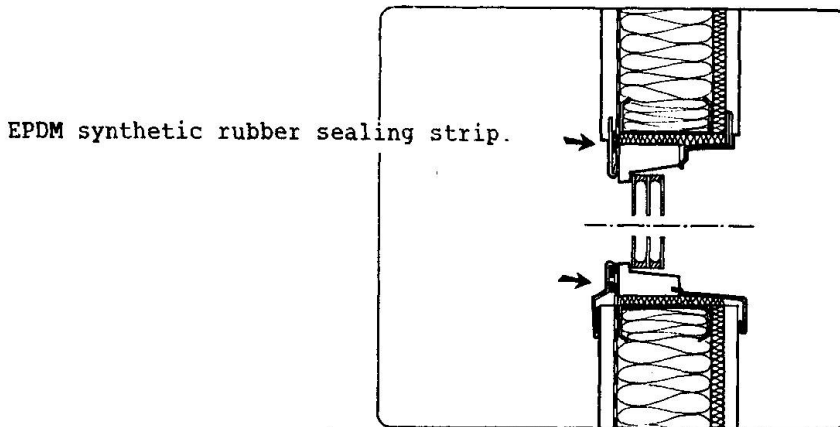
**Fig 7** Window detailing. The plastic sheet in the wall is drawn over the window frame and fastened with a special sealing strip. An EPDM synthetic rubber sealing strip between the plastic sheet and the window frame considerably reduces the risk for air-leakage.

It is of great importance from the point of view of air-tightness that the air-tight membrane is not punctured by ducts, electric conduit etc. Improved detailing and instruction is required here. It is of great importance that all services are planned in detail while the building is still on the drawing board and that ducts are avoided as far as possible. Fig 7 shows an example of a window-wall detail. Note the thermal insulation and the positioning of the air-tight sealant against the air-tight sheet in the wall.

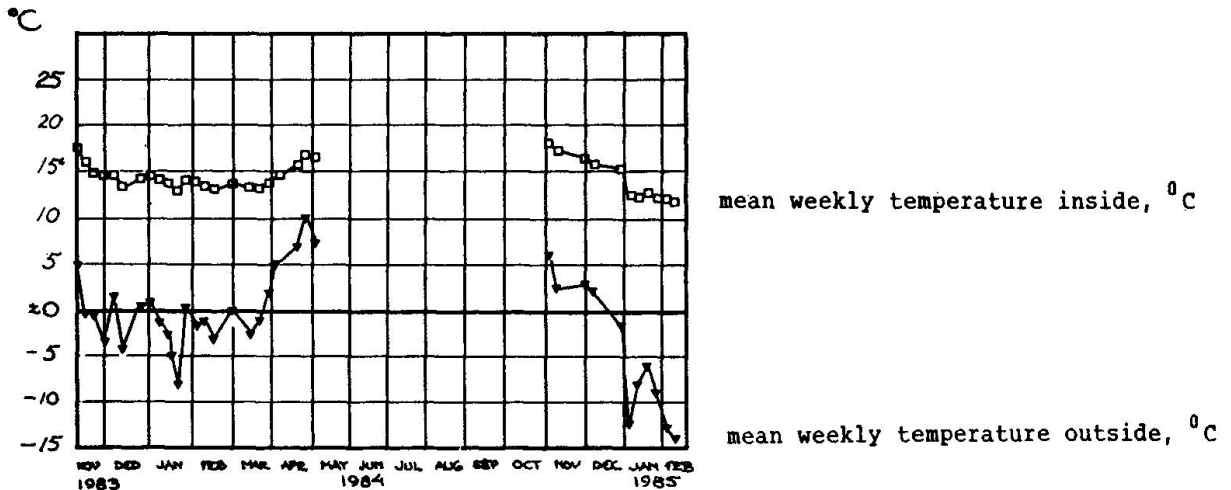
**Fig 7** Mean weekly temperature outside and inside respectively recorded at the Ekerö Tennis Centre during Nov. 1983 to Feb. 1985

The mean weekly temperature inside and outside the building has been continuously recorded during the heating seasons 1983/84 and 84/85. The temperature inside the building has never been below a mean weekly value of +12°C. During the period Nov. 83 to March 84 the mean weekly temperature was +14°C, see fig 8. During the winter of 1983/84, which was relatively mild, the building was never heated with the installed heating system. The heat produced by the lighting system was sufficient to keep the building at a suitable temperature in which to play tennis. It was first during the extreme winter of 1984/85 when the mean weekly temperature fell to -10°C for 6-8 weeks (which is 6-8°C below the mean monthly average for Stockholm) that the infra-red roof panels were used.

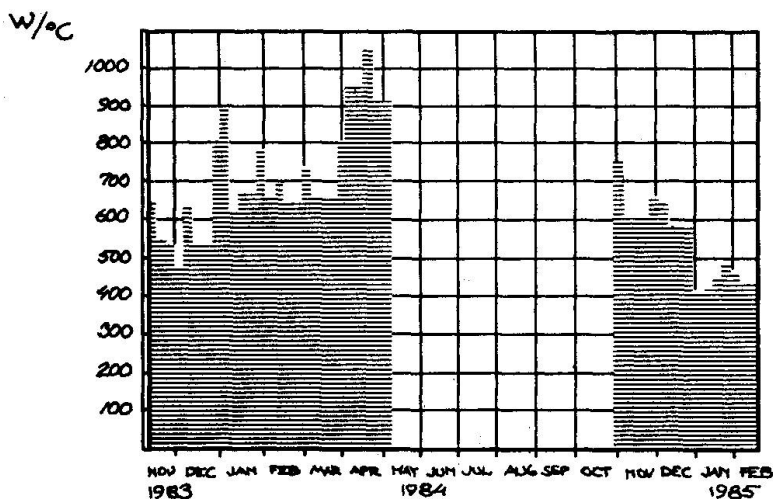
**Fig 8** Energy consumption for the Ekerö Tennis Centre during Nov. 1983-Feb. 1985. No recording during May 1984-Oct. 1984.

The total annual energy consumption, which is almost totally used for lighting is 70 000 kWh.
