**Artikel:** Continuous bridge slides laterally into final position  
**Autor:** Anderson, W. Victor / Trenkler, Ferdinand  
**DOI:** <https://doi.org/10.5169/seals-49292>

## Continuous Bridge Slides Laterally into Final Position

The Dundas Street Bridge in Trenton, ON, Canada was constructed to replace an aging multi-span bridge. The new bridge is a three-span continuous bridge which, following its completion, was moved laterally into its final position by a computer-controlled hydraulic jacking system. The methodology enabled replacement of the old bridge by a new bridge on the same horizontal alignment with only an eight-day interruption to traffic, and with minimal interference with adjacent property, buildings and underground structures.

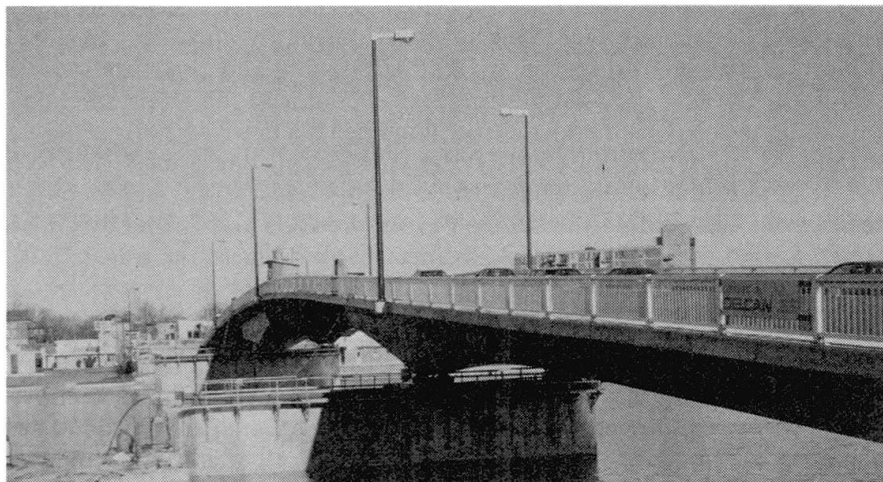
**Figure 2** - Bridge mounted on launching carriages and equipped with jacking system.

The bridge, mounted on the launching carriages and equipped with the jacking system, is shown in Figure 2. Details of the launching carriage and bearing assembly are shown in Figure 3.
