Artikel: Fatigue strength of wires

Autor: Tanaka, Yoshito

Fatigue Strength of Wires

Yoshito TANAKA
Dir., Eng. Div.
Shinko Wire Co, Ltd
Amagasaki, Japan

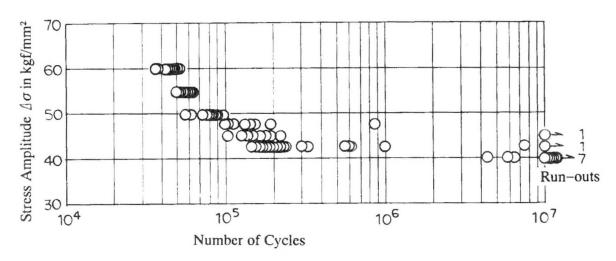
To establish S-N diagram for the galvanized wire, fatigue tests were carried out using 200 mm long specimens on a 10 ton capacity electro-servo type fatigue tester. Fatigue test results are given in Figs. 8 and 9 for the mean stresses of 50kgf/mm² (490 N/mm²) and 100kgf/mm² (980 N/mm²), respectively.

Fig. 9 Fatigue Test Result for 7 mm Dia. Galvanized Wire at a Mean Stress of 100 kgf/mm² (980 N/mm²)

The fatigue tests are still under way to establish a statistical analysis. However, the number of he test data available to date is not enough to permit a statistical calculation of the fatigue values and so we have to guess the endurance limit from the S-N diagrams. It is considered that the endurance limits are 50 kgf/mm² (490 N/mm²) and 40 kgf/mm² (392 N/mm²) for the mean stress of 50 kgf/mm² (490 N/mm²) and 100 kgf/mm² (980 N/mm²), respectively.
