The Nitpicker strikes again Part 1

Early 2-axle vans

by John Jesson

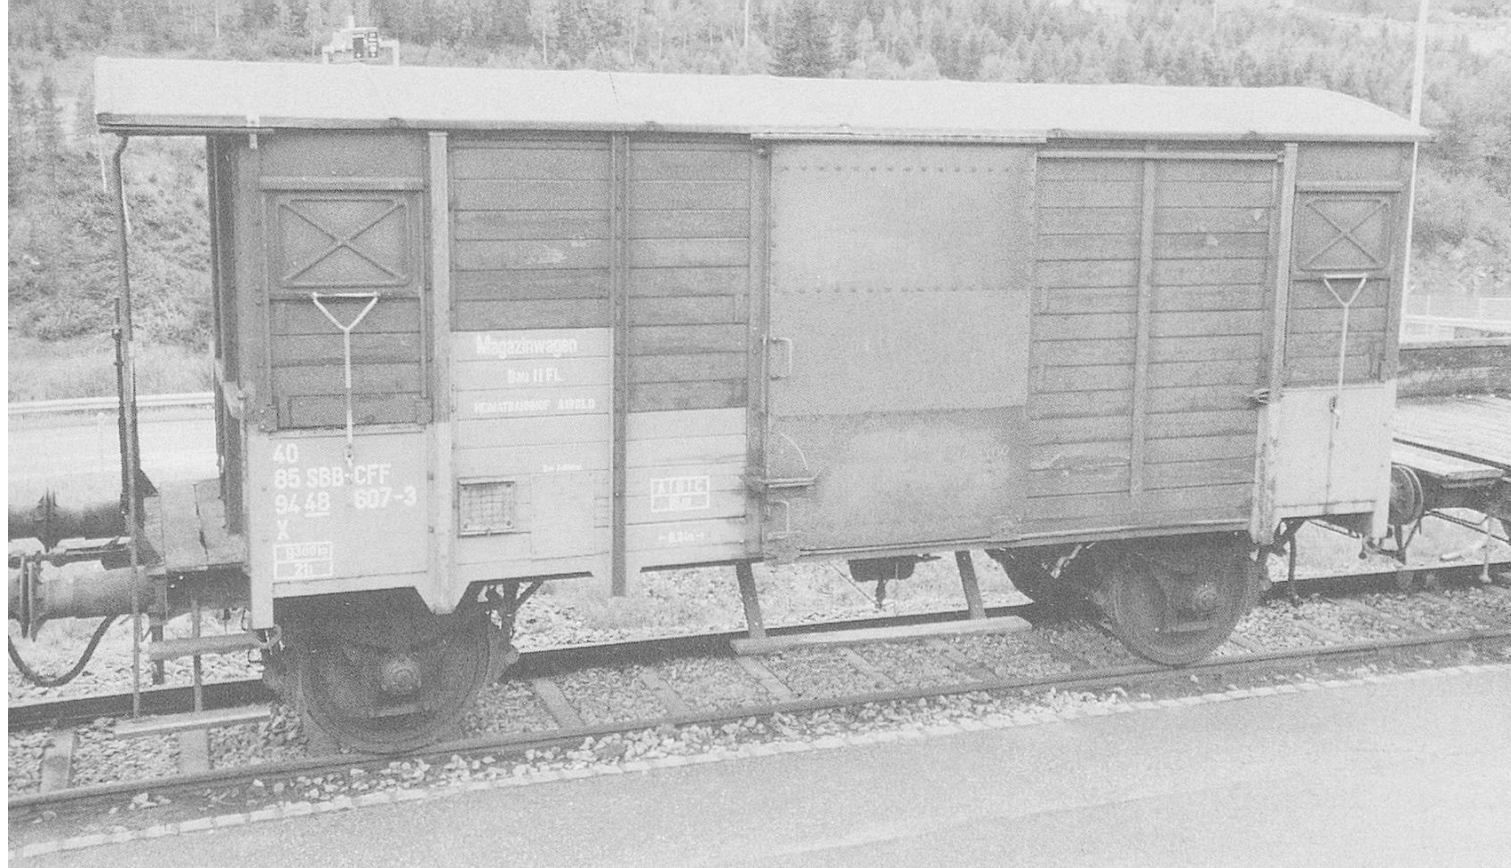
No K2 vans remain in revenue-earning service on the SBB, but many are in evidence as departmental vehicles. These two, now stores vans, were photographed at Airolo in September 1994. 48 607 is allocated to Airolo and carries inscriptions in German, the old inscriptions have been painted out, as has the door logo. 45 637, which has had the benefit of a new coat of paint, belongs to Rodi-Fiesco and its inscriptions are in Italian.
