# Plenary session 2: Structural contribution to natural disaster reduction

### **Structural Contribution to Natural Disaster Reduction**

## Natural Disaster Reduction through Structural Quality

### Alan G. DAVENPORT

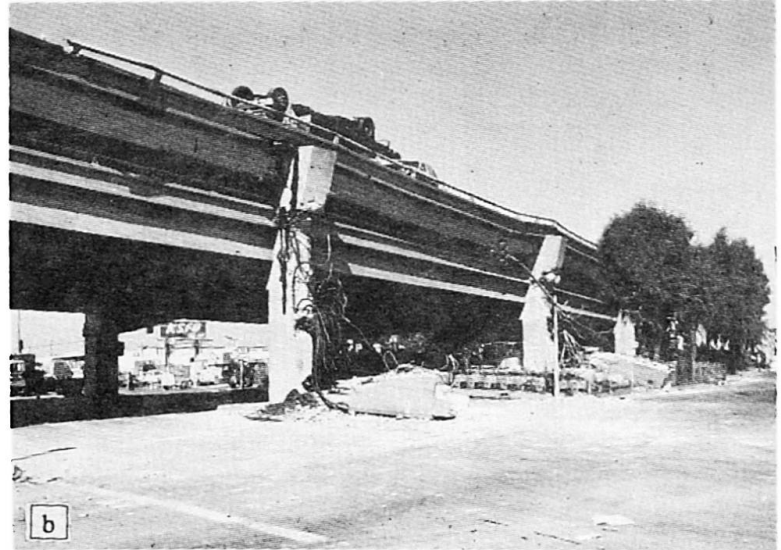
**FIG 1. Bridge Damage During the 1989 Loma Prieta Earthquake**

I-880  
Oakland, CA  
October 1989

Bridge damage and/or collapse is noticed mostly due to its impact on traffic circulation patterns following a major earthquake. Quite often, it is the bridges most needed for post-earthquake search and rescue and relief operations which are collapsed or have to be closed. The duration of closure directly impacts the economic post-earthquake recovery of the affected region. Again, while many seismic bridge problems (see Fig. 1) can be associated with the choice of the structural system, the earthquake hazard also could have been mitigated by appropriate design
