Fabrication survey of steel components facilitates quick bridge erection

Zeitschrift: **IABSE congress report = Rapport du congrès AIPC = IVBH
Kongressbericht**

Band (Jahr): **14 (1992)**

Fabrication Survey of Steel Components facilitates Quick Bridge Erection

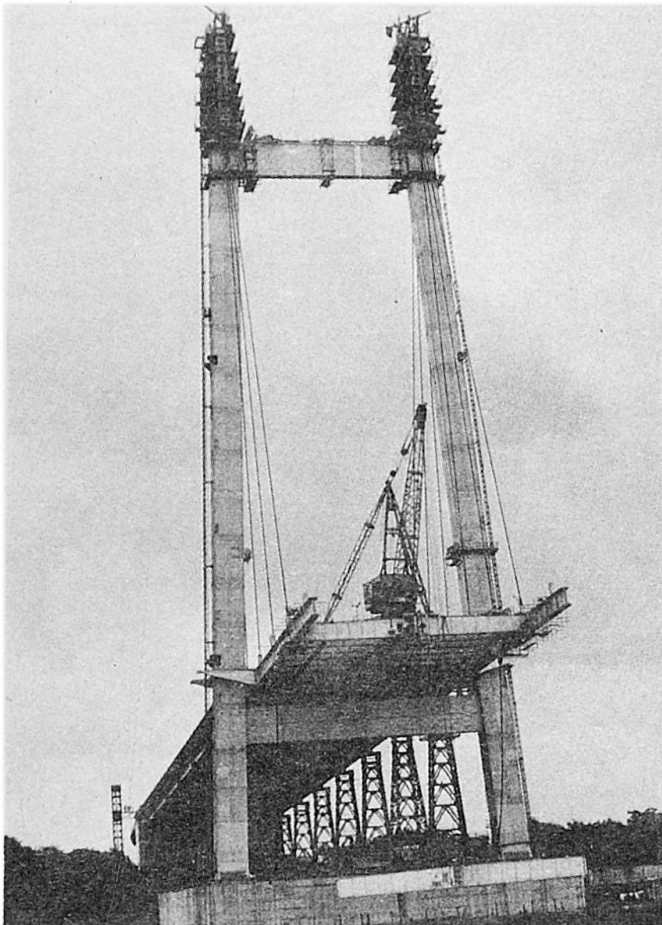
Fig. 1
H-shaped, 122 m high pylon at
Calcutta side

For the box sections of towers a fabrication survey procedure had to be established to control eccentricities of pylon axis either in longitudinal or in transversal direction of the bridge.

Space restrictions and progress of erection did not permit a full shop floor layout for the towers as it had been done for previous bridges. Transport and lifting facilities limited the length of a single box to a maximum of 6 m. Therefore one pylon leg comprises 19 sections up to the level of top portal.

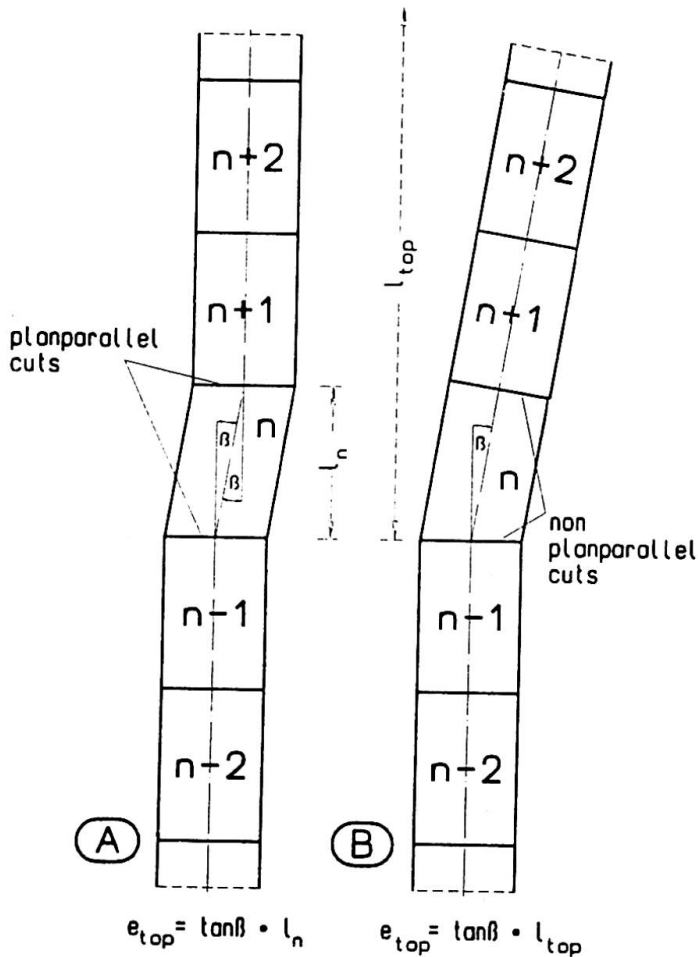
Fig. 2
Axis deviation due to skew cutting of individual section. For illustration (A) the skewed but planparallel cuts cause only a negligible shift of the axis.

Deviations from nominal pylon leg axis are caused mainly through skewed cutting of box section ends. On this account utmost care was taken during individual box machining. Before cutting of the second face was taken up, the box was aligned in reference to the face which was cut first. For this a dial gauge was mounted on the extended spindle of milling cutter to check perfect setting.

If cuts of an individual box are not perpendicular but planparallel (see A in Fig. 2), the amount of deviation from nominal axis is negligible, whereas non-planparallel cuts may lead to unacceptable eccentricities (see B in Fig. 2).

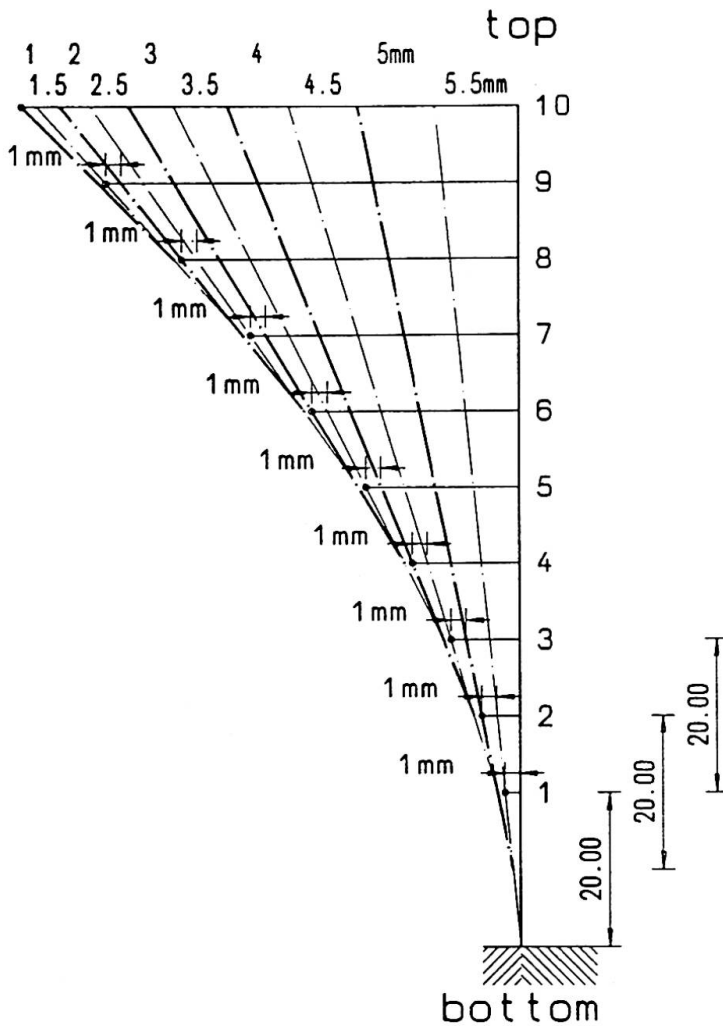
Fig. 3

Undetected deviation from nominal axis due to accumulative built-in error in control assembly survey, 10 nos. of assemblies with reference length of 20 m for each assembly lead to an eccentricity of 32.5 mm at top if built-in error is 1 mm per assembly.

An additional, but undetected deviation from the axis occurs due to a built-in error in survey procedure. Considering a 1 mm error per control assembly survey and assuming that the error accumulates in same direction for further assemblies, the deviation from nominal axis at the top amounts to 32.5 mm taking entirely 10 nos. of assemblies and the reference length is 20 m per assembly (see Fig. 3).

The undetected deviation at the tower top will increase with less reference length per assembly and more numbers of surveys. For that reason it could not be agreed to control assemblies with 3 or even 2 sections only.

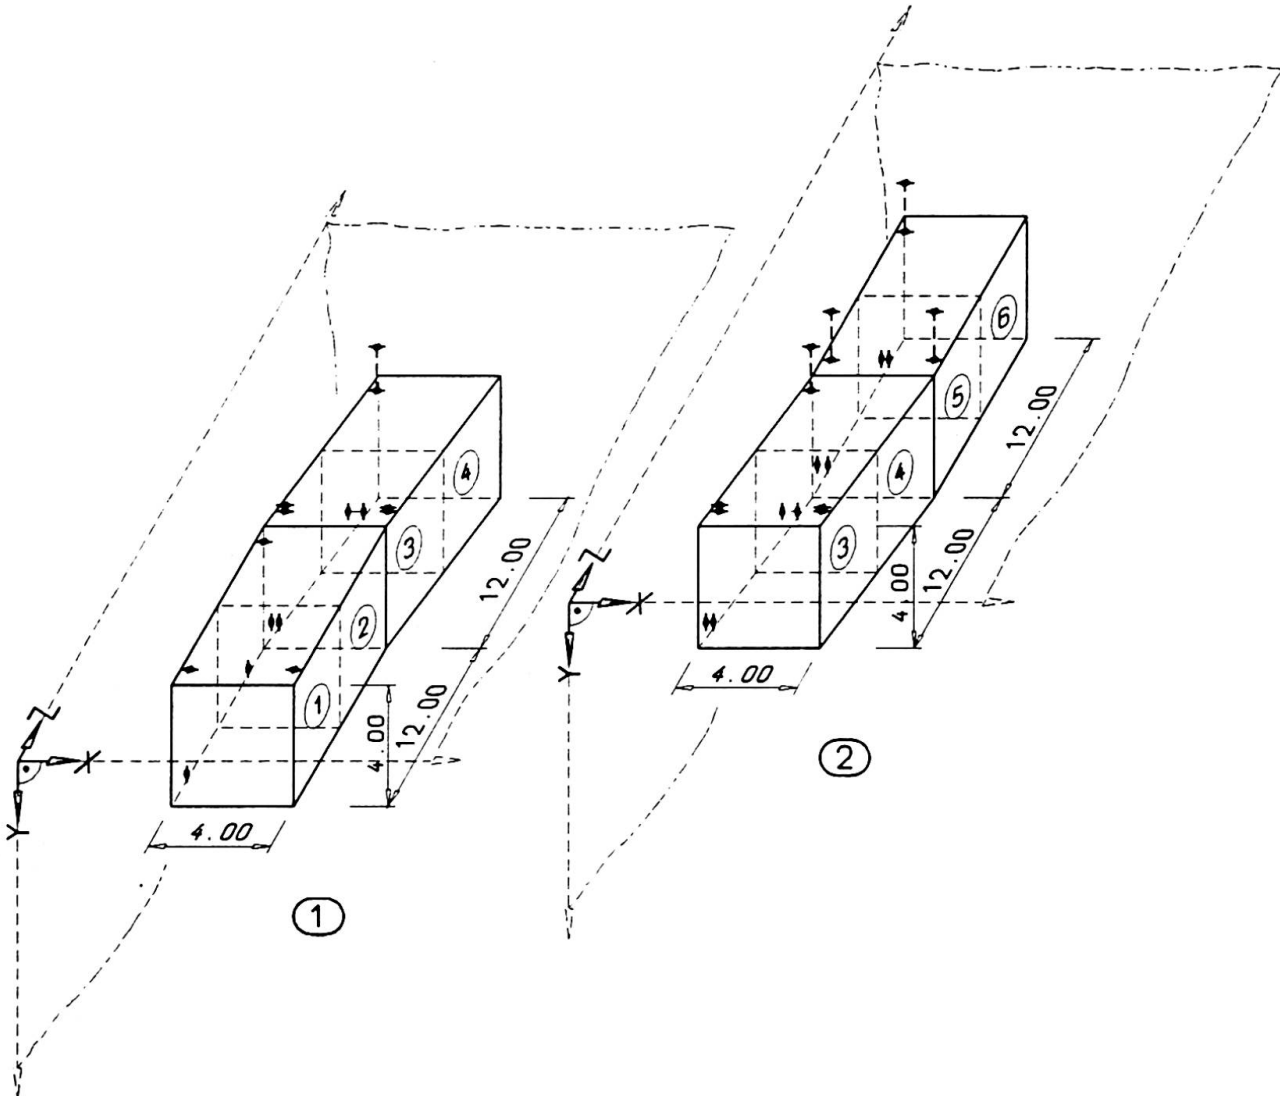
Sequence of control assembly for pylon leg, offsets at boxes 3 + 4 in assembly (1) are identical to offsets at same boxes in assembly (2) achieved by analytical transformation.

Shop floor survey for pylon legs has been executed with 4 sections per assembly horizontally laid out starting with base elements. By removing 2 rear sections and adding 2 sections at the front next assembly configuration was found. In Fig. 4 survey procedure for pylon legs is shown in principle for two subsequent assemblies. With a theodolite two perpendicular optical planes have been established. The intersecting line of these two optical planes represents nominal pylon leg axis. The offsets from the optical planes towards the wallplates of box sections were measured by scale in x-and y-direction. As a result, deviations from the axis were recorded.

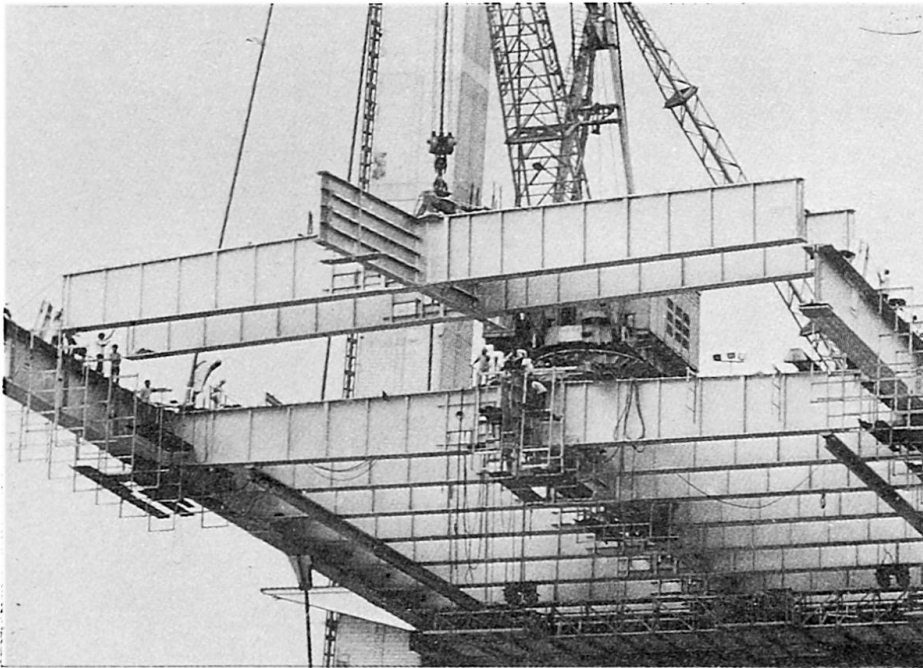
Fig. 5
Preassembly of middle girder and 4 cross girders being lifted. Both main girders are already in final position.
