**Artikel:** Fabrication survey of steel components facillitates quick bridge erection

# Fabrication Survey of Steel Components facilitates Quick Bridge Erection

Contrôles de fabrication pour le Pont Hooghly à Calcutta

Rudolf BERGERMANN
Consult. Eng.
Schlaich Bergermann und Partner
Stuttgart, Germany

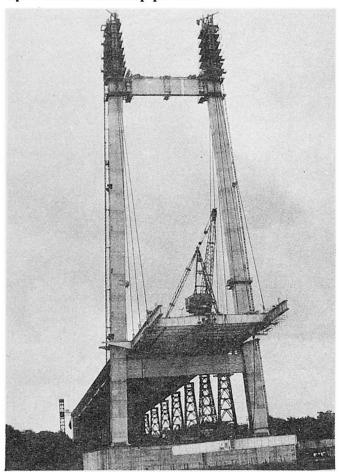
Fig. 1 H-shaped, 122 m high pylon at Calcutta side

For the box sections of towers a fabrication survey procedure had to be established to control eccentricities of pylon axis either in longitudinal or in transversal direction of the bridge.

Space restrictions and progress of erection did not permit a full shop floor layout for the towers as it had been done for previous bridges. Transport and lifting facilities limited the length of a single box to a maximum of 6 m. Therefore one pylon leg comprises 19 sections up to the level of top portal.

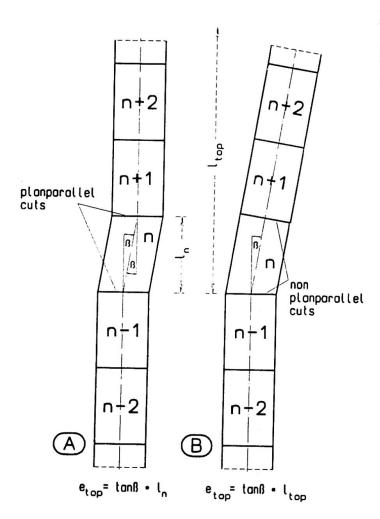
Fig. 2
Axis deviation due to skew cutting of individual section. For illustration (A) the skewed but planparallel cuts cause only a negligible shift of the axis.

Deviations from nominal pylon leg axis are caused mainly through skewed cutting of box section ends. On this account utmost care was taken during individual box machining. Before cutting of the second face was taken up, the box was aligned in reference to the face which was cut first. For this a dial gauge was mounted on the extended spindle of milling cutter to check perfect setting.

If cuts of an individual box are not perpendicular but planparallel (see A in Fig. 2), the amount of deviation from nominal axis is negligible, whereas non-planparallel cuts may lead to unacceptable eccentricities (see B in Fig. 2).

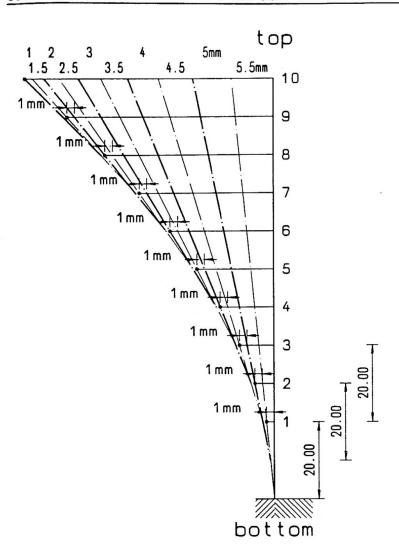
Fig. 3
Undetected deviation from nominal axis due to accumulative built-in error in control assembly survey, 10 nos. of assemblies with reference length of 20 m for each assembly lead to an eccentricity of 32.5 mm at top if built-in error is 1 mm per assembly.

An additional, but undetected deviation from the axis occurs due to a built-in error in survey procedure. Considering a 1 mm error per control assembly survey and assuming that the error accumulates in same direction for further assemblies, the deviation from nominal axis at the top amounts to 32.5 mm taking entirely 10 nos. of assemblies and the reference length is 20 m per assembly (see Fig. 3).

The undetected deviation at the tower top will increase with less reference length per assembly and more numbers of surveys. For that reason it could not be agreed to control assemblies with 3 or even 2 sections only.

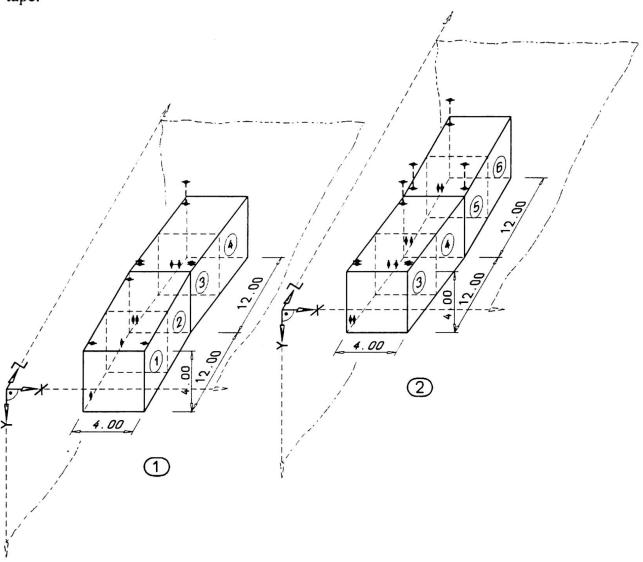
Fig. 4
Sequence of control assembly for pylon leg, offsets at boxes 3 + 4 in assembly (1) are identical to offsets at same boxes in assembly (2) achieved by analytical transformation.

Shop floor survey for pylon legs has been executed with 4 sections per assembly horizontally laid out starting with base elements. By removing 2 rear sections and adding 2 sections at the front next assembly configuration was found. In Fig. 4 survey procedure for pylon legs is shown in principle for two subsequent assemblies. With a theodolite two perpendicular optical planes have been established. The intersecting line of these two optical planes represents nominal pylon leg axis. The offsets from the optical planes towards the wallplates of box sections were measured by scale in x-and y-direction. As a result, deviations from the axis were recorded.

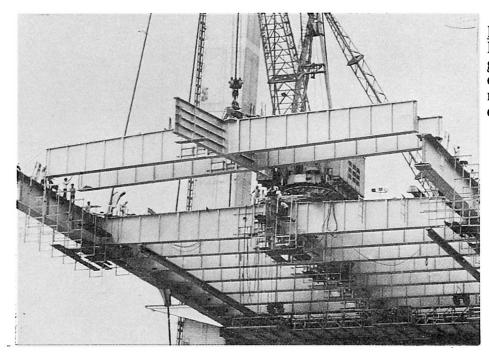
Fig. 5
Preassembly of middle girder and 4 cross girders being lifted. Both main girders are already in final position.
