# **Fabrication survey of steel components facilitates quick bridge erection**

Zeitschrift: **IABSE congress report = Rapport du congrès AIPC = IVBH  
Kongressbericht**

## **Fabrication Survey of Steel Components facilitates Quick Bridge Erection**

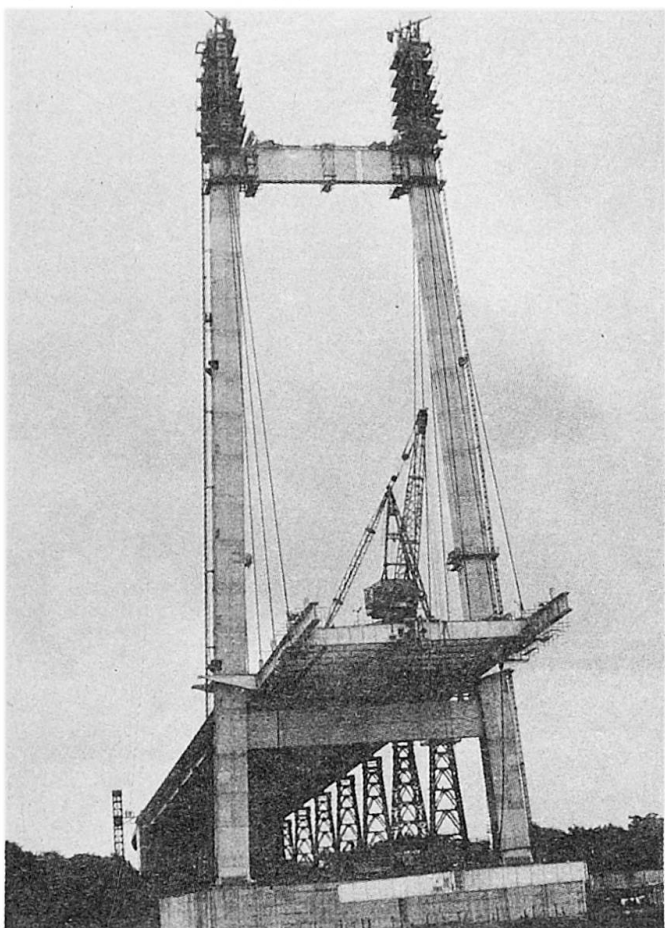
**Fig. 1**  
H-shaped, 122 m high pylon at  
Calcutta side

Space restrictions and progress of erection did not permit a full shop floor layout for the towers as it had been done for previous bridges. Transport and lifting facilities limited the length of a single box to a maximum of 6 m. Therefore one pylon leg comprises 19 sections up to the level of top portal.
