Zeitschrift: IABSE congress report = Rapport du congrès AIPC = IVBH
Kongressbericht

Band: 4 (1952)

Rubrik: BII3: Special erection methods

Typical methods of erecting four bridges across main rivers in the Netherlands

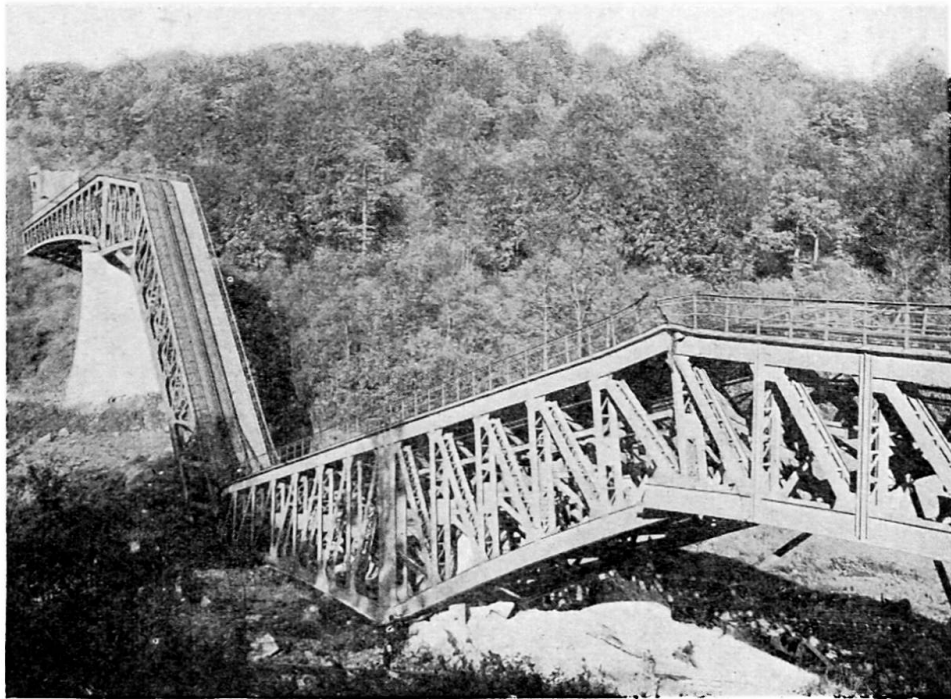
Fig. 5. Viaduc de Serrouville

totallement, les autres sur le tablier, qui fut sectionné en trois points, suivant schéma ci-joint (figs. 5 et 6).

Fig. 6. Viaduc de Serrouville. Destruction—détail de la lère cassure côté Conflans

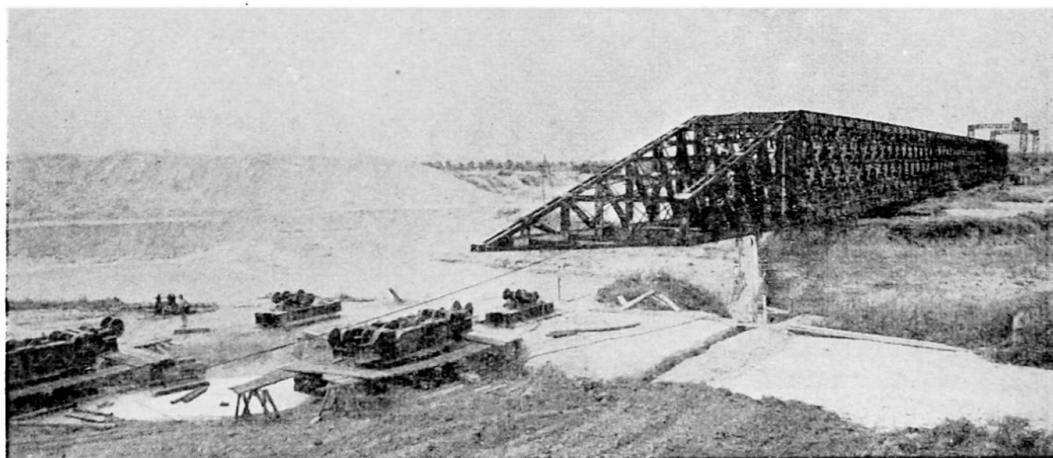
Fig. 10. Pont rail de Bollène—Ouvrage en cours de lançage
