Plenary session 2: Structural contribution to natural disaster reduction

Zeitschrift: **IABSE congress report = Rapport du congrès AIPC = IVBH
Kongressbericht**

Structural Contribution to Natural Disaster Reduction

Natural Disaster Reduction through Structural Quality

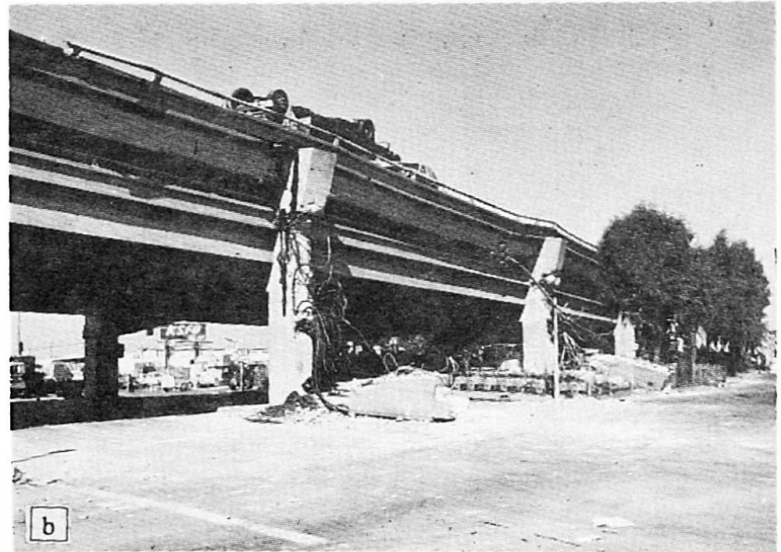
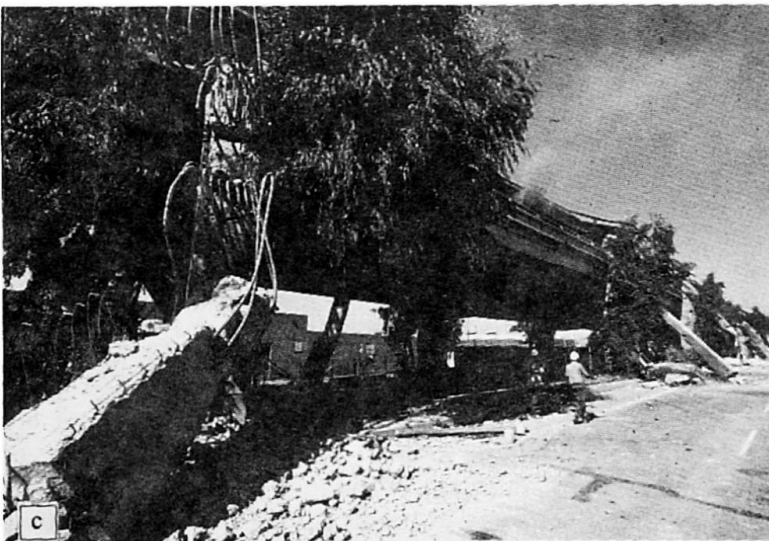
FIG 1. Bridge Damage During the 1989 Loma Prieta Earthquake

I-880
Oakland, CA
October 1989

Bridge damage and/or collapse is noticed mostly due to its impact on traffic circulation patterns following a major earthquake. Quite often, it is the bridges most needed for post-earthquake search and rescue and relief operations which are collapsed or have to be closed. The duration of closure directly impacts the economic post-earthquake recovery of the affected region. Again, while many seismic bridge problems (see Fig. 1) can be associated with the choice of the structural system, the earthquake hazard also could have been mitigated by appropriate design

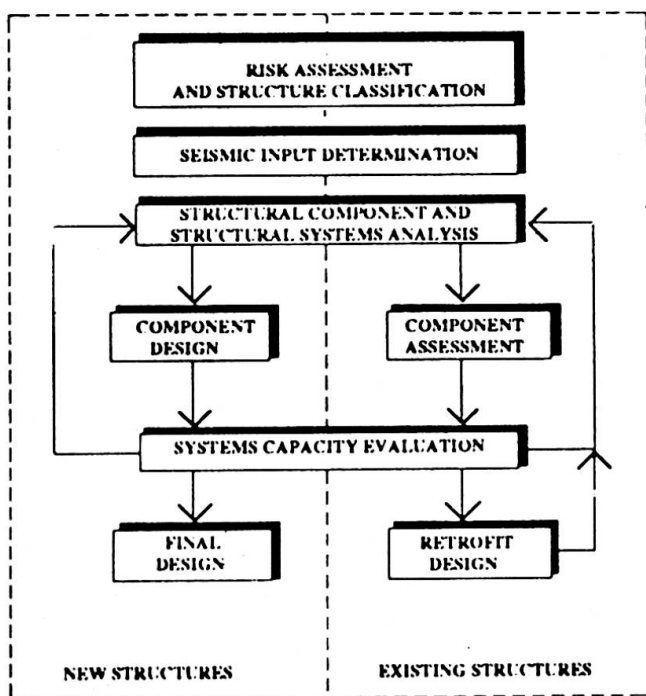
FIG 2. Seismic Design Process

A comprehensive seismic structural hazard design approach should include the components of (1) Risk Assessment, (2) Equivalent Seismic Load Input, (3) Component Assessment and/or Design (4) Systems Evaluation, (5) Final Design or Retrofit. These components are schematically outlined in Fig. 2.

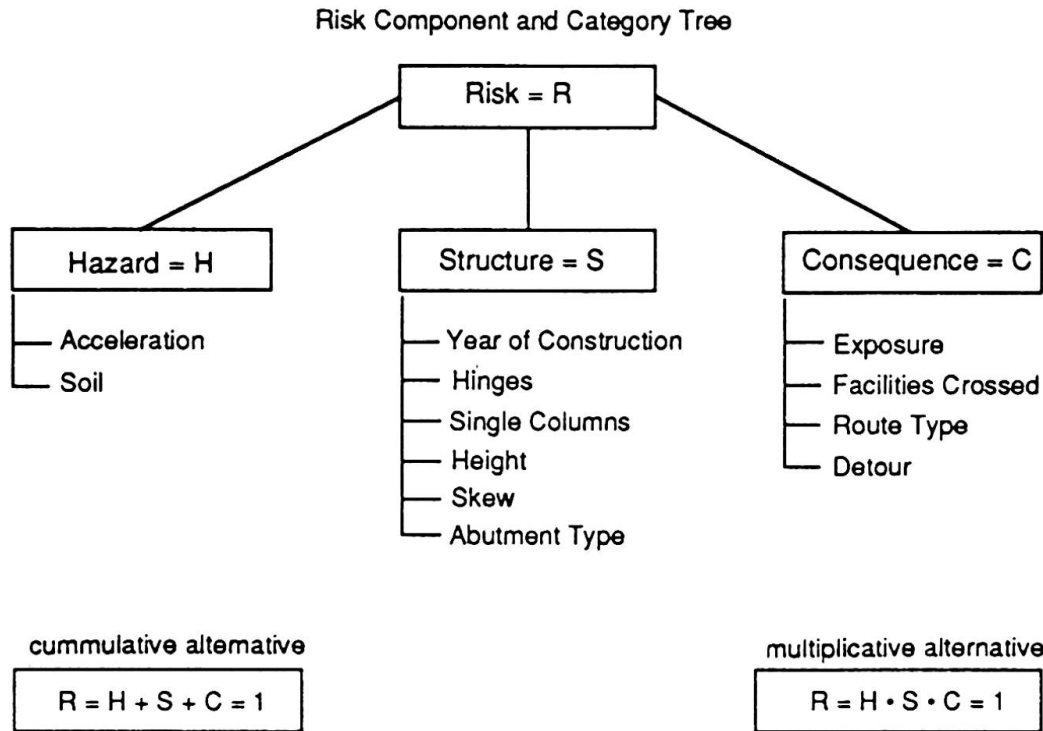
FIG 3. Seismic Risk Assessment Algorithm

The seismic risk assessment for a structure should involve the three principal components of hazard, structure and consequence. The hazard component reflects the probabilistic seismic input in terms of magnitude, probability of occurrence and soil/geological characteristics of the most probable seismic ground excitation. The structure component should address structural performance characteristics in terms of redundancy, detailing for inelastic action and critical geometry. Finally, the consequence component should address the importance of the structure and provide input on potential for loss of life consequences of failure or closure of the structure under evaluation. These three categories can be combined in a cumulative or multiplicative weighted risk algorithm to determine an estimate of the seismic risk for the structure. As an example of a risk assessment algorithm Fig. 3 shows the component and category tree structure currently used by

California Department of Transportation (Caltrans) to assess the seismic retrofit priorities of over 24,000 bridge structures in California [3]. This risk evaluation can now be used to determine critical design limit states for the structural system and guidelines on how these design limit states should be achieved.

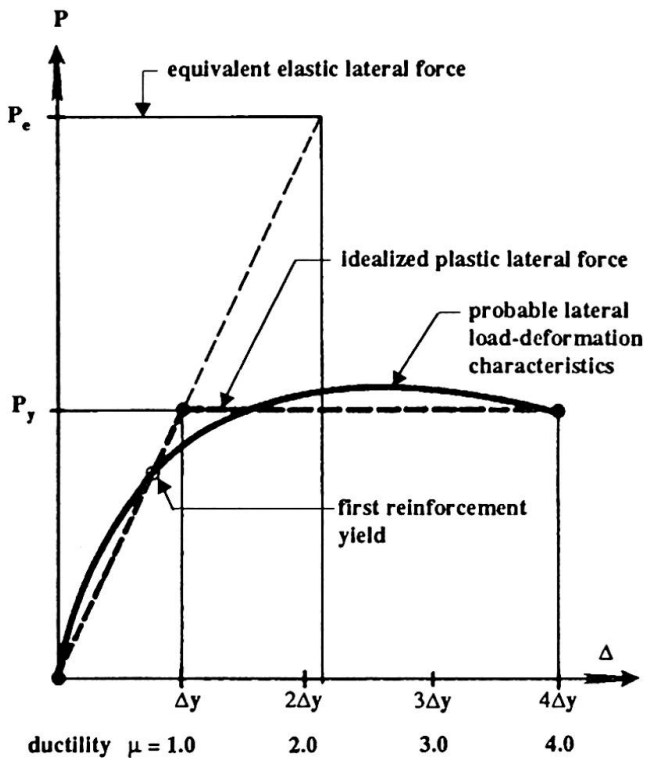
FIG 4. Load Deflection Behavior and Equivalent Elastic Forces

The derived elastic force reduction can now be used to establish an appropriate deterministic load input for the structural system in the form of acceleration response spectra which determine equivalent static seismic loads on the system.
