Fabrication Survey of Steel Components facilitates Quick Bridge Erection

Contrôles de fabrication pour le Pont Hooghly à Calcutta

Details of the fabrication survey, allowable tolerances, measurements, trial assembly and their favourable effect on the speed and accuracy of erection are described for the second Hooghly Bridge in Calcutta.

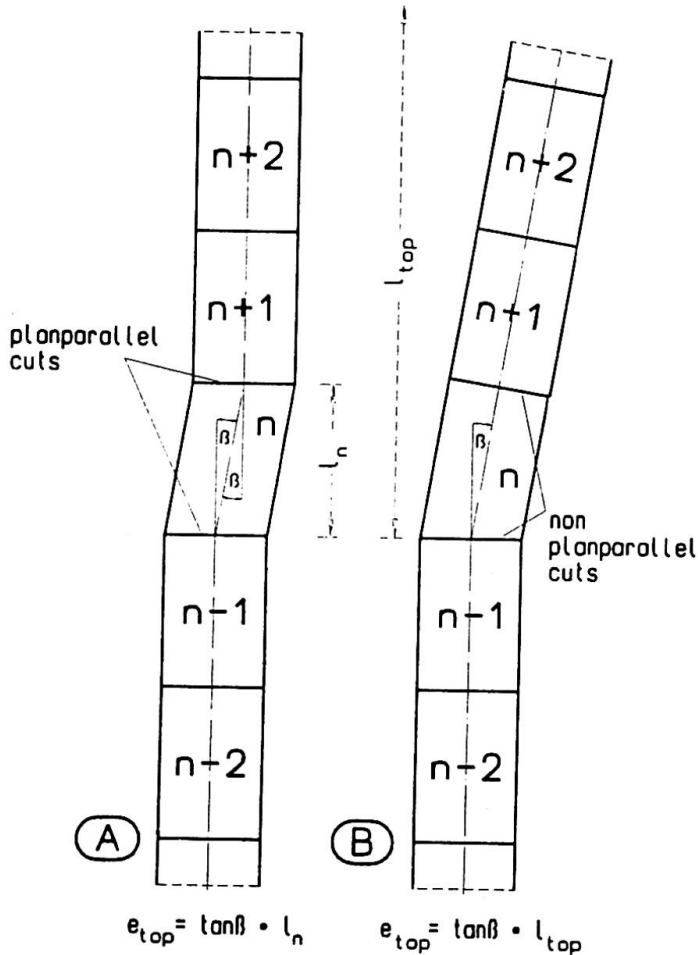
Fig. 2
Axis deviation due to skew cutting of individual section. For illustration (A) the skewed but planparallel cuts cause only a negligible shift of the axis.

Deviations from nominal pylon leg axis are caused mainly through skewed cutting of box section ends. On this account utmost care was taken during individual box machining. Before cutting of the second face was taken up, the box was aligned in reference to the face which was cut first. For this a dial gauge was mounted on the extended spindle of milling cutter to check perfect setting.

If cuts of an individual box are not perpendicular but planparallel (see A in Fig. 2), the amount of deviation from nominal axis is negligible, whereas non-planparallel cuts may lead to unacceptable eccentricities (see B in Fig. 2).

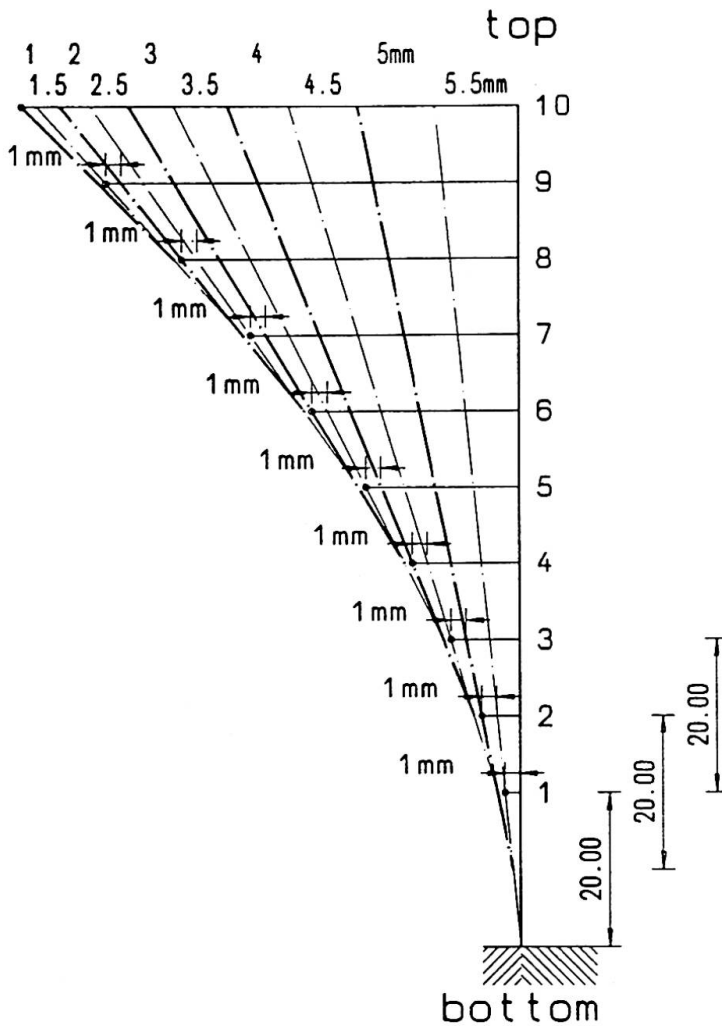
Fig. 3

Undetected deviation from nominal axis due to accumulative built-in error in control assembly survey, 10 nos. of assemblies with reference length of 20 m for each assembly lead to an eccentricity of 32.5 mm at top if built-in error is 1 mm per assembly.

An additional, but undetected deviation from the axis occurs due to a built-in error in survey procedure. Considering a 1 mm error per control assembly survey and assuming that the error accumulates in same direction for further assemblies, the deviation from nominal axis at the top amounts to 32.5 mm taking entirely 10 nos. of assemblies and the reference length is 20 m per assembly (see Fig. 3).

The undetected deviation at the tower top will increase with less reference length per assembly and more numbers of surveys. For that reason it could not be agreed to control assemblies with 3 or even 2 sections only.
