Fabrication survey of steel components facilitates quick bridge erection

Fabrication Survey of Steel Components facilitates Quick Bridge Erection

Rudolf BERGERMANN

Ulrich DILLMANN

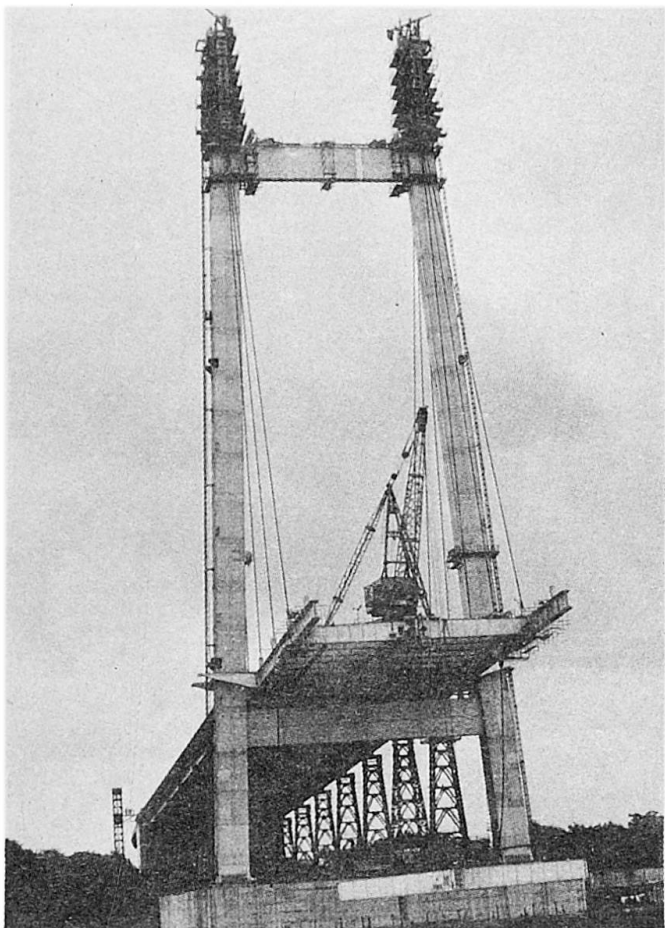
Fig. 1
H-shaped, 122 m high pylon at
Calcutta side

For the box sections of towers a fabrication survey procedure had to be established to control eccentricities of pylon axis either in longitudinal or in transversal direction of the bridge.

Space restrictions and progress of erection did not permit a full shop floor layout for the towers as it had been done for previous bridges. Transport and lifting facilities limited the length of a single box to a maximum of 6 m. Therefore one pylon leg comprises 19 sections up to the level of top portal.

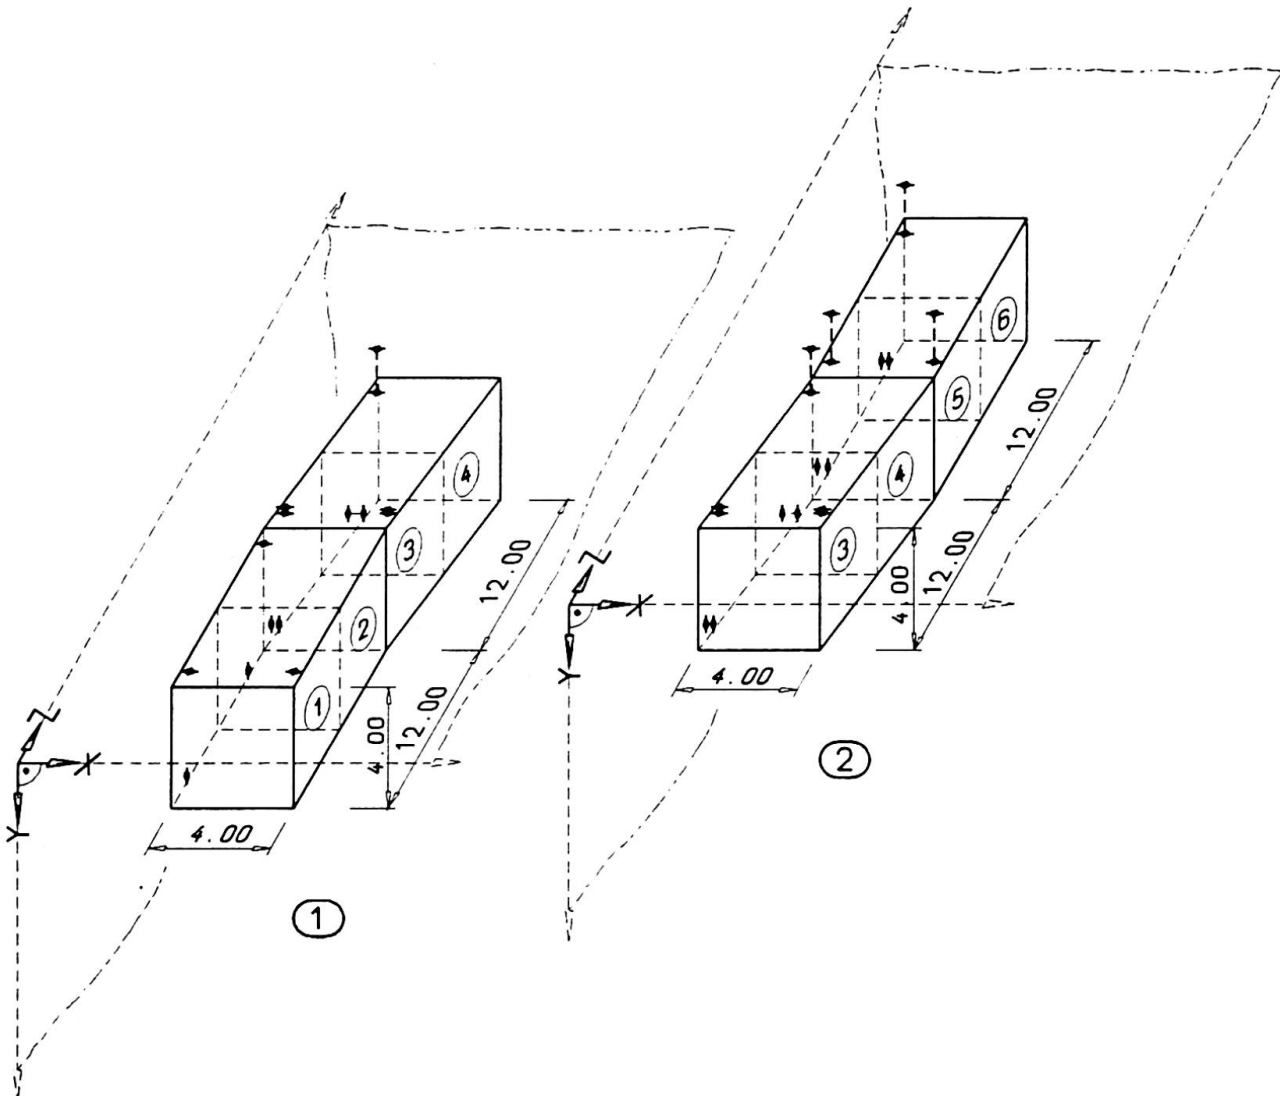
Sequence of control assembly for pylon leg, offsets at boxes 3 + 4 in assembly (1) are identical to offsets at same boxes in assembly (2) achieved by analytical transformation.

Shop floor survey for pylon legs has been executed with 4 sections per assembly horizontally laid out starting with base elements. By removing 2 rear sections and adding 2 sections at the front next assembly configuration was found. In Fig. 4 survey procedure for pylon legs is shown in principle for two subsequent assemblies. With a theodolite two perpendicular optical planes have been established. The intersecting line of these two optical planes represents nominal pylon leg axis. The offsets from the optical planes towards the wallplates of box sections were measured by scale in x-and y-direction. As a result, deviations from the axis were recorded.
