Investigations concerning the co-operation of old and newly added concrete structural parts

Ing. ADALBERT POGANY, Cracow.

I. Test of flexure on girders

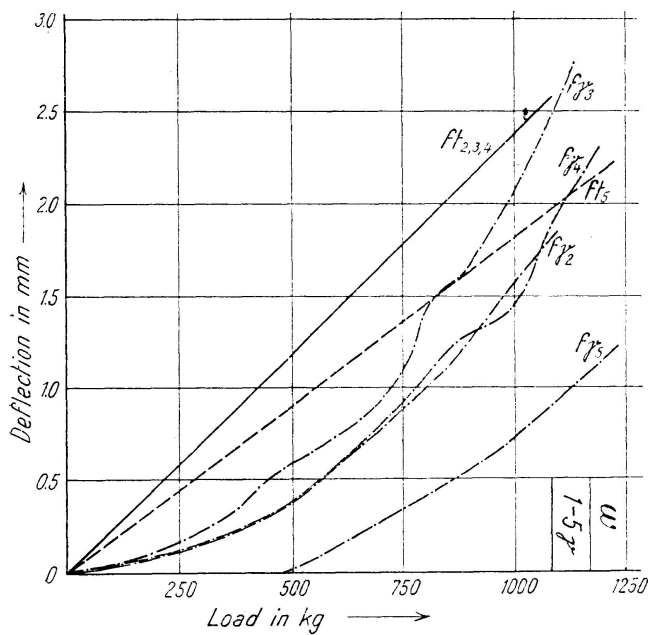
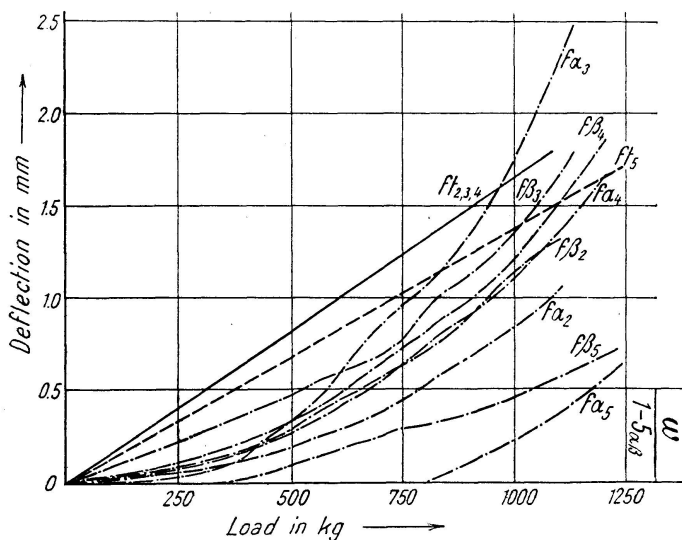
Comparison of the deflection

In the 6 graphic schedules three demonstrate the deflexion of the girders at the points α and β , also at points where the symmetric loads have their effects; the other three demonstrate the deflexion of the girders at the central points. On each schedule 5 girders of equal reinforcement are dealt with. One of them is homogeneously built of concrete, the four others in partly

new and partly old concrete with junctions at a different distance. For each of the groups the theoretical deflexion-line was calculated and traced out. It is known that the deflexion-line of a certain point is a straight one, i.e. that the deflexion of a point is theoretically proportional to the load. In practice there generally is a great discrepancy concerning this linear relation. The deflexion-lines for the points α and β should be theoretically the same. But this is not so, not even if homogeneously built. The disparity of deflexion is probably due to structural want of symmetry. The deflexion-lines of the points α and β and the deflexion-line of the point γ are not parallel. The γ lines generally are steeper, the moment and stress greater, the fractures show earlier and the deflexion-line reaches earlier the plastic sphere than at α and β -lines.

On a plain girder there is generally (but not always) the smallest deflexion to be seen. The cracks in it are nearly always later shown and the plastic sphere is reached at the latest time.

The deflexion-lines of the girders newly joined with concrete, are variable and more sensitive. They have not the same slightly parabolic character as those of the plain girders. One has the feeling as if on the newly joined parts on the deflexion internal stretchings are levelled down in wave-like step, similar to the re-crystallization of cast-iron bars. The concrete girders built in two stages which, as above mentioned, reach the plastic sphere earlier, have a smaller load capacity.

A functional connexion between the distance of the junctions and the deflexion-dimension can hardly be established. But it is almost true, that the biggest deflexion arise on girders, on which the junctions are in the center of the girder with some exceptions. Between the deflexion of girders without stirrups and those with stirrups there seems to be no great difference and the stirrups seem to have no greater tension-distributional influence concerning the deflexion.

In the first and second group (of 4 five-millimetre reinforcement) the bending lines contrary to the third group (of 2 eight-millimetre reinforcement), also with a greater reinforcement cross-section, show a quiet course. The four round bar-reinforcements seem to equilibrate the internal tension better than the 2 with a greater cross-section.

Concerning the last group (No. 16, 17, 18, 19, 20) it had to be established how the reinforcement taken from shattered constructions works in the newly joined concrete. The concrete-girders made from destroyed slabs, are made on the same principle as the rest (16, 17, 18, 19), all the four of them of reinforcement taken from shattered constructions. The girder No. 20 is also made of concrete and reinforced with steel. The deflexion-lines of the points α β and γ show clearly and without doubt the influence of the steel-reinforcement which is loaded to the utmost limit of bending. This fact is distinctly visible in girders 18 and 19. The α β and γ lines show great vari-

ation even after a relatively small loading. Thus the old reinforcements remaining from the shattered constructions have a great influence upon the lessening of the carrying capacity of the composite construction.

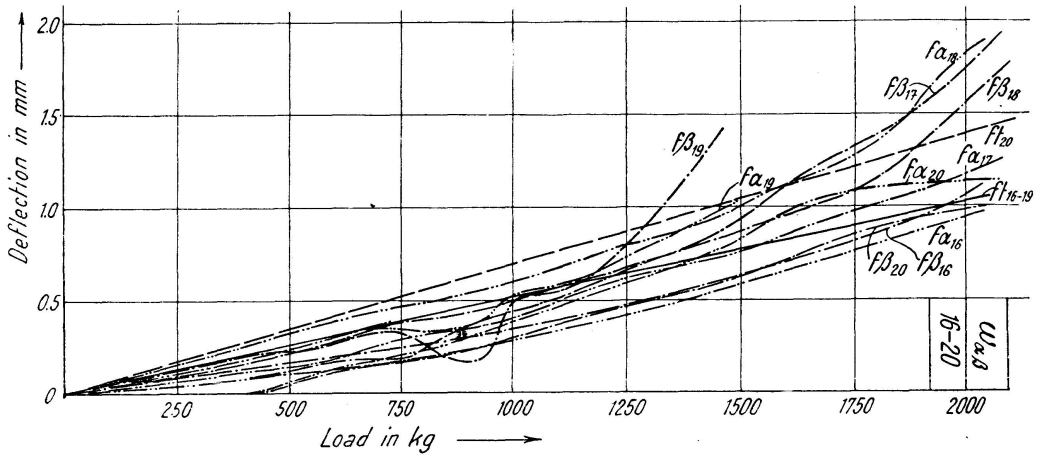
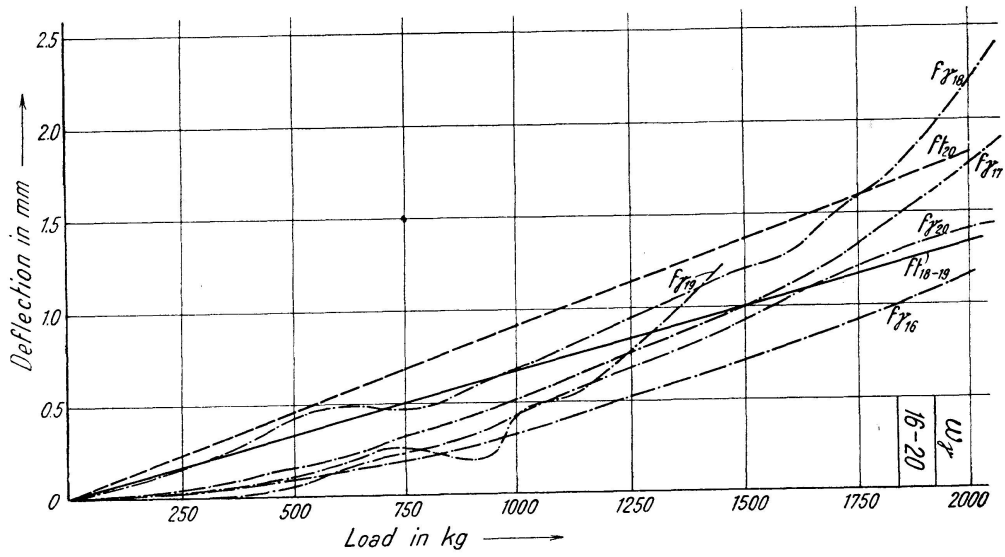
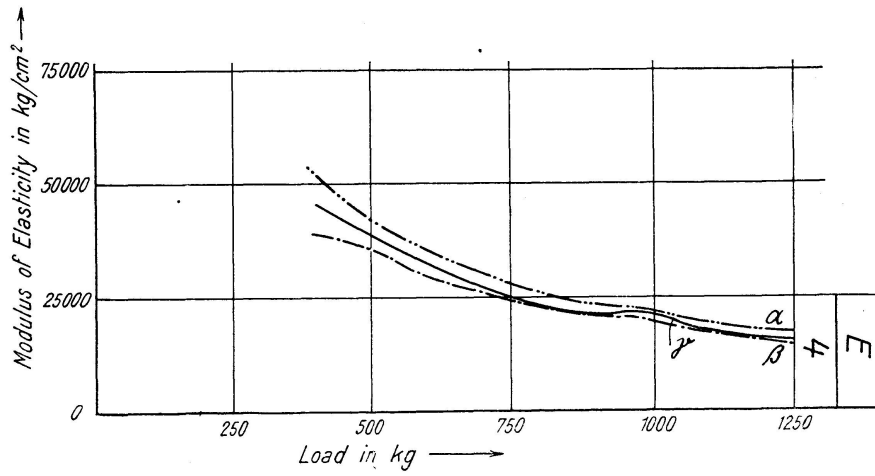
E-curve-lines

As above mentioned our E -values are in no simple connection with the moduli of elasticity of the concrete and steel; thus, even if there were a formal connexion to be found, I do not consider that the efforts made in this respect clear up our problem. The calculation of our E -value derived from the deflection-value also contains physical hypotheses which do not entirely agree. All the E -curved lines have a common characteristic feature: they have a parabolic form of greater importance and approach the axis of forces asymptotically.

The E -value diminishes with greater loading. It is clear that if near the plastic sphere the load is heavier, the deformations are greater. The E -value is on the contrary proportional to the deformation. The E -curve lines are in the same girder nearly parallel concerning the points α , β and γ . With one part concrete (girder No. 10) the three lines nearly synchronize with each other. Also there where the points of measurement α , β and γ fall on the concrete built at the time (the three of them on the older, or the three of them on the newer part), the curve-lines are parallel and very near to each other. But if the points lie on different parts (new and old) the E -curve-lines not only are not parallel but sometimes cut each other and have irregular local deviation. The E -curve-lines are very sensitive to all the internal tensions which arise in the joined construction through additional building with con-

crete. The biggest differences generally are in the smallest deflexions and slowly diminish in the plastic sphere. The analysis of the curve-lines of the girders No. 16 to 19 confirm the result obtained of the deflexion-line. It is clear also here that the reinforcement works even under a smaller load already in the plastic sphere, thus explaining the early proceeding of cracks in the concrete. The E -curve-line of girder No. 20 (one part concrete-addition to new reinforcement) is also traced out concerning the smaller sphere of load and shows in the sphere of initial loading very big values. Loading of about 600 kg (1323 lb.) causes a very big change of deformation. On the girder built of two part concrete the first part of the deformation of the E -curve-line with its steep branches could not be established.
