Zeitschrift: IABSE proceedings = Mémoires AIPC = IVBH Abhandlungen
Band: 10 (1986)
Heft: P-104: Fatigue strength of tension flanges with stud shear connectors

Artikel: Fatigue strength of tension flanges with stud shear connectors
Autor: Maeda, Yukio / Kajikawa, Yasuharu
DOI: <https://doi.org/10.5169/seals-39613>

Fatigue Strength of Tension Flanges with Stud Shear Connectors

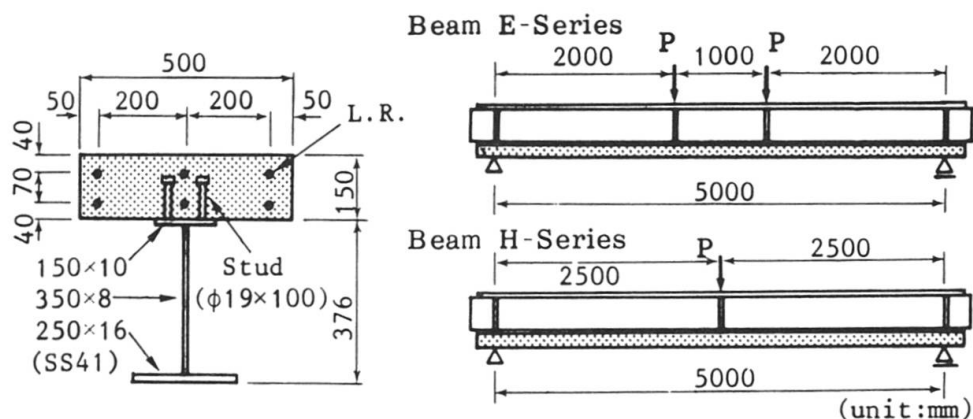
Fig. 1 Cross-section and loading points of beam specimens.

All of the beams have the same cross-section, but the loading condition for E-series is different from H-series as shown in Fig. 1. In each specimen, combinations of longitudinal reinforcements (in terms of the diameter, D) embedded in the slab and stud spacings along the beam were decided as shown in Table 1. As the result of the material test, the yielding point, the tensile strength and the elongation for the steel beam of which grade was SS41 by JIS (Japanese Industrial Standards) designation, were 279 MPa, 444 MPa and 30 %, respectively. The mean compressive strength of the slab concrete was 30 MPa.

The beam was simply supported with the span length of 5 meters, setting the concrete slab upside down as shown in Fig. 1. Repeated negative bending moments were applied to the steel flange of the beam by using hydraulic jacks of a Losenhausen-type fatigue testing machine at the rate of about 5 Hz.

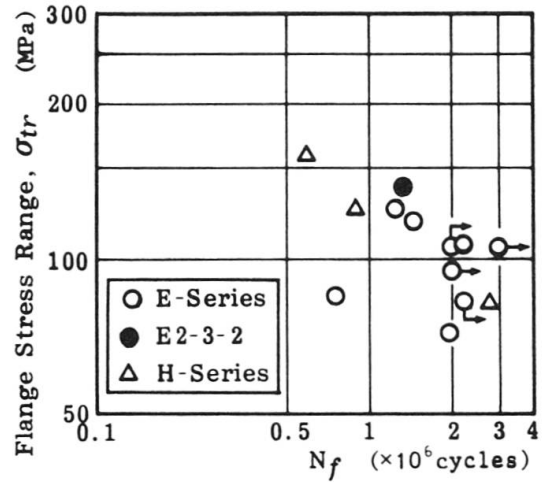
Fig. 3 S-N relations for beam specimens.

Fig. 3 shows S-N relationships expressed in terms of flexural stress ranges in the tension flange, σ_{tr} . The points vary widely and the fatigue strength at two million cycles is only about 80 MPa. These would have been caused by changes in material properties due to the welding heat, occurrence of weld residual stress, stress concentration due to the discontinuity of geometrical shape at the root of the stud, and so on. Judging from the above-mentioned conditions for the crack initiation, however, it can be known that the horizontal shear force which acted on the stud shear connector must be a more important influence factor for the fatigue life of the tension flange.

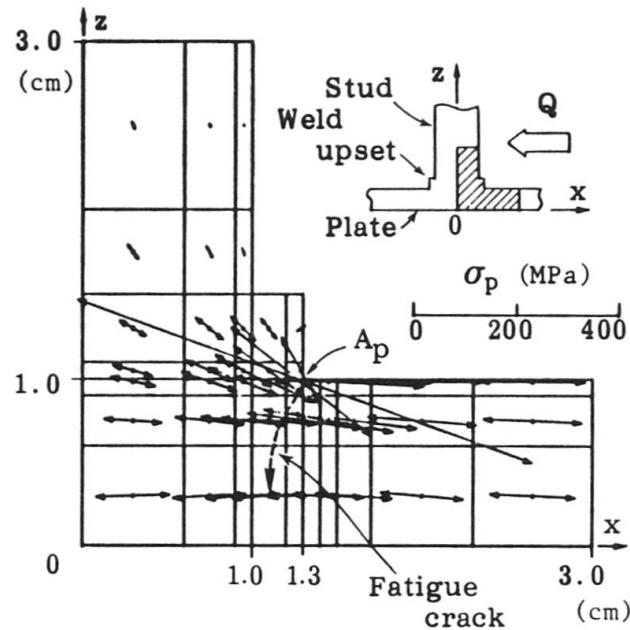
Fig. 16 Principal stress distributions at the base of stud under combined tension and shear.

Fig. 16 shows a maximum principal stress distribution in the vicinity of the point A_p in a symmetrical section (z - x plane at $y=0$). The flow of tensile principal stresses in the plate is distorted at the corner point A_p due to the both of geometrical discontinuity and shear force, and a large amount of the stresses penetrate into the stud shank through the weld upset. The principal stresses, too, were distributed similarly to those obtained by superposing the case of tension and that of shear. The broken line in the figure shows the approximate propagating path of a fatigue crack which was observed in the test for D-series. Its direction is nearly perpendicular to the flow of the principal stresses throughout the length. From these facts, the fracture process under the combined loading could be explained to a certain extent.

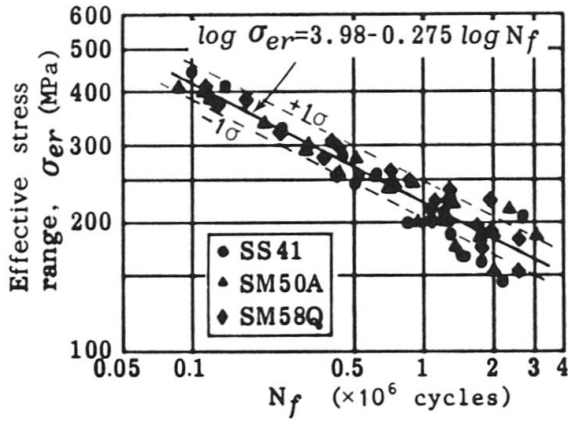
Fig. 17 S-N relations for effective stress.

The rearranged data by applying Eq.(3) to the test results for four different test series (C, D-1, D-2 and D-3) of the three kinds of steels (see Figs. 6 ~ 8), are plotted in Fig.17 in terms of the effective stress range, σ_{er} . A S-N curve and a scatter band (σ means standard deviation) of all the points which were determined by using the least square method, are also shown in the figure. Most of the points are distributed in a comparatively narrow scatter band, though they vary somewhat widely at the cycle lives larger than one million cycles.

From the fact that all of the data formed a well-arranged S-N relationship irrespective of shear stress levels or steel grades, it was recognized that the fatigue strength of plates with welded studs under combined tension and shear could be reasonably evaluated by the effective stress.

The lower confidence limit with minus two standard deviations for the present test data in Fig.17 can be expressed by a S-N curve with the slope constant of $m=3.6$ which nearly gives σ_{er} a value of 150 MPa at 2×10^6 cycles. The plate with studs under combined stress conditions might be conveniently classified into the Detail Category 140 on the safety side provided that a normal stress range on the ordinate in Fig.19 is regarded as an effective stress range. Then, the fatigue strength $\Delta\sigma_R$ could be determined in accordance with Chapter 6 (Fatigue Strength) in the Recommendations, although this classification results in a higher category in comparison with those for the above-mentioned similar cases due to the combined effects of normal and shear stresses on the fatigue strength.

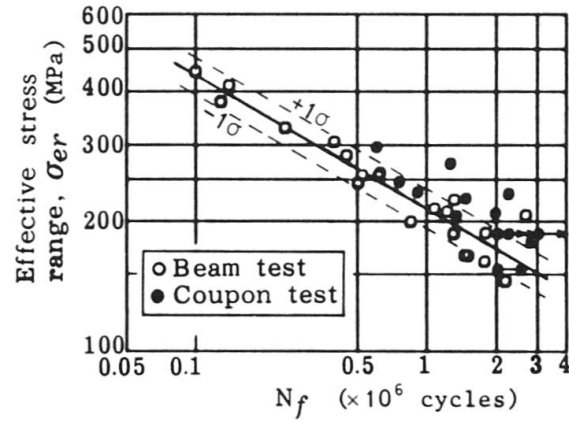
Fig. 18 Comparison of fatigue data between beam tests and coupon tests for SS41.

Next, the beam-type test results in Table 1 are compared with the coupon-type ones for SS41 steel by using the effective stress as shown in Fig. 18. The S-N curve and scatter band were obtained for the coupon-type test data only. The beam test results scatter near the upper bound of the scatter band, being distributed nearly parallel to the S-N curve of the plate. The difference between them might be caused mainly by over-estimation of stud forces in the beam specimens, because the stiffness of cracked concrete slab could not be exactly assumed in the

incomplete interaction analysis. Taking into consideration of such over-estimation of the stud forces, the fatigue characteristics in both beam-type and coupon-type tests could be consistently interpreted by means of the effective stress. Besides, it may be said that the fatigue strength of the flange on which the studs are welded can be estimated sufficiently by the coupon-type test data.

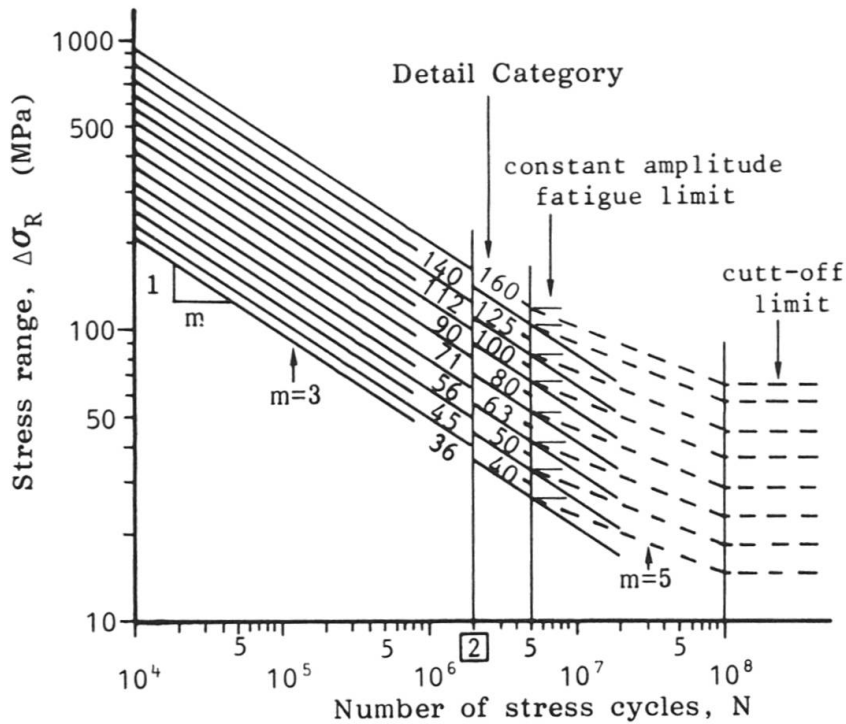
Fig. 19 ECCS-TC6 fatigue strength curves for normal stress ranges.

- where $\Delta \sigma_R$: the fatigue strength defined as the stress range in Fig.19 corresponding to a given number of stress cycles,
- $\Delta \sigma_E$: the equivalent constant amplitude stress range which is calculated from the design stress spectrum,
- γ_m, γ_s : partial safety factors to be applied to the fatigue strength and the fatigue loading, respectively.

Fig.19 indicates the ECCS-TC6 fatigue strength curves for normal stress ranges and these curves represent the mean experimental value minus two standard deviations for the details classified.
