**Zeitschrift:** IABSE proceedings = Mémoires AIPC = IVBH Abhandlungen  
**Band:** 11 (1987)  
**Heft:** P-107: Design and construction of the flood resistant Pongola River Bridge

**Artikel:** Design and construction of the flood resistant Pongola River Bridge  
**Autor:** Oosthuizen, Andries / Davis, Stuart  
**DOI:** <https://doi.org/10.5169/seals-40367>

## Design and Construction of the Flood Resistant Pongola River Bridge

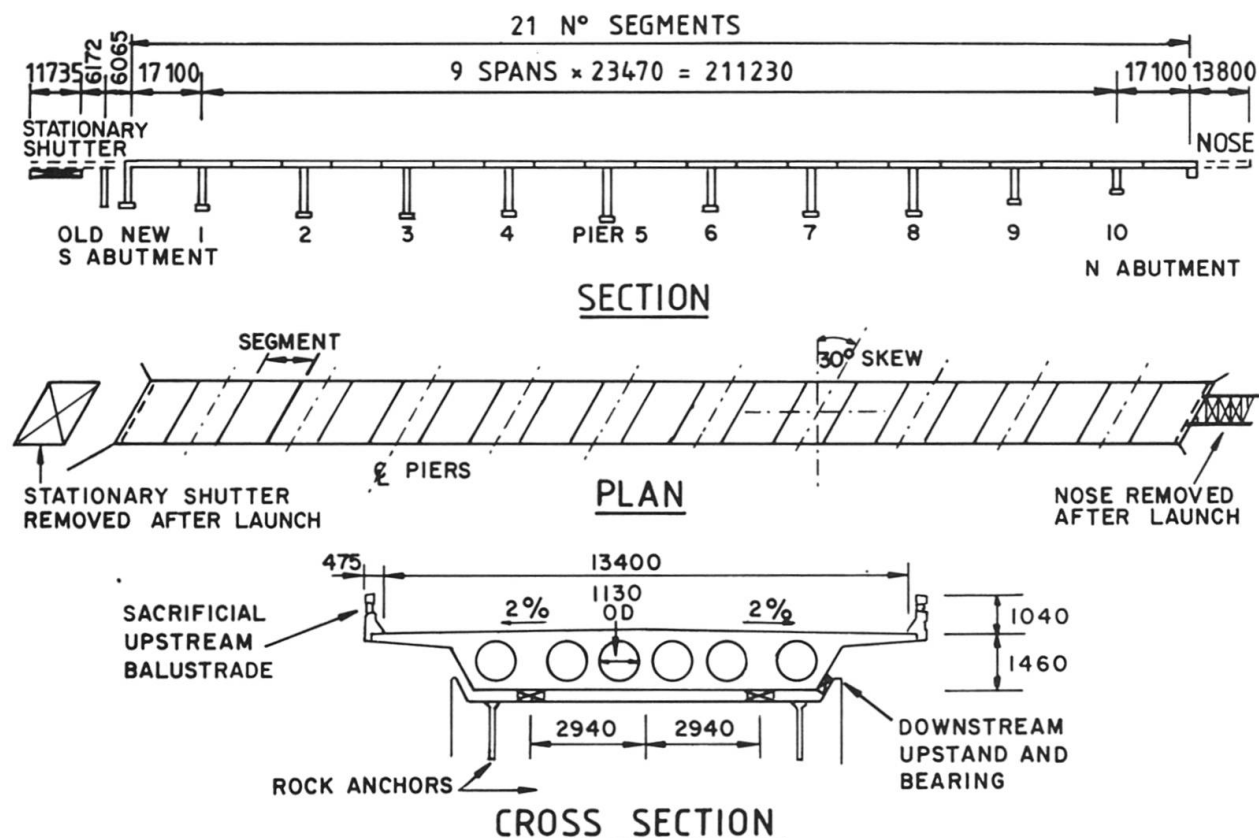
Figure 1: GENERAL ARRANGEMENT

These criteria led to the choice of an 11 span continuous, reinforced concrete, voided slab with cantilevers. A beam and slab configuration like the previous structure was rejected both for hydraulic reasons and because the replacement bridge is wider than the previous one, and this would have meant widening the piers to accommodate the additional beams. Both full and partial prestressing of the slab were investigated but were found to be considerably more costly than the reinforced concrete alternative. Circular voids were chosen in preference to rectangular ones to simplify construction of the shallow, 1,6 m deep slab. The general arrangement of the bridge is shown in Figure 1.

In cross-section, the deck comprised 6 circular voids with, correspondingly, 7 webs. The two bearings were positioned under the webs adjacent to the outermost pair (that is, under webs 2 and 6). In the final condition, loads are transferred to the bearings by the heavy cross-beam located over the bearings, but clearly during the launch this cross-beam was not always present. Without the cross-beam, very high shear forces have to be transmitted transversely across the top and bottom flanges of the circular voids adjacent to the bearings. This effect was minimised by departing from the usual uniform void spacing and increasing the width of the two webs positioned on the line of the bearings, as shown in Figure 1.

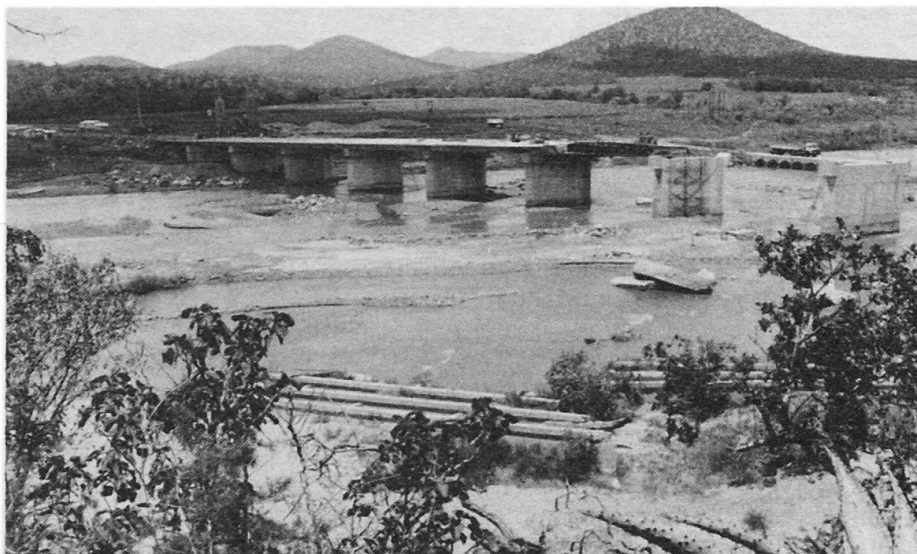
Fig. 3 : Bridge during construction, with remains of earlier structure in the foreground.

The deck was then constructed by incremental launching from the South bank. The lack of prestress and overall simplicity of the deck cross-section allowed for the unusually short cycle time for the preparation, casting and launching of each segment of 5 days. Segments were launched after about 62 hours, once a concrete strength of 15 MPa had been obtained. This is considerably less than the usual strength requirement for an incrementally launched deck. With the 5 day cycle, the bridge deck was constructed at a rate equivalent to 33 m<sup>2</sup> of deck per day.

The bridge is shown under construction in Figure 3.
