## Conserving and Strengthening Prestressed Concrete Structures

### Dieter JUNGWIRTH

Dr.-Ing., Dir.  
Dyckerhoff & Widmann AG  
Munich, Fed. Rep. of Germany

Using the Gänstor prestressed concrete bridge in Ulm as an example for strengthening, the tasks involved are explained and further typical applications are illustrated.

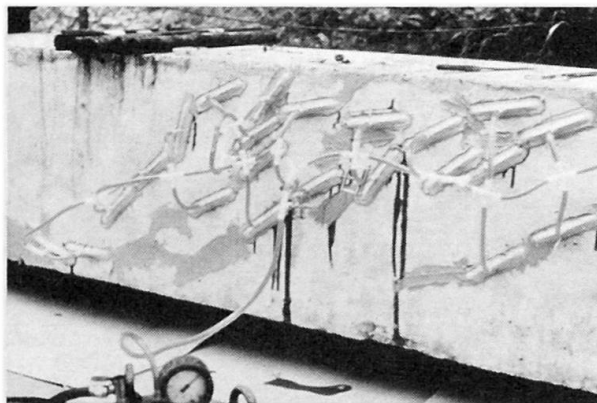
Fig. 18 Example of Crack Grouting

- . sealing, coatings to fill out cracks
- . crack grouting (Fig. 18); particular requirements must be observed when grouting coupling joints
- . repairing corrosion locations
- . vacuum grouting, using specially formulated resins, if need be (Table 2) in wet ducts (high specific weight, water displacing, high consolidation etc.).

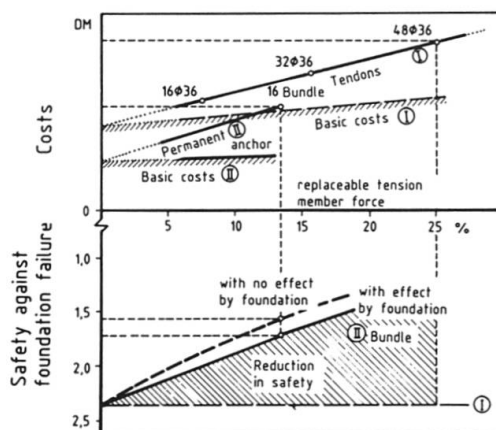
Fig. 21 Impact of Safety Against Foundation Failure on Repair Costs

Fig. 21 shows the relationship between the performance of the various measures, the loss of safety due to penetrating investigation of the structure, and the costs, thus aiding the client in making a decision which, in the end, must also take into account further - and also political - criteria for the one or the other case. Lastly this must be the best solution as regards the overall cost effective considerations. A decision was made in favour of the permanent anchor solution.
