INTRODUCTORY REPORT

H. THUL – F.K. REINITZHUBER
Germany

1. The Orthotropic Plate

4. Nature of Damage and its Causes

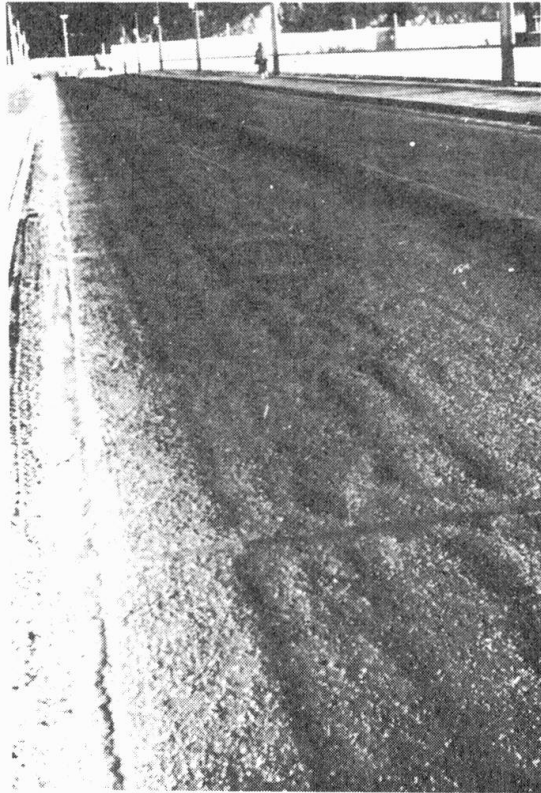
Rutting is a frequent problem, caused at high temperatures by a bitumen content either too rich or too soft. Ruts may be spaced regularly corresponding to the longitudinal stiffeners. See figure 6.

Figure 6: Rutting (transverse waving)

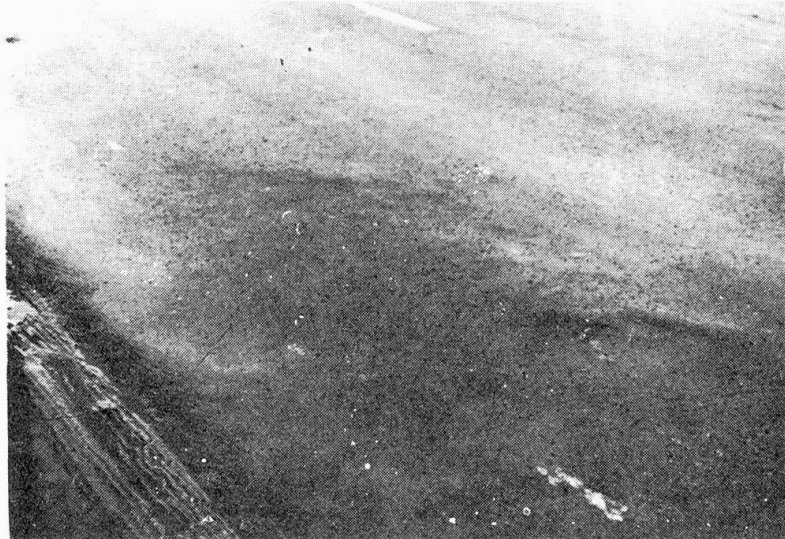
The surfacing may, however, have become so soft that, due to traffic, lateral shoving occurs over long distances forming wide ruts superimposed on the aforementioned undulations, spaced like the stiffeners. See figure 7.

Figure 7: Big-sized shoving,
up to 7 cm deep

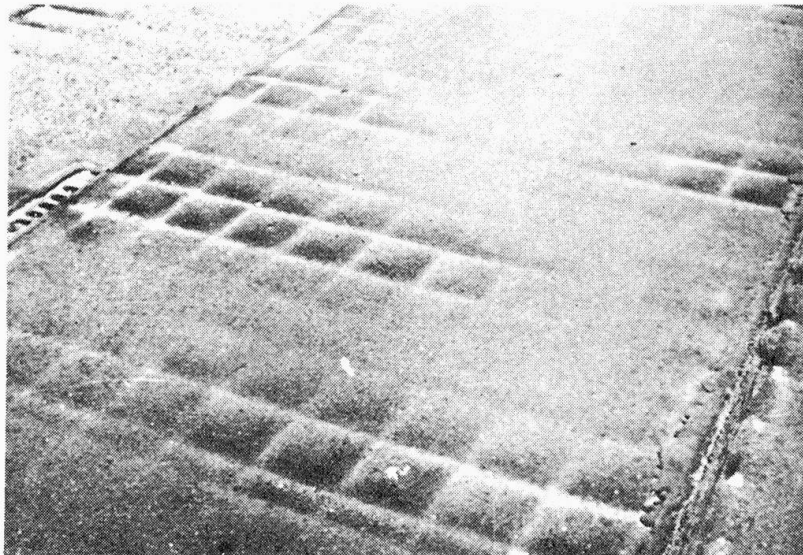
Any surfacing will be destroyed within short time due to insufficient shear strength or bond. It has been tried, therefore, to dowel the surfacing to the steel plates by mechanical means, e.g. by welding mesh reinforcing steel on studs to the plate. This method has not been successful. Due to different thermal expansions of steel and asphalt square targets in size of the mesh appeared on the top surface, presumably indicating insufficient bond. Small furrows up to 2,5 cm = 1" deep may develop atop of the mesh rods, causing cracks in harder types of asphalt and, eventually, destruction in total. See figure 13.

Figure 13: Steel mesh anchoring;
plasterlike top surface
