INTRODUCTORY REPORT

H. THUL – F.K. REINITZHUBER
Germany

1. The Orthotropic Plate

4. Nature of Damage and its Causes

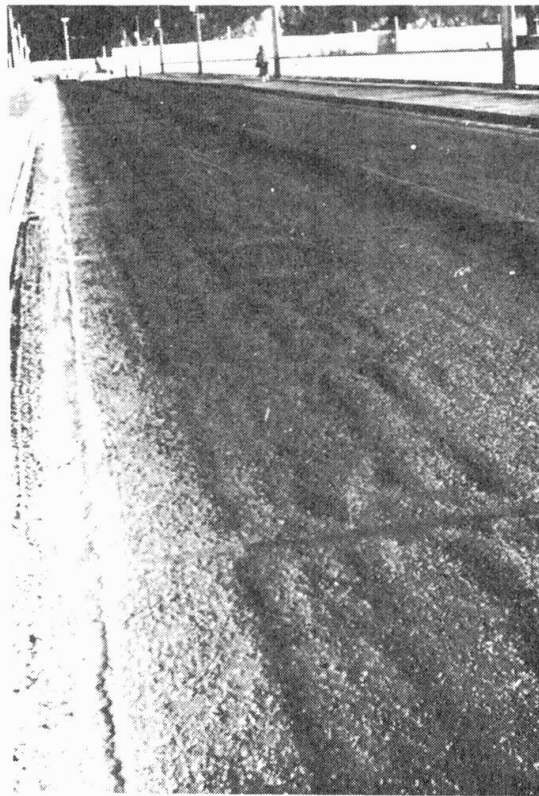
Rutting is a frequent problem, caused at high temperatures by a bitumen content either too rich or too soft. Ruts may be spaced regularly corresponding to the longitudinal stiffeners. See figure 6.

Figure 6: Rutting (transverse waving)

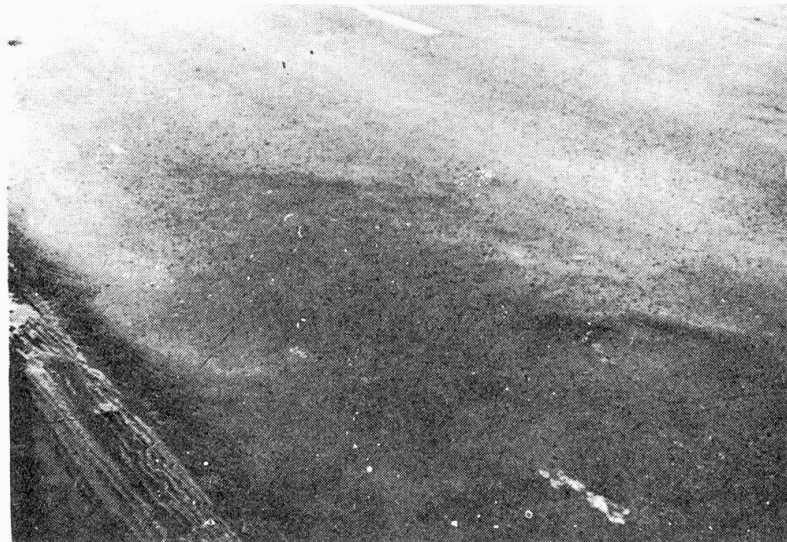
The surfacing may, however, have become so soft that, due to traffic, lateral shoving occurs over long distances forming wide ruts superimposed on the aforementioned undulations, spaced like the stiffeners. See figure 7.

Figure 7: Big-sized shoving,
up to 7 cm deep

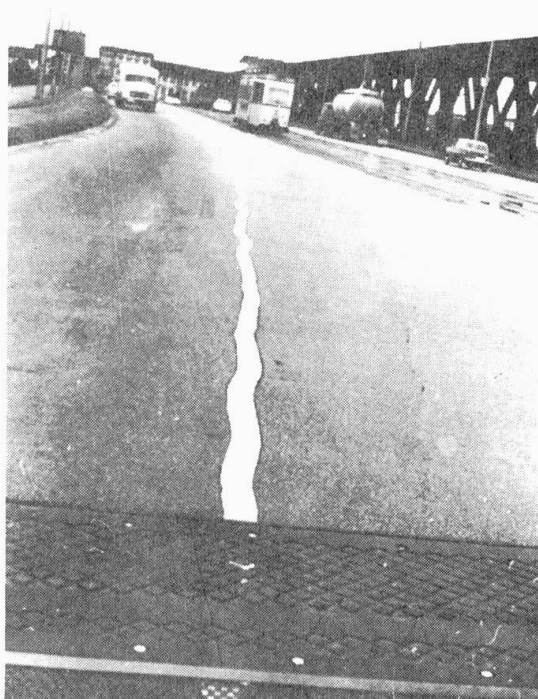
Even shoving and flowing of big areas has been observed on the top surface. See figure 10.

Figure 10: Shoving visible from
deformed marking strip
