Ship Collisions with Bridges in Sweden

Werner von OLNHAUSEN

Head, bridge section,
Swedish Natl. Road Adm.
Borlänge, Sweden

The article gives some facts about five ship collisions with bridges, which have happened in Sweden since 1965. The road administration has developed design rules, which have been applied for new bridges since 1967. After the Tjörn bridge disaster in 1980 a complete survey was made of the collision risk at all Swedish bridges.

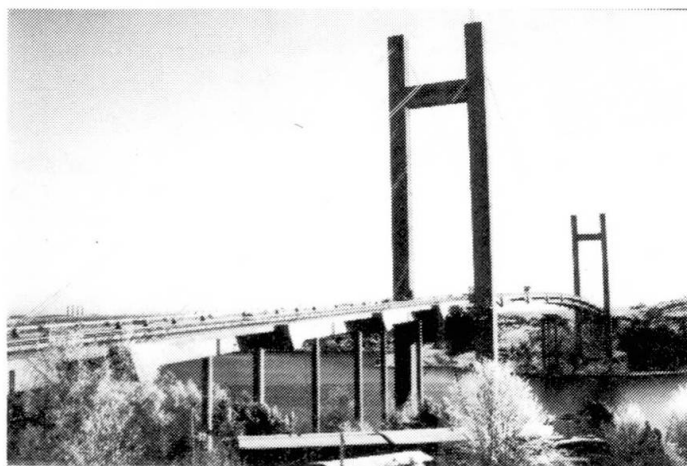
Fig 3. The new Tjörnbridge

About 16 month after the order - certainly a remarkable record in construction time - two lanes of the new bridge could be taken into use on Nov. 9th 1981, fig 3. The total cost for the new bridge and the temporary ferries was about 210 M SEK.

The collapse of the bridge interrupted a very important communication for the people on the islands of Orust and Tjörn, prolonging the roadway distance to Gothenburg by about 80 km. A provisional ferry-lane was therefore established immediately after the disaster, giving a capacity of about 2000 vehicles/day. At the same time a new bridge was planned and - after an international competition - the order for its construction was given in medio July 1980 to a Swedish-German consortium. The new bridge was built on the same place, but as a cable-stayed steel boxbeam of 366 m theoretical span. The about 100 m high pylons and the approaches were made in reinforced concrete. In order to make sure that the new bridge not could be hit by a ship, the pylons were placed on the rocks about 25 m on land. The free height was chosen to 45,3 m on 110 m width.-
