Newport bridge collision

Newport Bridge Collision

Thomas R. KUESEL
Senior Vice President
Parsons Brinckerhoff
Quade & Douglas, Inc.
New York, NY, USA

In 1981 a main tower pier of the 488-m Newport suspension bridge in Rhode Island, USA, was struck head on by a fully laden 45,000-ton tanker. The ship was shortened 3.5 m through bow crushing, but the bridge pier suffered only superficial damage. Details of bridge design and accident are given, and forces developed during the collision are derived.

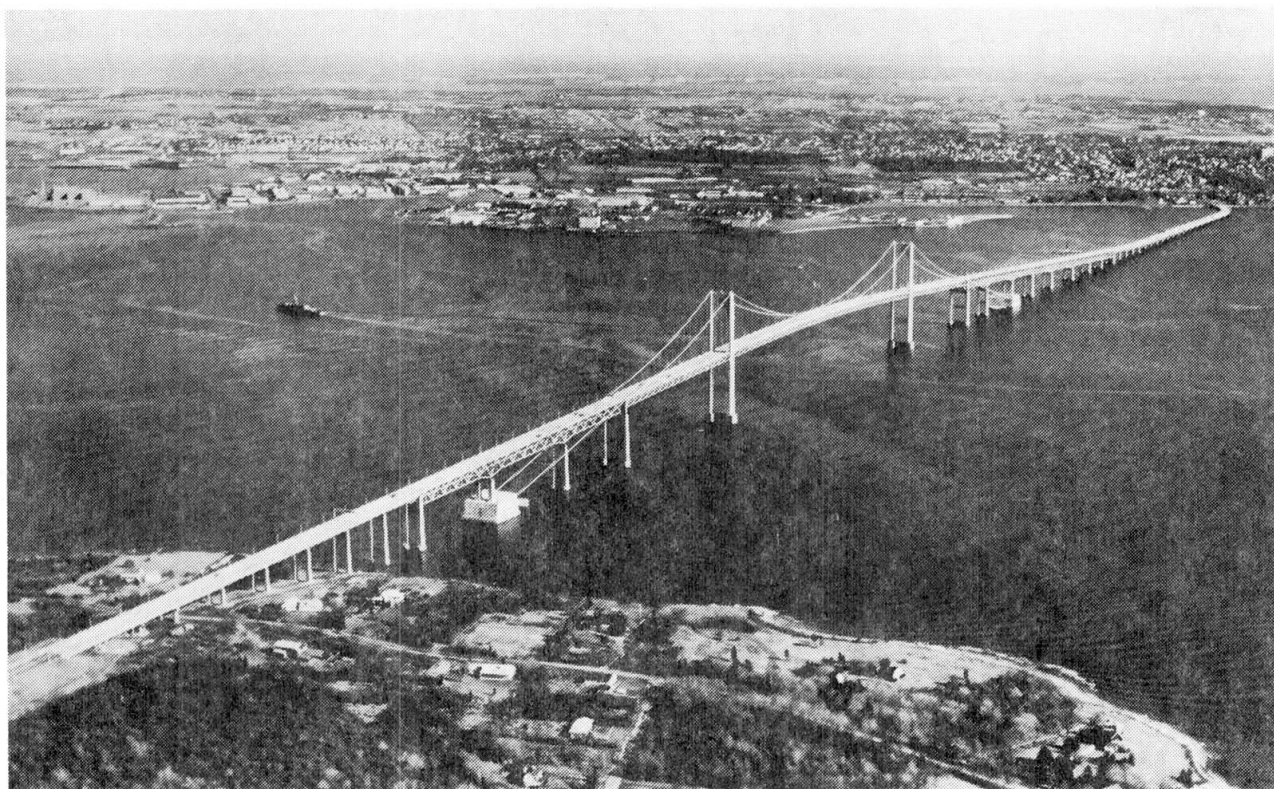
Fig. 1. Newport Bridge, Newport, Rhode Island, USA.

The Newport Bridge is approximately 3 km long, crossing the Eastern Passage of Narragansett Bay at Newport, Rhode Island (Fig. 1). The main shipping channel is bridged by a suspension span 488 m long, with a clear height of 66 m at the center of the channel. The water depth beneath the suspension spans ranges from 30 to 45 m. The tower piers are of "Potomac type" caisson construction, founded on steel H-piles driven into sands that fill the glacial gorge underlying the bay.
