Diagnostic Analysis of Masonry Buildings

Luigia BINDA MAIER

Pier Paolo ROSSI

G. SACCHI LANDRIANI

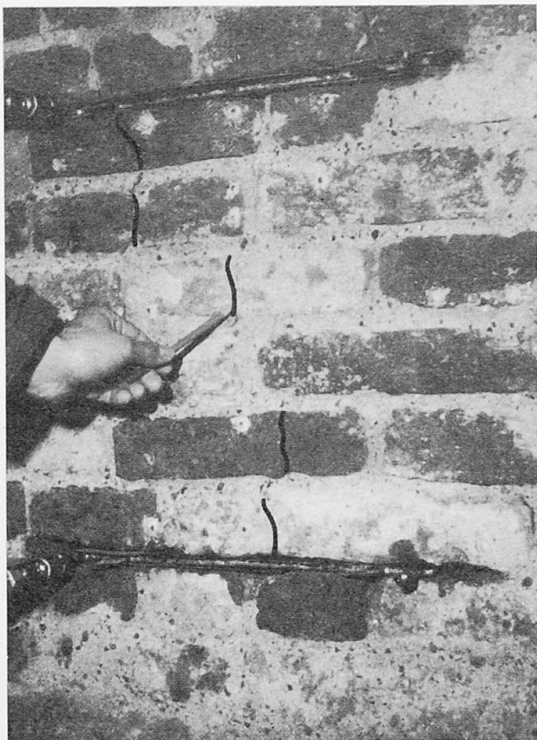
Fig. 12 Photo showing the appearance of first cracks.

To estimate the strength limit, a test was carried out up to the appearance of the first cracks in the bricks (Fig. 12).

The ultimate stress value measured was equal to 3.1 MPa.
