Analysis of a Brunelleschi-Type Dome Including Thermal Loads

A. CHIARUGI

M. FANELLI

G. GIUSEPPE

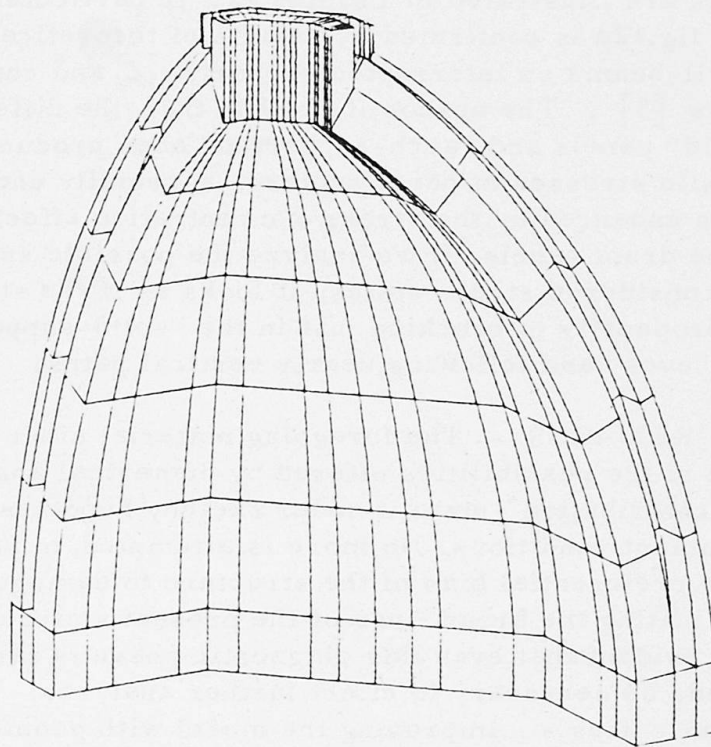
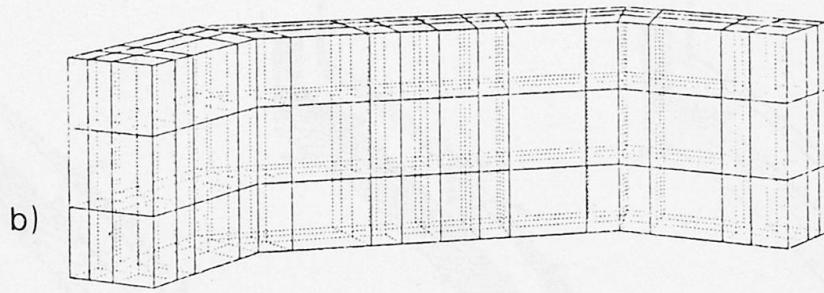
Fig. 1 a)

Fig. 1 - a) F.E. mesh of a quarter of the dome ; b) F.E. mesh of the drum underlying the dome

Fig. 5 - Contour lines of σ_z in horizontal sections: a) c) as in fig. 3 for hor. sect. at level of first gallery (load=deadweight); d) f) same as a) c) but for hor. sect. at level between second and third layer of elements in fig. 1 a)

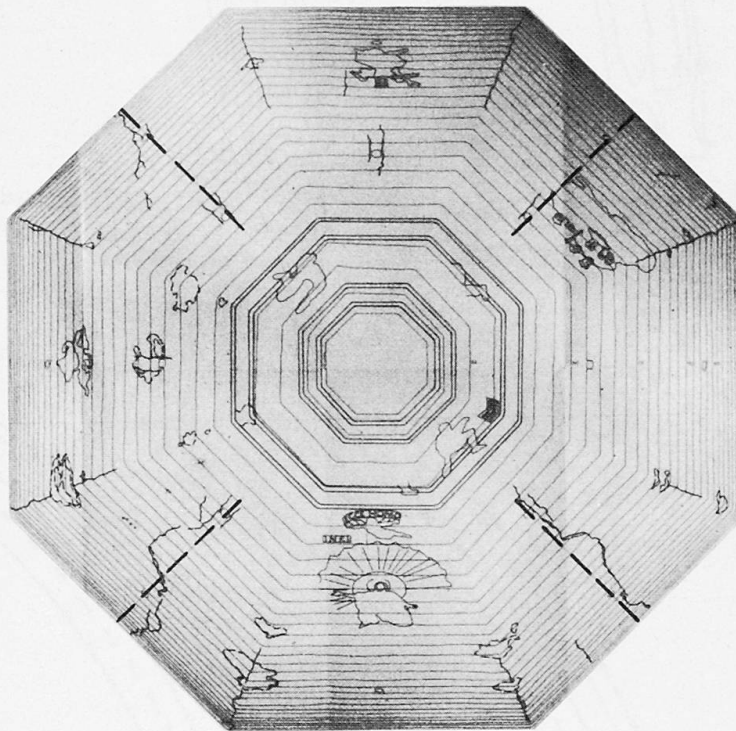
Fig. 2 - Nadiral view of crack pattern in Florence Cathedral dome
(-----) assumed cracks

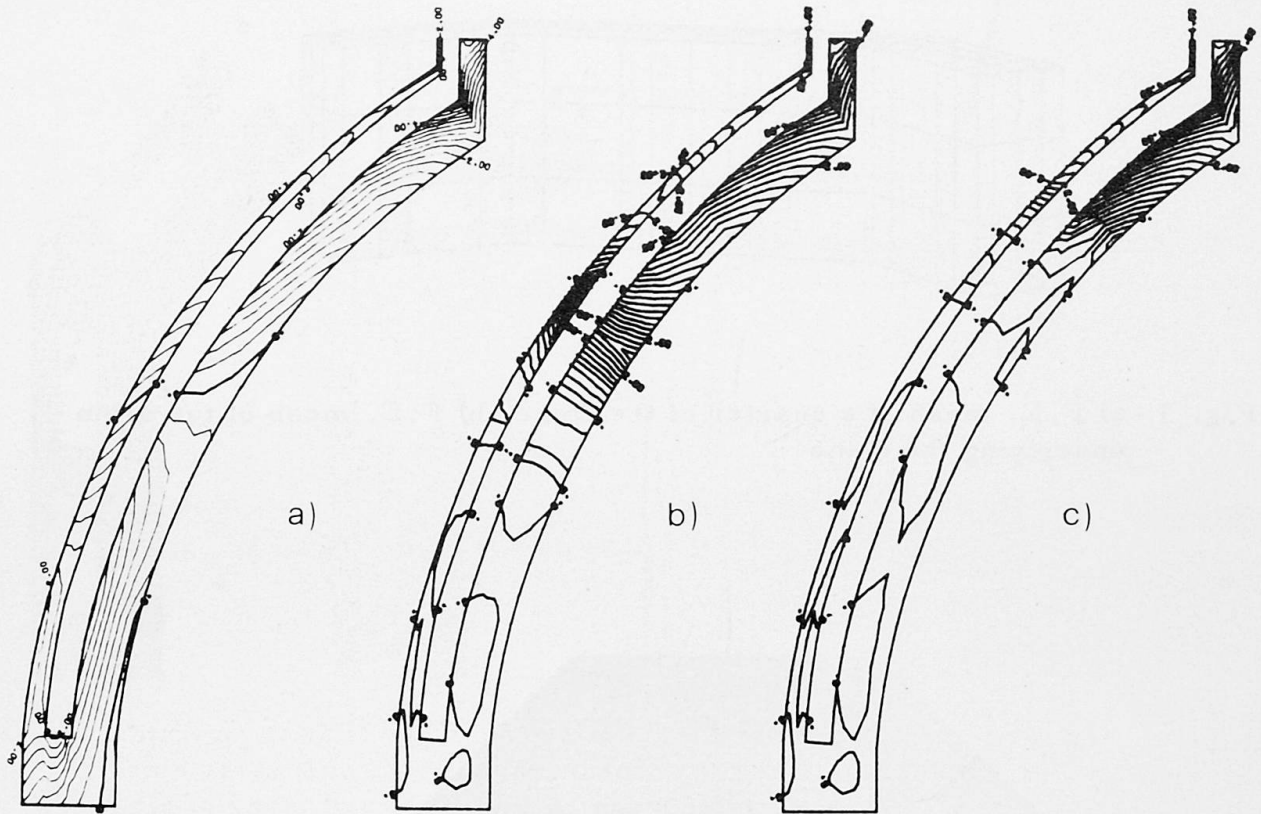
Fig. 3 - Contour lines of σ_x in the cross-section at mid-panel (load = dead-weight) ; a) uncracked structure; b) crack up to one-half height; c) crack up to two-third height

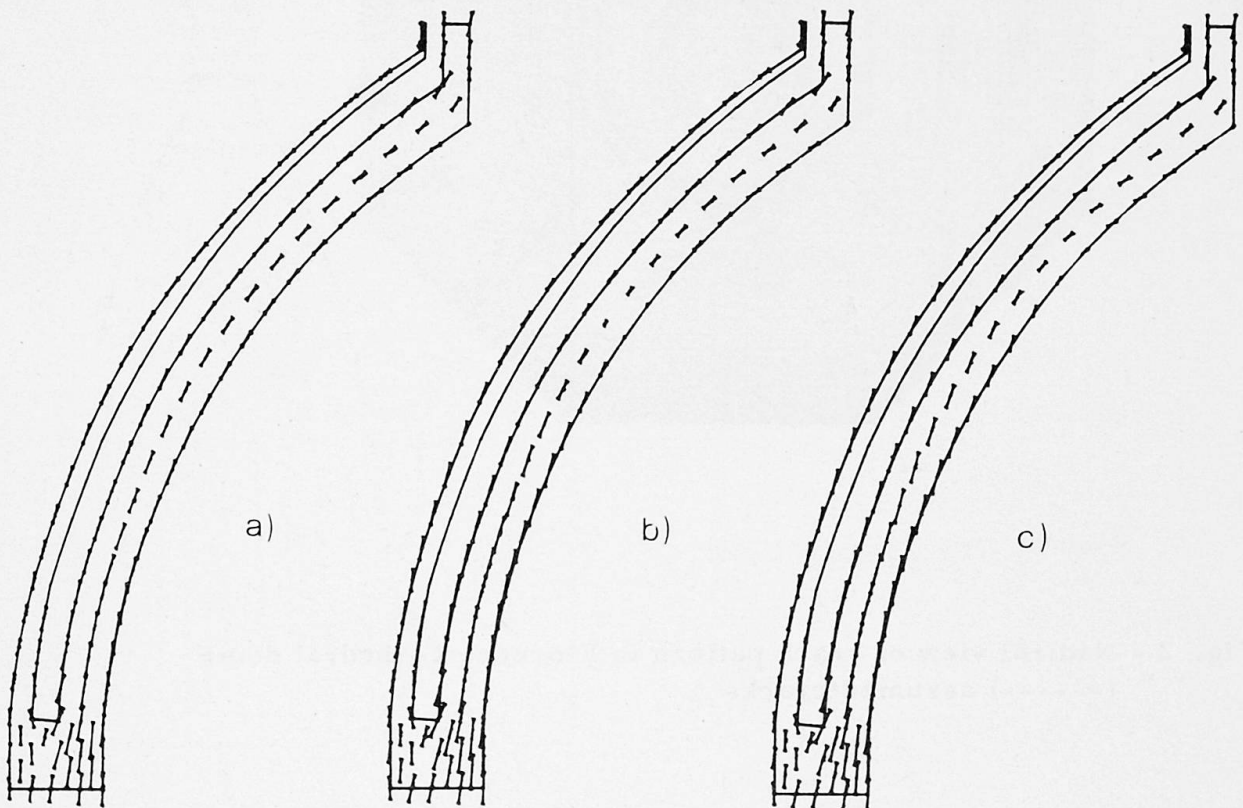
Fig. 4 - Principal stresses in cross-section at mid-panel: a) b) c) as in fig. 3 (load=deadweight)

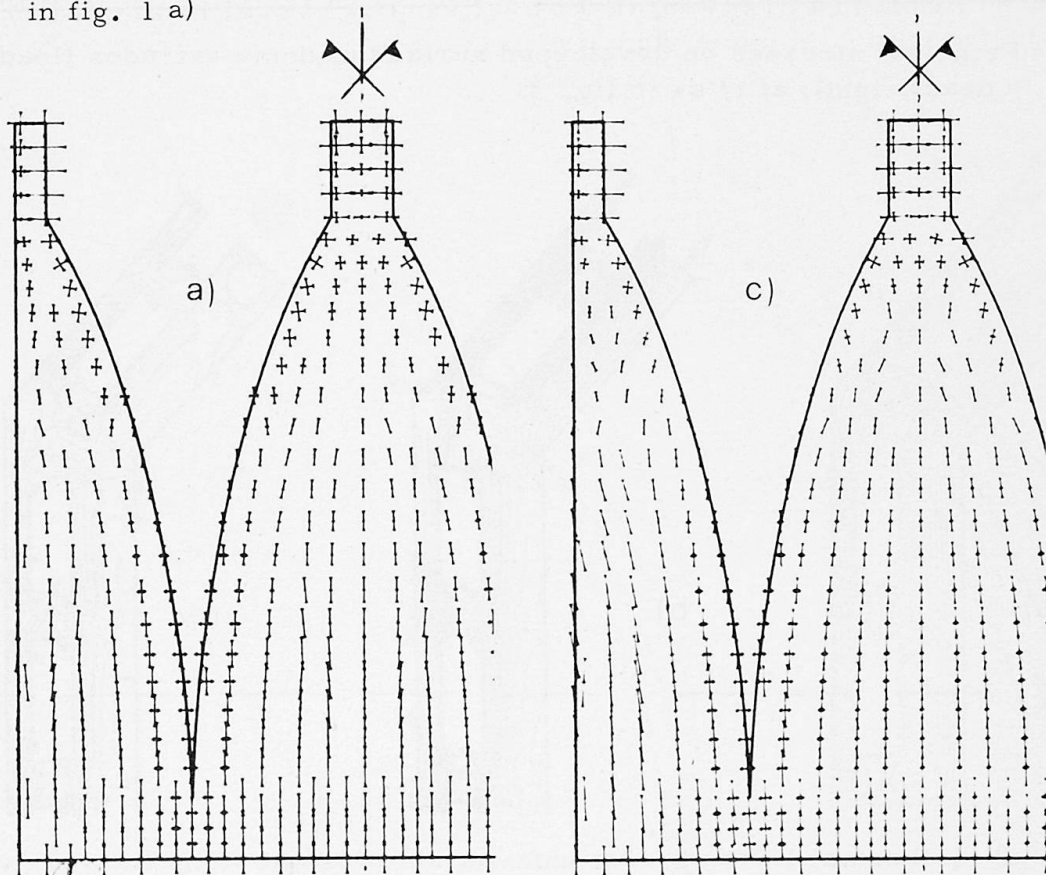
Fig. 6 - Principal stresses on developed surface of dome intrados (load = deadweight); a) c) as in fig. 3

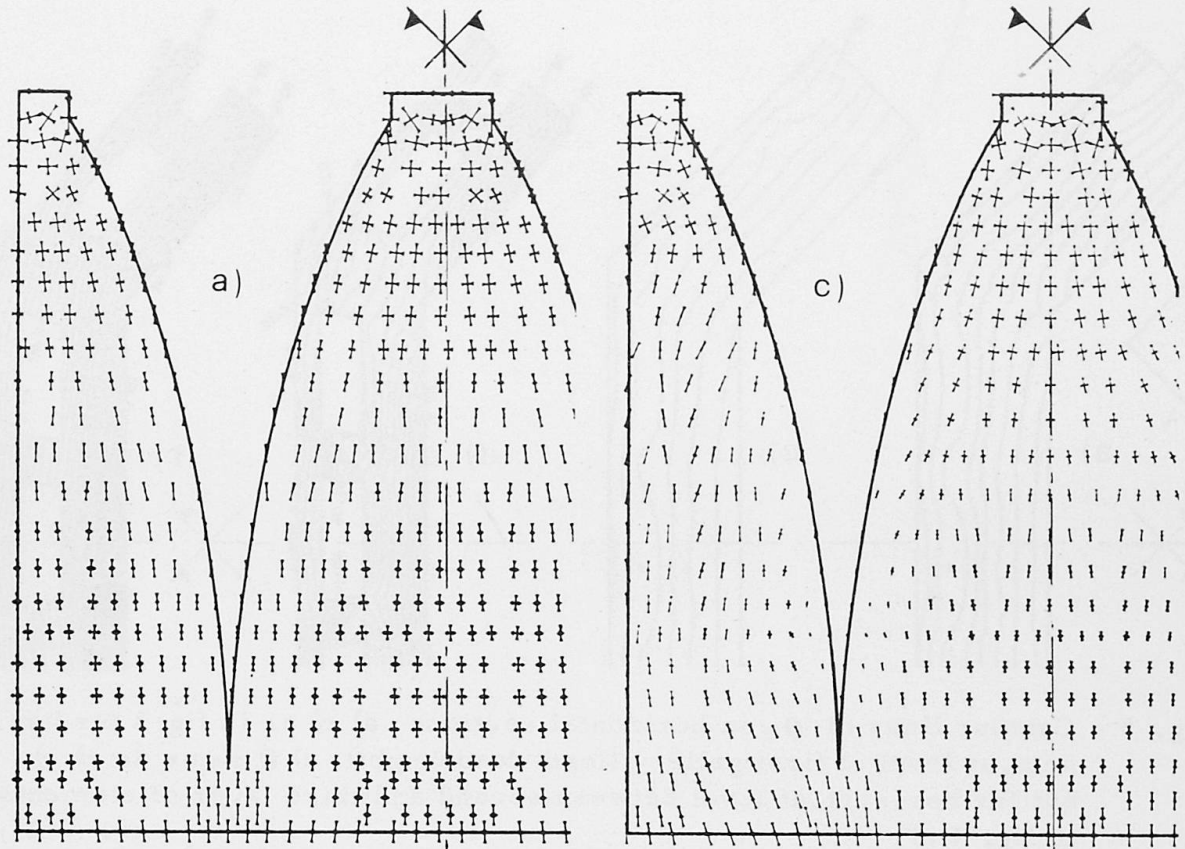
Fig. 7- Principal stresses on developed surface of dome extrados (load = deadweight); a) c) as in fig. 3

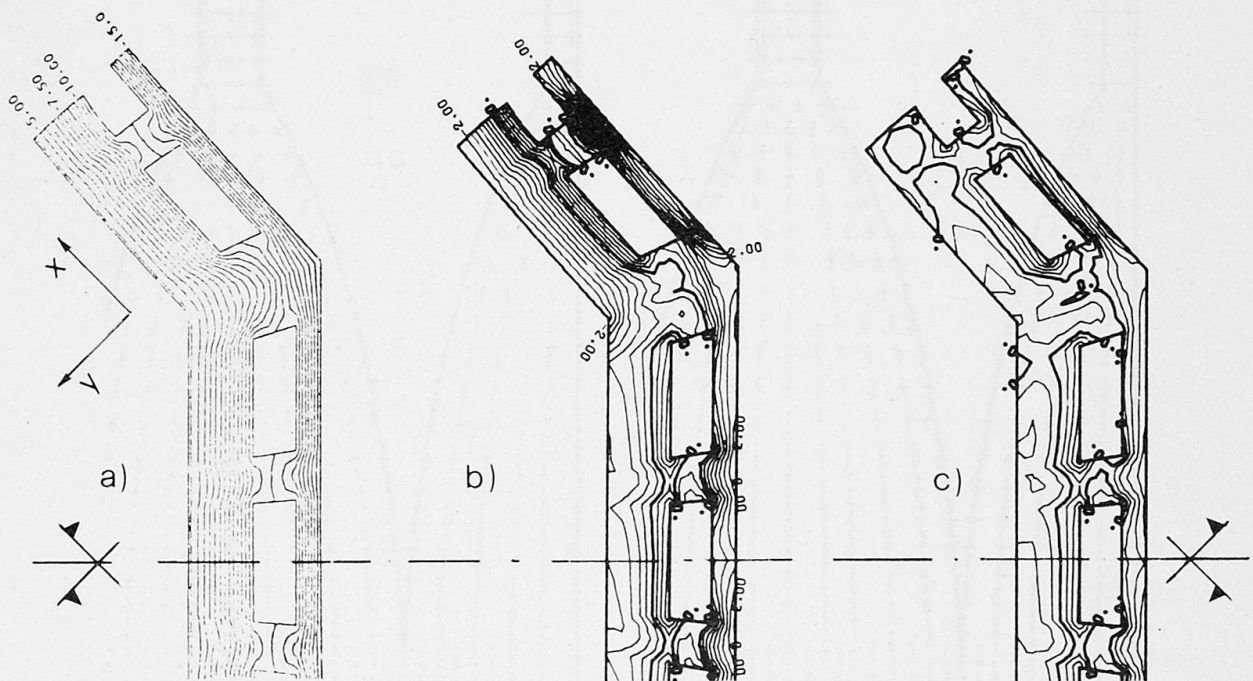
Fig. 8 - a) Isothermal lines at most unfavourable instant along the yearly cycle (Jan.) at hor. sect. between second and third layer of elements in fig. 1 a); b) Horiz. sect. between second and third layer of elements in fig. 1 a): contour lines for σ_x , uncracked structure, thermal load at Jan.; c) as b), but for cracked structure, maximum extension of cracks

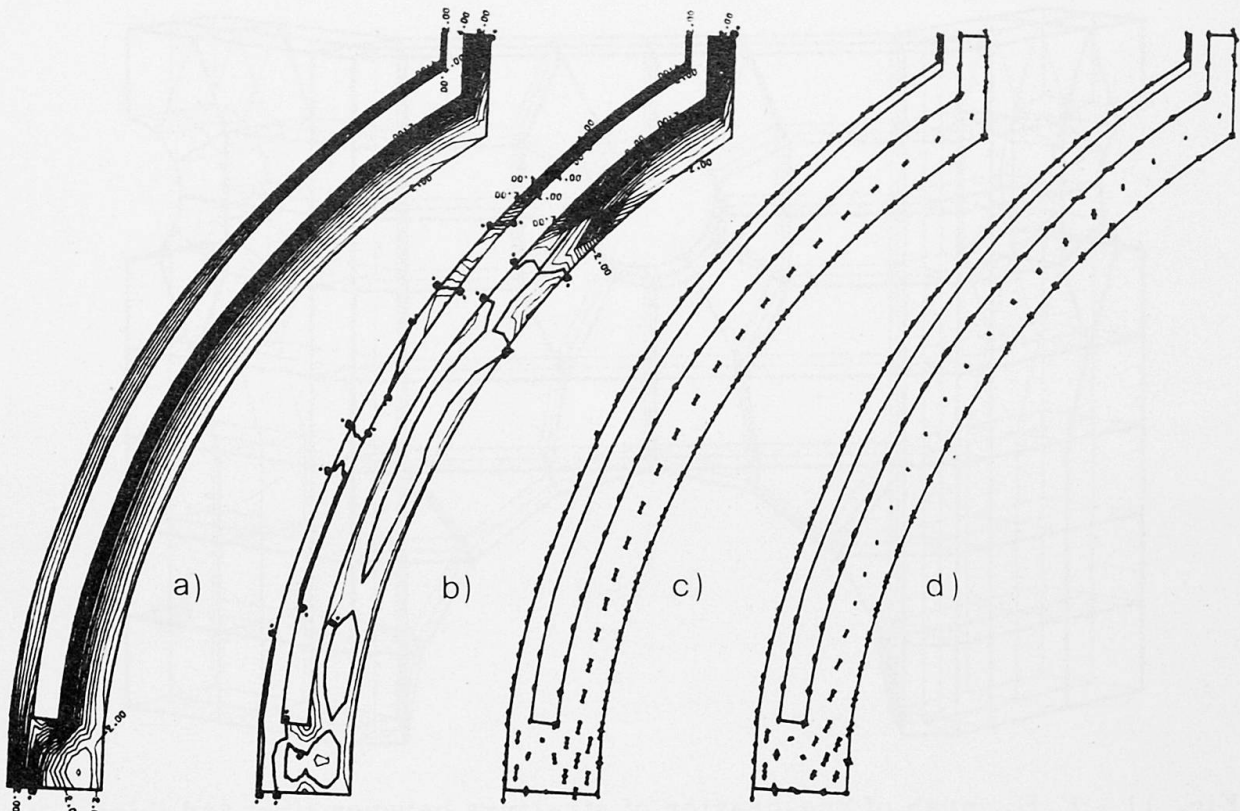
Fig. 9- a) Contour lines for σ_x on vertical cross-section at mid-panel, uncracked structure, thermal load at Jan.; b) as a), but for cracked structure, max. extension of cracks; c) principal stresses on vertical cross-section at mid-panel, uncracked structure, thermal load at Jan.; d) as c), but for cracked structure, max. extension of cracks

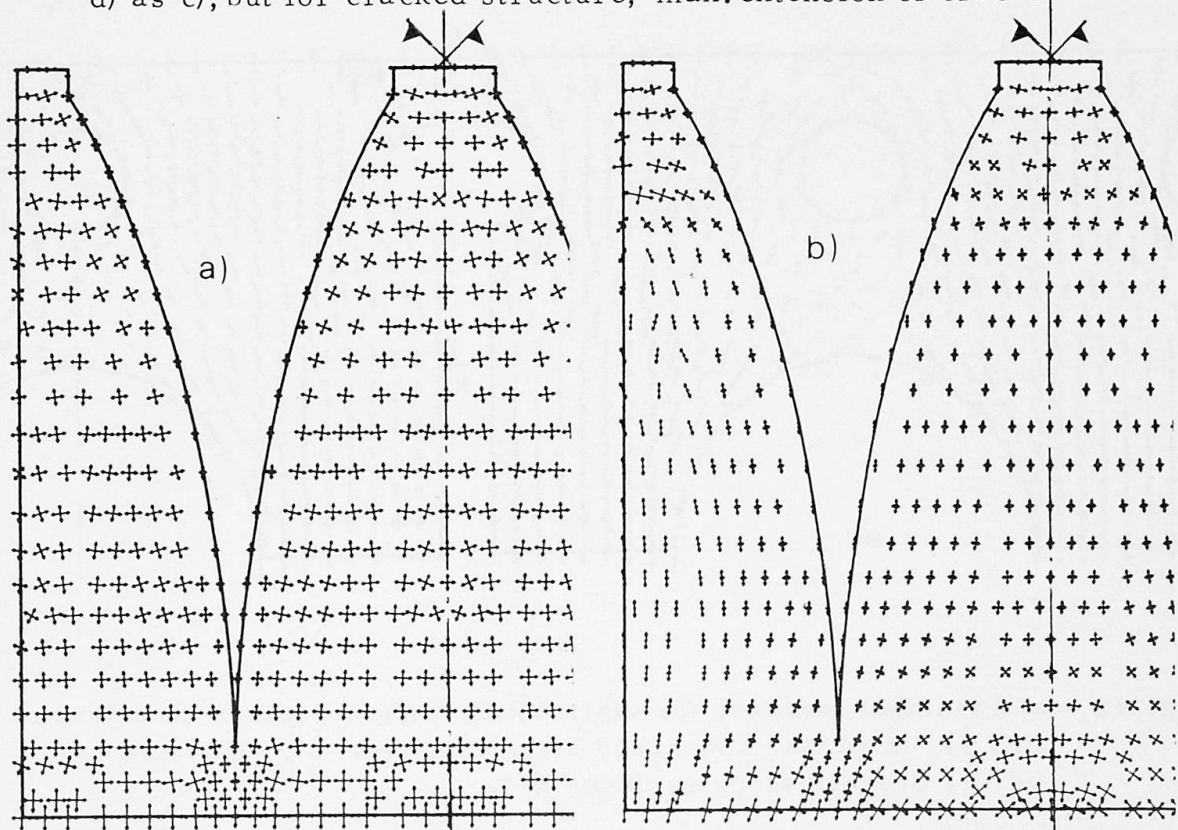
Fig. 10 - a) Thermal load at Jan., uncracked structure; principal stresses on extrados; b) as a), but for cracked structure, max. extension of cracks

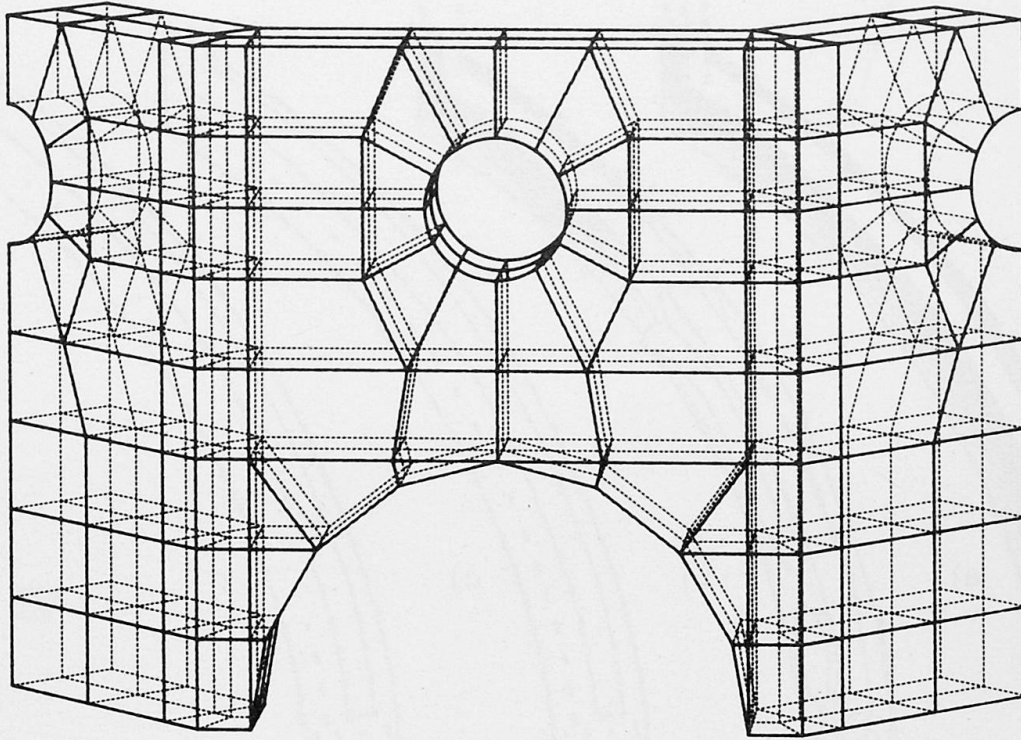
Fig. 11 - F.E. mesh of one-quarter of structure between first and third gallery

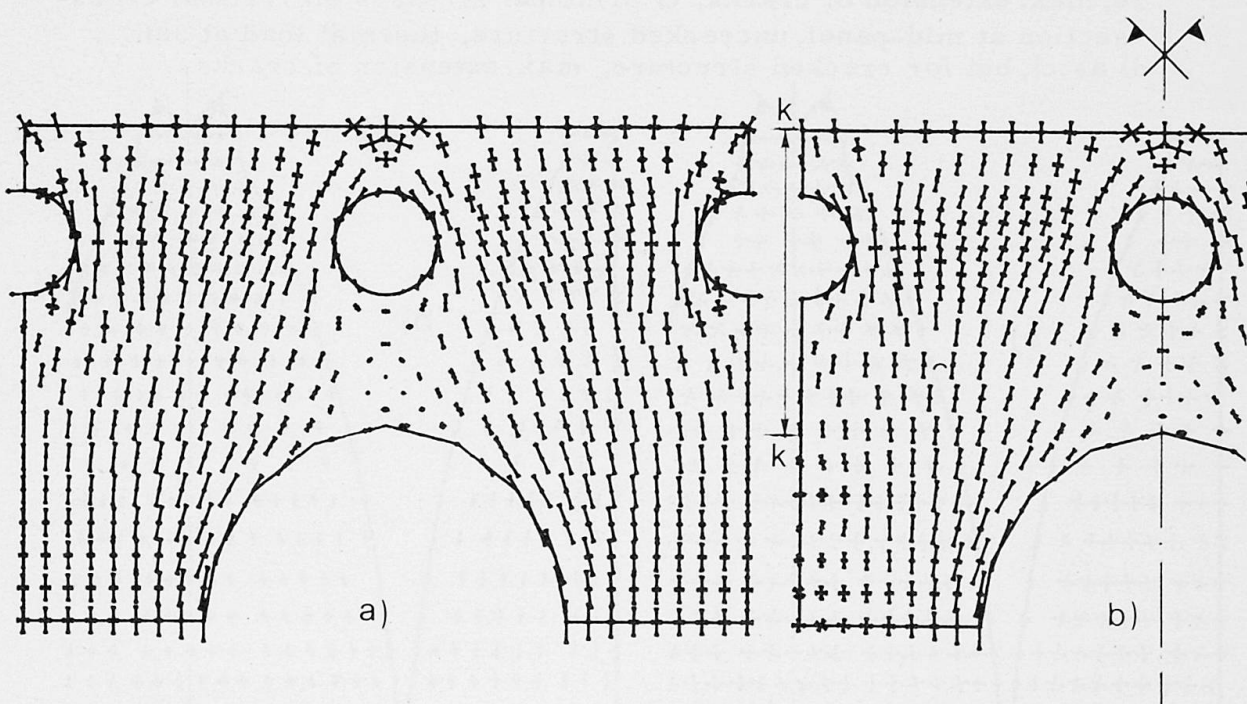
Fig. 12 - a) Principal stresses for distributed vertical load on structure of fig. 11, intrados, uncracked structure; b) as a), structure of fig. 11 cracked along surfaces K-K

Some of the results are illustrated in figure 12. In particular, the stress pattern seen from fig. 12a is confirmed by results of theoretical studies concerning curved wall-beams on interrupted supports [2] and continuous, curved intrados beams [3]. The upshot of it all is that the difference in stiffness between "solid" panels and "arch-supported" ones produces a bias in the horizontal tensile stresses at panel centers, especially under vertical loads. This bias is enhanced by the stress-concentration effect due to the "eyes" piercing the drum panels. If we analyze the possible superpositions of the previously considered stress states, it looks as if the structure possessed a natural propensity to cracking just in the "solid-supported" panels, starting from the "eyes" and following nearly vertical paths.
