Autor(en): **Cantù, Ester / Cauvin, Aldo**

Zeitschrift: **IABSE reports = Rapports AIPC = IVBH Berichte**

Band (Jahr): **46 (1983)**

## Non-linear Analysis and Strengthening of a Reinforced Concrete Building

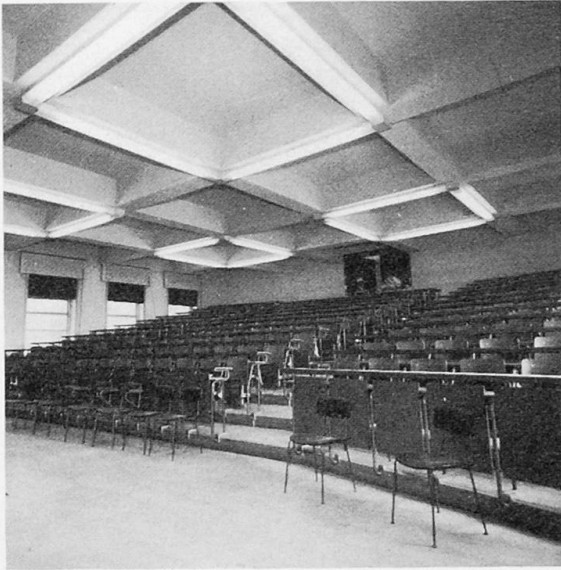
Fig.1 Typical floor

The aforesaid considerations were applied to the case of a recently built r.c. building, where damages occurred due to excessive deflections (Figs.1 and 2). The building is schematically shown in Fig.3: it is composed of 3 floors, the ground floor being used as lecture-hall. The others were partitioned in order to be used as studies and laboratories.

The floors, 15 meters square, are orthogonal grids of r.c. beams. These beams were designed as simply supported, despite the fact that no discontinuities exist between the beams and their supporting columns.
