Zeitschrift: IABSE reports = Rapports AIPC = IVBH Berichte
Band: 48 (1985)

Steel Buildings with Low Annual Energy Consumption

Arne ELMROTH

Carl Michael JOHANNESSEN

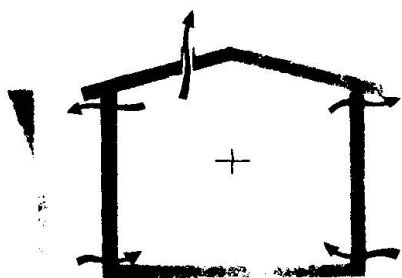
Air pressure on a calm day
Air leakage
Cold outside - warm inside

Fig 1 An insufficiently air-tight building where cold air seeps in at floor level and warm air leaks out at roof level due to thermal forces, wintertime. The pressure gradient is for temperature related pressures on a calm day and fore evenly distributed air leakage.

The governing force for air-leakage and ventilation in buildings is the difference in pressure of the air inside and outside the building. The forces affecting the air adjacent to and inside the building (excluding ventilation fans) and setting it in motion are wind and temperature. On a calm winters day the air pressure in the lower part of a building is lower inside the building than outside, and in the upper part of the building the air pressure on the inside is higher than that outside. The result is that cold air will seep in at floor level and that warm air will leak through the upper walls and the roof, fig 1, giving rise to, apart from the increased energy consumption, uncomfortable draughts at floor level. Such draughts are unacceptable in a quality building. At roof level, and especially in the eaves area, warm air leaks out which, when cooled, may even give rise to condensation and moisture problems in the roof itself. In order to reduce the seepage of cold air at floor level and the leakage of warm air at roof level it is necessary that the climate shield of the building be air-tight.

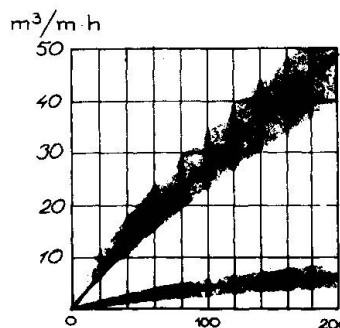
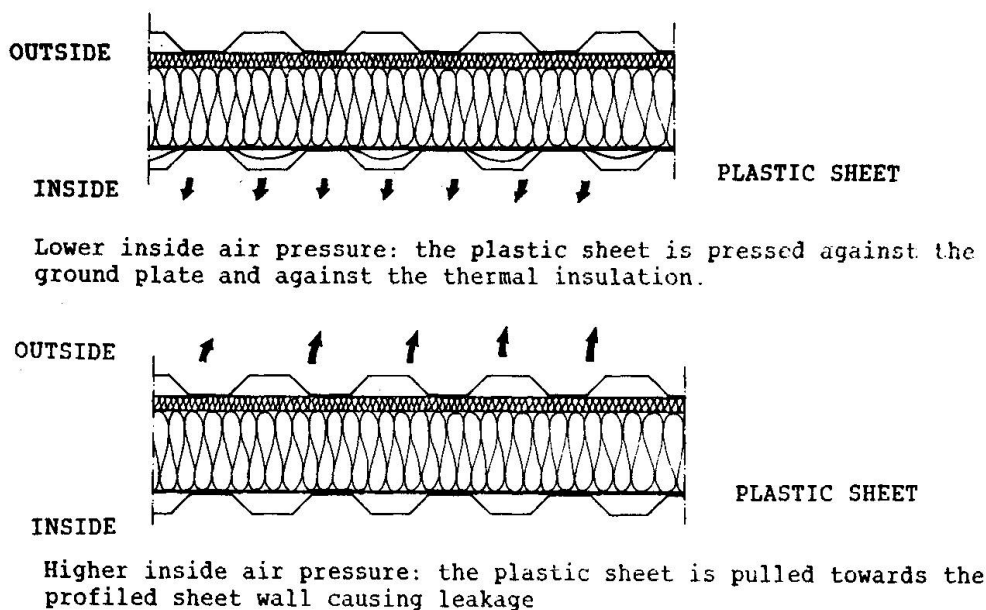
Lower pressure inside than outside

Higher pressure inside than outside.

Fig 2 If the plastic sheet is fixed to the ground plate only by means of a profiled steel sheet the air pressure at floor level will pull the sheet away from the ground plate and allow air leakage. If the air pressure is higher inside than outside the sheet will be pressed against the ground plate and reduce leakage. The latter case is however not the most usual one.

The air-tight membrane in walls constructed with cold formed sheet steel studs and sheet steel cladding is a plastic sheet between the inside surface of the thermal insulation and the inside wall finish. This form of construction creates no problems on undisturbed walls. If the wall is punctured by vents, adjoining walls, joints, windows etc great care must be taken in the design of these details. For example where the bottom edge of the plastic sheet is free - when the plastic sheet is fixed in place with a profiled steel sheet - air will seep in easily if the inside air pressure is lower than that outside. If the air pressure inside is higher than that outside the plastic sheet is pressed against the ground plate, reducing air leakage. It is most common to find lower air pressure at floor level which makes it necessary to find a better method of construction to avoid the free edge of the plastic sheet which is found today. Figure 2.

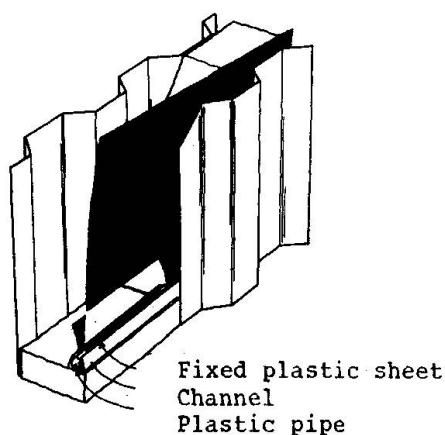
Fig 3 If the plastic sheet is fixed in a channel with a plastic pipe, electric conduit for example, excellent air tightness is achieved.

There are several methods of ensuring good air-tightness in the ground plate detail, one of which is a sheet steel channel in which the plastic sheet is clamped by means of a plastic pipe as shown in fig 3. When tested, this detail gave 100 times less leakage than that of a free sheet edge. Another version of the same detail which also gives a low leakage value is to fasten the plastic sheet between a fixing strip and sealant as shown in fig 4. These details cost very little but are essential; the extra cost being very quickly repaid.

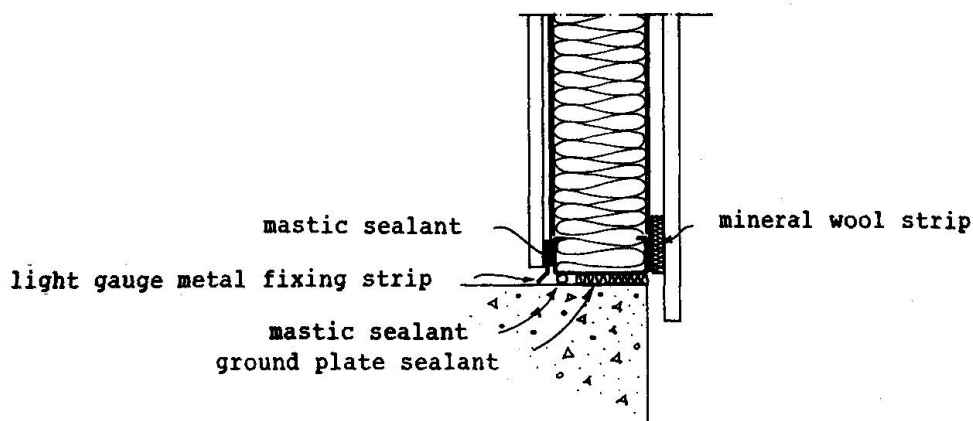
Fig 4 An alternative method of achieving good air-tightness in the ground plate detail is to fasten the plastic sheet with a special light gauge metal fixing strip. A mastic sealant or sealing strip placed between the plate and the sheet will ensure air-tightness. The joint between the ground-plate and the concrete foundation slab must be well sealed; mineral wool with a joint sealant on the inside gives an acceptable result.

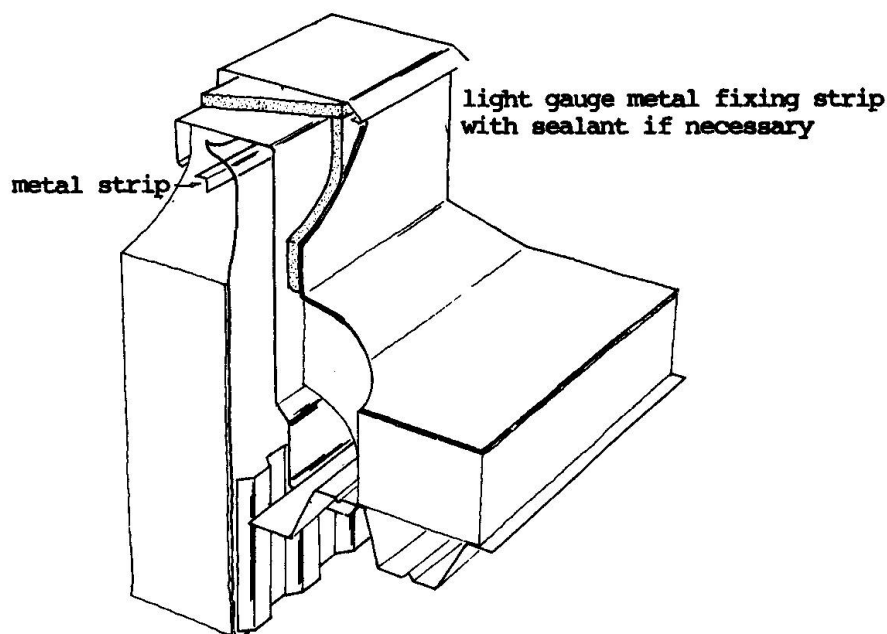
Fig 5 If the plastic sheet at the roof eaves is placed round the outside of the eaves beam there is a risk for air leakage being as the air pressure is often higher inside the building than outside. The sheet is drawn away from the beam and leakage occurs. The sheet must therefore be fixed with, for example, a fixing strip and mastic sealant in order to obtain sufficient air-tightness.

There is normally some kind of special light gauge sheet steel eaves beam which causes the plastic sheet to be led round it in some way, usually on the outside. The internal excess air pressure presses the sheet away from the eaves beam creating a gap for leakage. This is an unsatisfactory detail which is simple to resolve. Here again all that is required is a light gauge metal fixing-strip which fixes the plastic sheet to the eaves beam, with a sealant between if necessary, as shown in fig 5. Again the cost per metre is very low. Minor adjustments in detailing can give greatly improved air tightness.

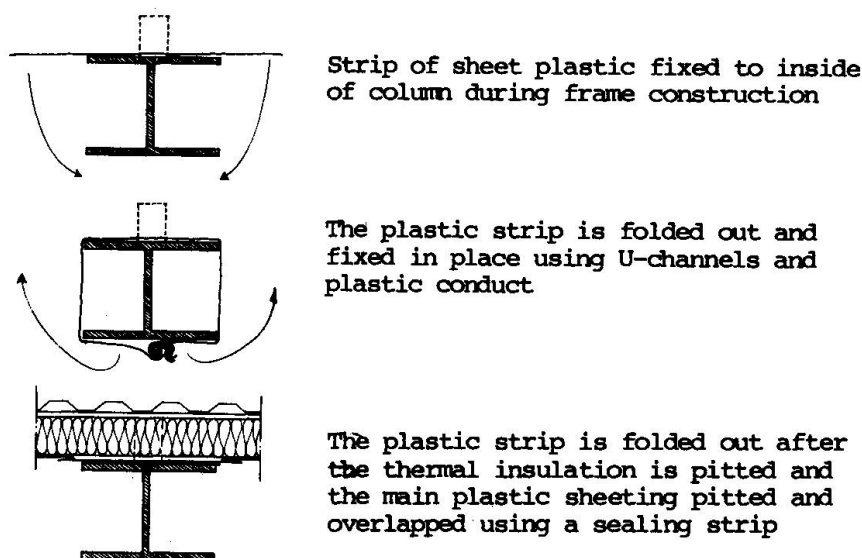
Fig. 6 It can be difficult to place the plastic sheeting when steel columns are placed inside the facade. A strip of plastic sheet is therefore fitted directly after the completion of the frame and carefully fastened so as to avoid wind damage during construction. When the thermal insulation and the plastic vapour barrier are in place the strip is folded out to give a good overlap joint with the main plastic sheet.

The method of jointing the plastic sheet in the external walls is also of consequence to air-tightness. One method used which gives good joint tightness is to wrap a 0.5 m wide strip of plastic sheet round the column before the horizontal studs are fixed in place. Sealant is applied to the support details and the strip of sheet kept wrapped around the column. When the plastic sheet in the wall has been fitted in place after the completion of the thermal insulation, the wrapped around strip is folded out and sealed in the overlaps with a sealing strip as shown in fig 6. Overlapping edges in the plastic sheet without any form of sealing strip or the pressing together of the overlap will not give satisfactory air-tightness. This detail is not costly but does require thorough workmanship. The wrapped around strip of sheet must be carefully fastened during construction to avoid wind damage.

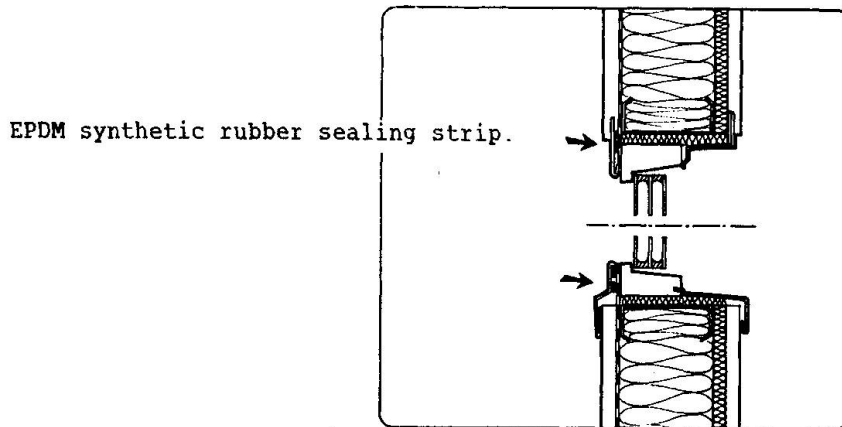
Fig 7 Window detailing. The plastic sheet in the wall is drawn over the window frame and fastened with a special sealing strip. An EPDM synthetic rubber sealing strip between the plastic sheet and the window frame considerably reduces the risk for air-leakage.

It is of great importance from the point of view of air-tightness that the air-tight membrane is not punctured by ducts, electric conduit etc. Improved detailing and instruction is required here. It is of great importance that all services are planned in detail while the building is still on the drawing board and that ducts are avoided as far as possible. Fig 7 shows an example of a window-wall detail. Note the thermal insulation and the positioning of the air-tight sealant against the air-tight sheet in the wall.

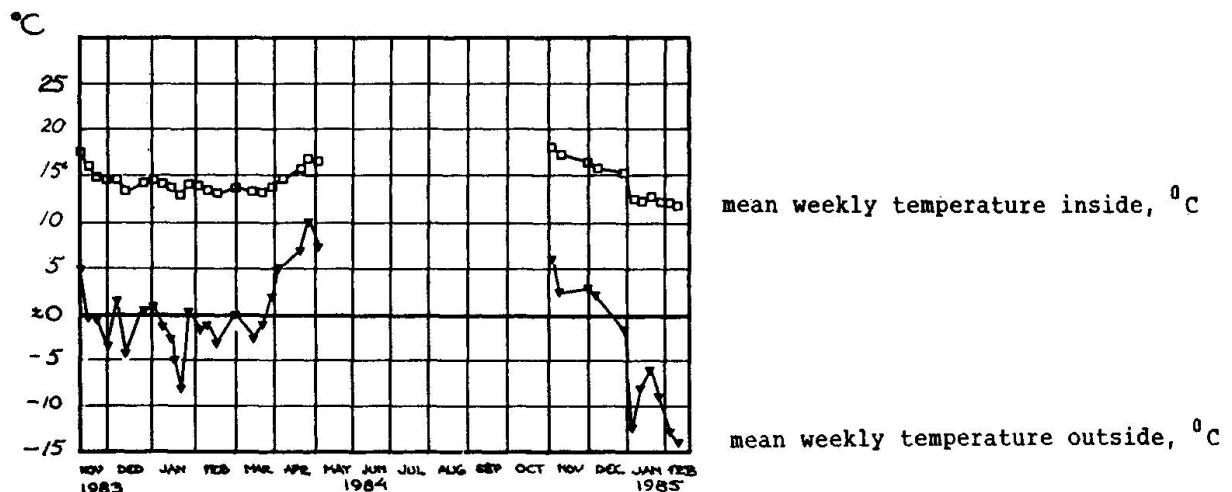
Fig 7 Mean weekly temperature outside and inside respectively recorded at the Ekerö Tennis Centre during Nov. 1983 to Feb. 1985

The mean weekly temperature inside and outside the building has been continuously recorded during the heating seasons 1983/84 and 84/85. The temperature inside the building has never been below a mean weekly value of $+12^{\circ}\text{C}$. During the period Nov. 83 to March 84 the mean weekly temperature was $+14^{\circ}\text{C}$, see fig 8. During the winter of 1983/84, which was relatively mild, the building was never heated with the installed heating system. The heat produced by the lighting system was sufficient to keep the building at a suitable temperature in which to play tennis. It was first during the extreme winter of 1984/85 when the mean weekly temperature fell to -10°C for 6-8 weeks (which is 6-8 $^{\circ}\text{C}$ below the mean monthly average for Stockholm) that the infra-red roof panels were used.

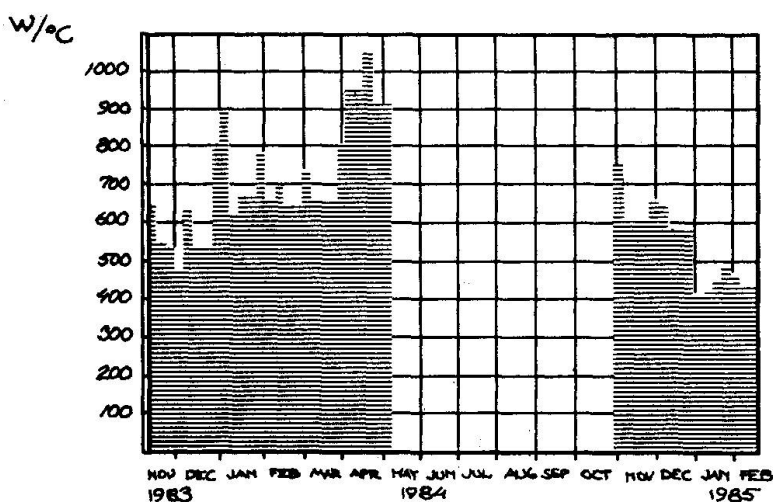
Fig 8 Energy consumption for the Ekerö Tennis Centre during Nov. 1983-Feb. 1985. No recording during May 1984-Oct. 1984.

The total annual energy consumption, which is almost totally used for lighting is 70 000 kWh.
