Reinforcement of the Marghera -Venice Overbridge

Salvatore VENTO
Venice, Italy

Luigi GUADAGNINI
SACAIM S.p.A.
Venice, Italy

The works of improvement and adjustment to suit the new Italian Highways and Bridges Standards here described, refer to the Marghera (Venice) Overbridge.

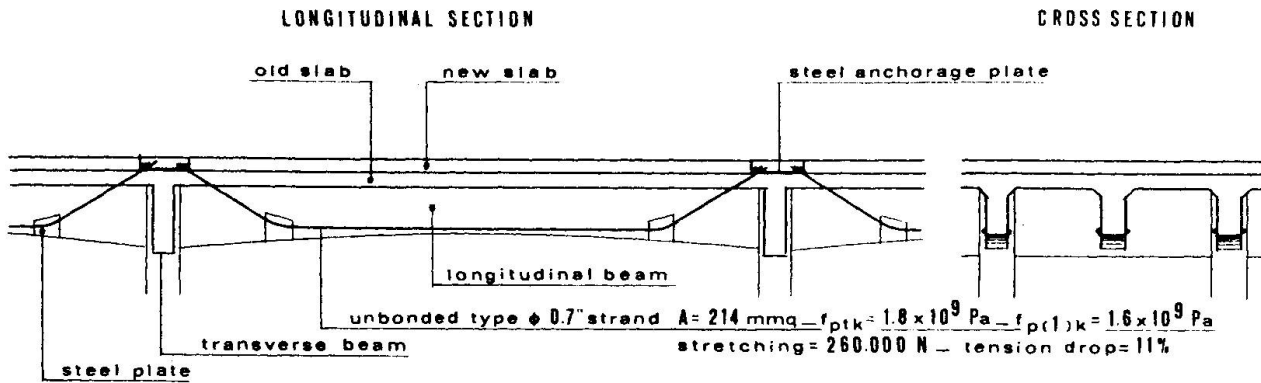
The longitudinal girders (completely unfit to shearing stresses and scarcely fit to bending) have been improved by partially prestressing the structure.

Each longitudinal girder is supported by two UNBONDED TYPE 0 0,7" strands (greased and sheathed with a high density polypropylene sheath) running along each side of the lower ledge of the beam. At the end of the beam the strands are shunted 30° upward by means of a u-shaped steel plate.

The anchorage consists in a steel plate positioned on the existing slab where the longitudinal beam connects with the traverse beam. This anchorage plate is supplied with a series of frustum shaped clamps having a threaded inside hole holding the strands.

The single wires of the strands are greased and protected by a polypropylene sheath and this one is protected by a second polypropylene sheath.

The stretching of both the strands of a beam is done simultaneously by means of an hydraulic jack from one side of the beam, in two periods with a 260.000 N force. Losses due to friction resulted nil.
