Durability and development of epoxy-coated reinforcement

Zeitschrift: **IABSE reports = Rapports AIPC = IVBH Berichte**

Durability and Development of Epoxy-Coated Reinforcement

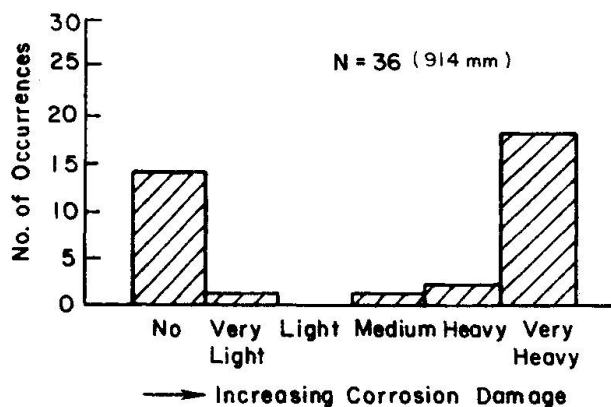
Fig. 2 Histogram of corrosion of uncoated reinforcement

Fig. 2 indicates that heavy corrosion was observed on a majority of the uncoated specimens. The corrosion often extended along the bar for 6 to 10 diameters. The classifications "heavy" or "very heavy" corrosion include evidence of severe pitting. Fig. 3 indicates that the epoxy-coated reinforcement showed very little evidence of corrosion. In a few cases the epoxy coating had chipped off the bar deformations at the cracks resulting in very light surface corrosion with no evidence of pitting. Fig. 4 indicates that the epoxy-coated reinforcement was extremely beneficial for crack widths of 0.38 mm. At crack widths of 0.05 mm where there was still some corrosion of uncoated reinforcement the coating was completely effective. The half-cell potential readings for the uncoated bars correctly predicted that corrosion was occurring. However, with coated bars, the half-cell potential readings frequently suggested corrosion activity, but when the post-mortem was carried out visual inspection indicated no corrosion.

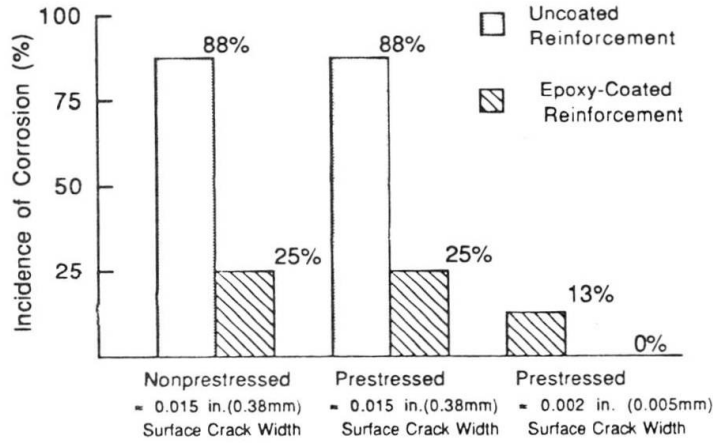
Fig. 4 Comparison of incidence of corrosion of reinforcement in nonprestressed and prestressed specimens

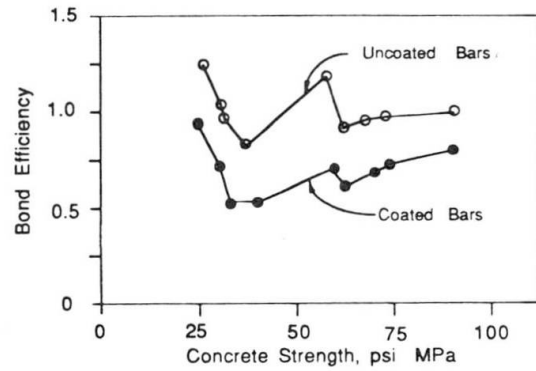
Fig. 5 Bond efficiency vs concrete strength

Epoxy-coated bars developed approximately 65 percent of the bond of uncoated bars. Based on specimens with an average coating thickness greater than 5 mils, the mean bond ratio between coated and uncoated bars was 0.65 with a standard deviation of 0.06. The reduction in comparison with theoretical bond strength [6] was nearly identical to the measured results. The mean ratio of measured bond strength to theoretical bond strength (bond efficiency) for the uncoated bar specimens was 0.996 with a standard deviation of 0.13. The mean bond efficiency of the coated bar specimens was 0.58 with a standard deviation of 0.065. The bond efficiency of the coated and uncoated bars is shown in Fig. 5.

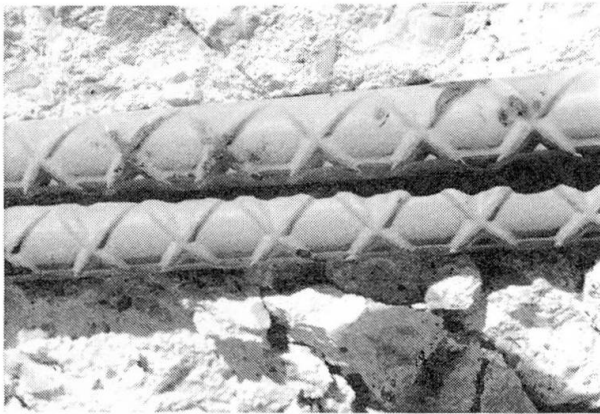
(a) Uncoated bars

(b) Epoxy-coated bars

Fig. 6 Visual appearance of bar and concrete surfaces after test

A distinguishing feature of the coated-bar failures is the total lack of adhesion between the bar surface and the concrete. Fig. 6 shows the surfaces after failure for coated and uncoated bars. Note the shiny surface of the concrete and coated bar. The thickness of the coating did not influence the strength. In any case, coating thicknesses are not uniform. Fig. 7 shows a histogram of measured coating thickness. While the average is near the specified thickness, there was considerable variation.

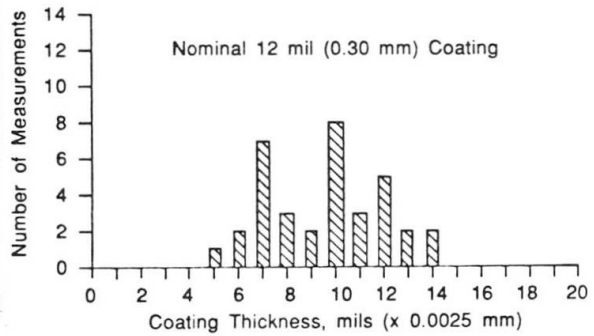
Fig. 7 Variation in coating thickness 36 mm bars
