Autor(en): **Badoux, Marc / Jirsa, James O.**

Zeitschrift: **IABSE reports = Rapports AIPC = IVBH Berichte**

Band (Jahr): **55 (1987)**

Retrofitting of Reinforced Concrete Structures with Steel Bracing Systems

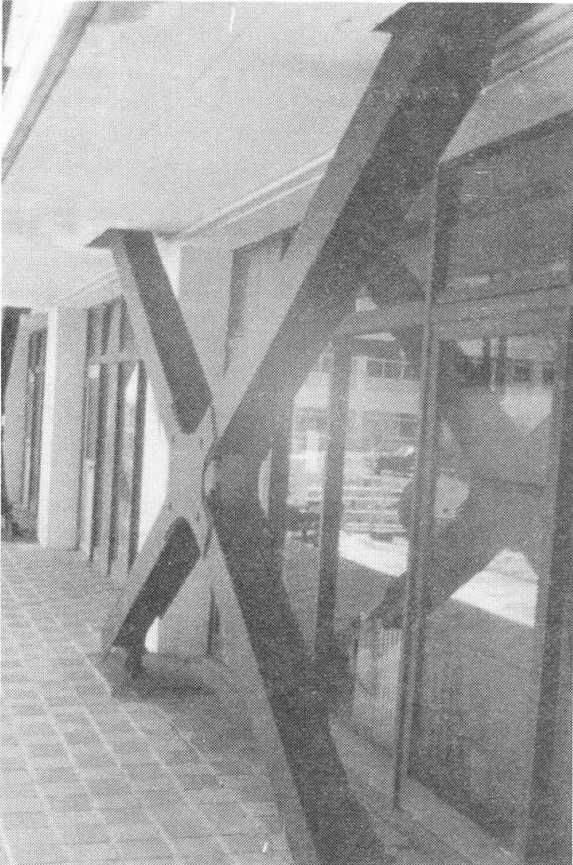
Fig. 1 Sendai School, Japan [1]

Steel bracing has been used for retrofitting inadequate structures as well as for repairing damaged structures. A well-publicized example is the five story Japanese school building shown in Fig. 1 [1]. The perimeter frames consist of deep spandrel beams and short columns damaged in the 1978 Tokachi-Oki earthquake. The damaged frames were retrofitted with a bracing system detailed to provide maximum energy dissipation under cyclic inelastic loading. Retrofitting also included altering the deep spandrel beams in order to transform the brittle "weak column-strong beam" frame into a ductile "strong column-weak beam" frame.

The use of the bracing retrofit technique has also been considered in the U.S., particularly for cases similar to the Sendai School, which is typical of many buildings constructed in the 1950's in seismic zones. The behavior of a frame featuring weak short columns and strong beams retrofitted with a steel bracing system was investigated experimentally using a large scale model shown in Fig. 3 [3]. The experimental work was coupled with the analytical study presented in the next section.
