**Artikel:** Fatigue of cross-beam connections in plate-girder highway bridges  
**Autor:** Okura, Ichiro / Fukumoto, Yuhshi  
**DOI:** <https://doi.org/10.5169/seals-45714>

## Fatigue of Cross-Beam Connections in Plate-Girder Highway Bridges

Fatigue cracks often grow from connections of cross beams to main girders in plate-girder highway bridges. The structural parameters which govern cracking at cross-beam connections are examined based on the overall behaviour of the bridges. Cracking patterns at cross-beam connections are determined from fatigue tests. A recommendation is given for connection details between concrete slabs and main girder flanges.

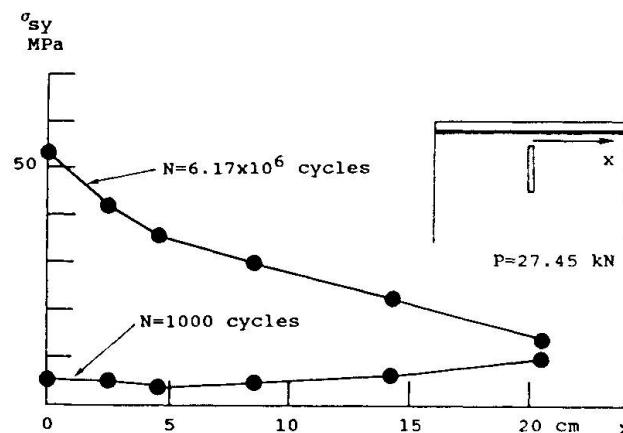
Fig.11 Distribution of web surface stress  $\sigma_{sy}$  along the flange-to-web fillet weld (Specimen B-1)

The distribution along the flange-to-web fillet welds of the stress  $\sigma_{sy}$  on the surface of the web plate is shown in Fig.11 for Specimen B-1. In the figure, at  $N=1000$  cycles  $\sigma_{sy}$  is very small and Type 1 crack does not occur, while at  $N=6.17 \times 10^6$  cycles  $\sigma_{sy}$  becomes large and Type 1 crack is initiated and grows. Therefore in the series B the propagation of Type 1 crack makes the local stress  $\sigma_{by}$  increase, and then results in Type 4 crack initiation.
