Vibration and Serviceability in Post Terminal Buildings

Harald DAHLSJÖ

Sven OHLSSON

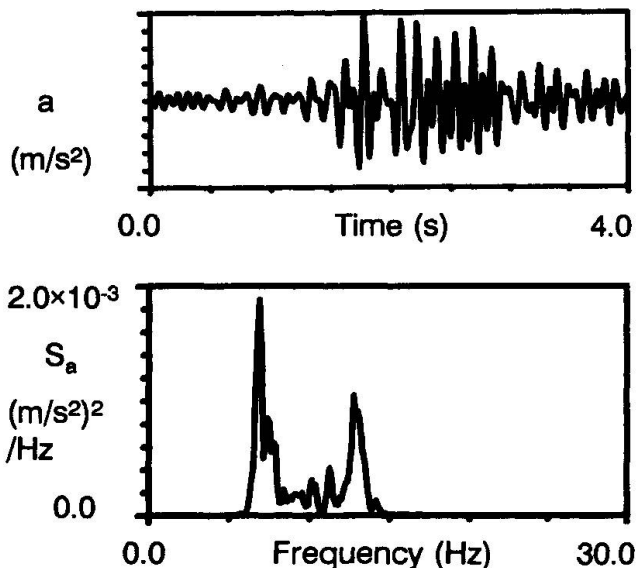
Fig. 3 Acceleration time record ($\pm 0.5 \text{ m/s}^2$) and corresponding acceleration spectral density S_a for ground floor due to regular driving of a forklift of type AT.

vicinity of the driving area for the forklift are presented in Figs. 3 and 4 (after [4] 1991). It is worth noting that the softer wheels of the forklift of type AT result in a low-frequency dominated acceleration spectrum, basically limited to the frequency band 5 - 15 Hz, while the corresponding frequency range for the forklift type Rocla is approximately 8 - 30 Hz. From Fig 3, it is clear that the spectral function shows a pronounced peak around 6.5 Hz. Closer studies have shown that this is not an effect of a floor resonance, but rather originates from the dynamic characteristics of the vehicle. This peak appears in vibration spectra for different floor areas and it changes only when the load carried by the forklift is altered.

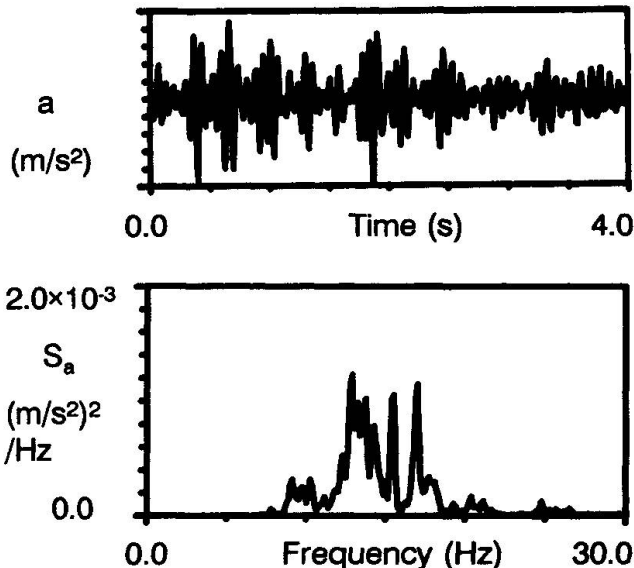
Fig. 4 Acceleration time record ($\pm 0.5 \text{ m/s}^2$) and corresponding acceleration spectral density S_a for ground floor due to regular driving of a forklift of type Rocla.
