Establishment of foundation design parameters for limestone

Zeitschrift: **IABSE reports = Rapports AIPC = IVBH Berichte**

Establishment of Foundation Design Parameters for Limestone

1 THE ØRESUND LINK PROJECT

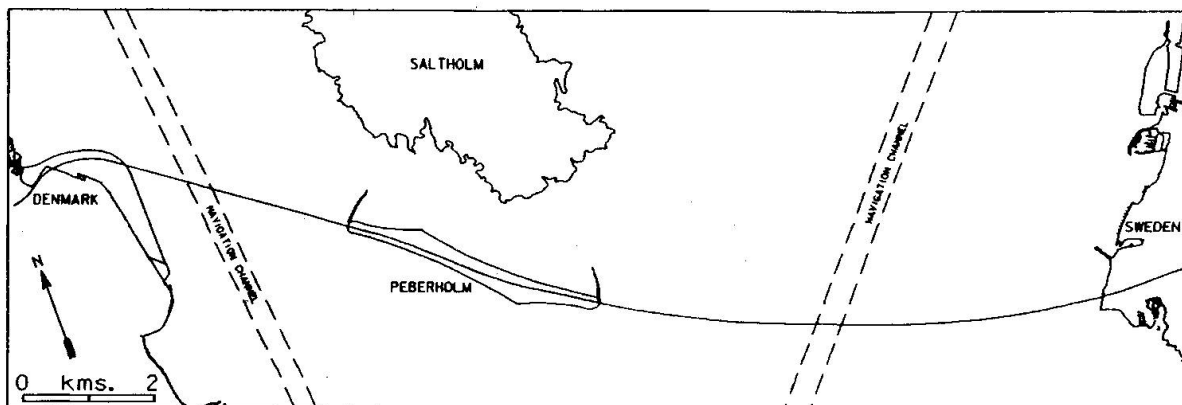
Fig.1 Alignment for the Øresund Link between Denmark and Sweden

The fixed link comprises a 3510 m long immersed tunnel, a 4055 m long artificial island and a high bridge and approach bridges of a total length of 7845 m. The combined road and rail link is scheduled to open for traffic in the year 2000.

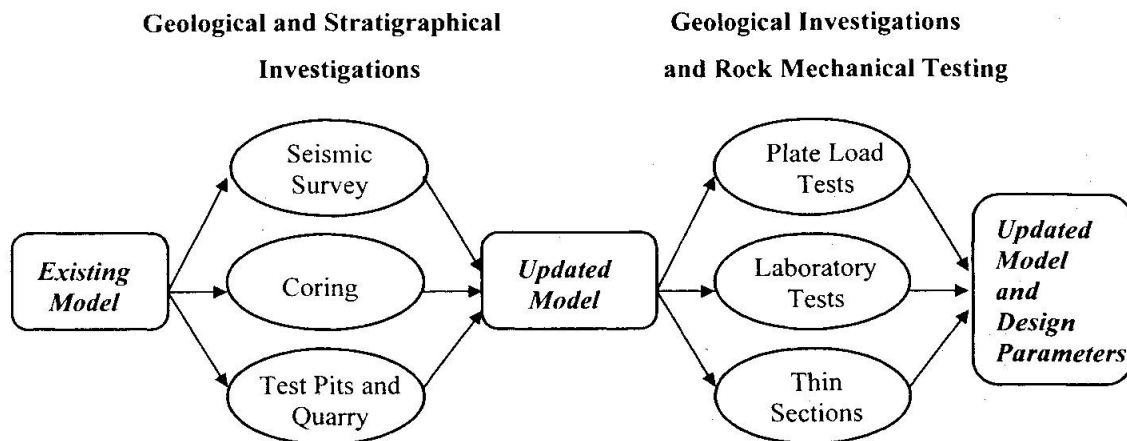
Fig. 2 Methodology for Establishment of Geology and Parameters

Based upon existing knowledge about the geology and the stratigraphy of the Link Area, an Existing Model, ref. Fig.2, for the geology was established. Via this Existing Model additional geological and stratigraphical investigations were planned and executed. These investigations constituted reflection seismic and refraction seismic surveys and borehole logging for assessment of the stratigraphy, performance of core drillings for collection of samples for geological and rock mechanical description and performance of coccolith analysis, and performance of test pits inland on the Danish side, in the Sound and inland on the Swedish side, and investigations of a limestone quarry on the Swedish side. The test pits were performed to extrapolate the detailed investigations in the Sound. These investigations resulted in an Updated Model, ref. Fig.2, for the geology and the stratigraphy. To further assess the rock mechanical parameters and the foundation design parameters for the Copenhagen Limestone large size plate load tests, 0.5 m size laboratory tests and thin sections analysis of the limestone were performed. This finally led to the Updated Model and the Design Parameters for the Copenhagen Limestone. The process and the various activities within the process is presented schematically in Fig. 2., and described in further details below.

In conclusion, the applied methodology, by firstly establishing a geological model, secondly obtaining a physical understanding of the behavior and failure mechanisms of the limestone, and finally assessing the strength and deformation parameters through an interpretation of the performed tests based on this physical understanding has succeeded. The use of the methodology has led to design parameters which, to a far extent, represents the true nature of the Copenhagen Limestone.

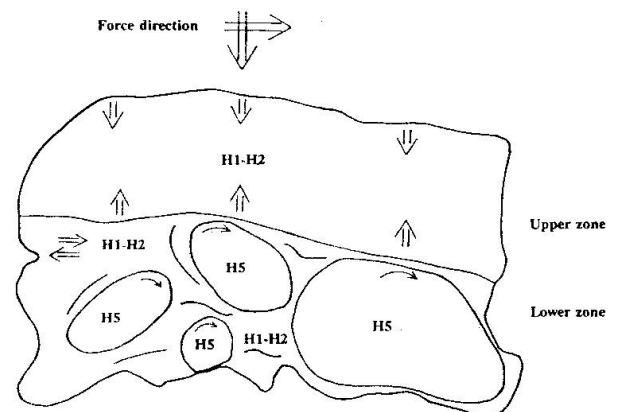
Fig. 4 Principal Sketch of Limestone Sample.

To study the physics of the limestone at failure, both undisturbed reference samples and samples of material subjected to shearing at the plate bearing tests were extracted, ref [3] and [5]. Both the reference samples and the sheared samples were impregnated under vacuum by epoxy, to stabilize the samples and to enable a microscopic study of thin sections under UV-light. In the microscopic study the following subjects were analyzed: changes of the porosity, fissures and patterns of fissures, fissuring and movements of

shells and more indurated limestone parts, ductile flow and the directions of deformations of the material within the samples, as depicted in Fig. 4. In the analysis comparisons were made, both between the reference samples and the sheared samples, and within each individual sheared sample. This study provided the information that for slightly indurated limestone without any content of hard nodules, the limestone will experience a reduction of the porosity leading to a stronger material which eventually will endure a higher failure load than limestone with some content of hard nodules. The explanation is that the nodules will prevent the compaction of the limestone during shearing, leading to unchanged strength parameters for the slightly indurated material, and to movement of the nodules which will further cause fissures to open and to destabilize the material. This leads to a comparatively lesser bearing capacity of the material with the content of nodules

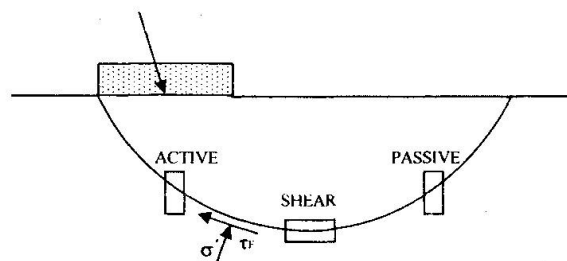
Fig. 6 Principal Failure Conditions

In Fig. 6 the principal failure conditions in the mechanism are depicted. This failure surface has previously been introduced [1].

The shear strength at any part of the failure surface can be given by : $\tau_F = c' + \sigma' \cdot \tan \phi'$.

From the insitu plate load tests performed at Lernacken [4] it became evident that the failure mechanism of the limestone could be divided into active, shear and passive failure conditions, as illustrated in Fig. 3.
