## **Establishment of Foundation Design Parameters for Limestone**

Tove Feld
Project Engineer
L&T-RAMBOLL Consulting
Engineering Ltd. Denmark

S. Juel Petersen
Head of Department
L&T-RAMBOLL Consulting
Engineering Ltd. Denmark

For the establishment of the design parameters for the foundation design for the stay bridge and the immersed concrete tunnel for the 15 km long Øresund Link Project between Sweden and Denmark, a geological model was first established. The geological model included the method of deposition of the Copenhagen Limestone, and was developed assisted by seismic profiling, boreholes, geophysical borehole logging and visits to quarries.

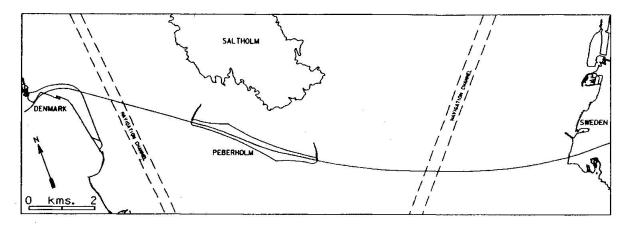
Fig.1 Alignment for the Øresund Link between Denmark and Sweden

The fixed link comprises a 3510 m long immersed tunnel, a 4055 m long artificial island and a high bridge and approach bridges of a total length of 7845 m. The combined road and rail link is scheduled to open for traffic in the year 2000.

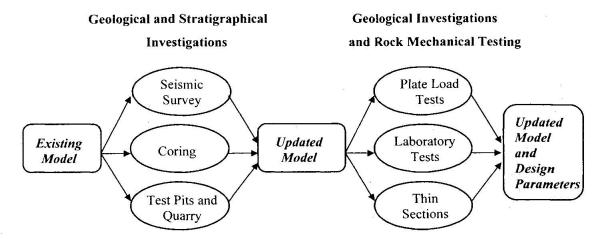
Fig. 2 Methodology for Establishment of Geology and Parameters

Based upon existing knowledge about the geology and the stratigraphy of the Link Area, an Existing Model, ref. Fig.2, for the geology was established. Via this Existing Model additional geological and stratigraphical investigations were planned and executed. These investigations constituted reflection seismic and refraction seismic surveys and borehole logging for assessment of the stratigraphy, performance of core drillings for collection of samples for geological and rock mechanical description and performance of coccolith analysis, and performance of test pits inland on the Danish side, in the Sound and inland on the Swedish side, and investigations of a limestone quarry on the Swedish side. The test pits were performed to extrapolate the detailed investigations in the Sound. These investigations resulted in an Updated Model, ref. Fig.2, for the geology and the stratigraphy. To further assess the rock mechanical parameters and the foundation design parameters for the Copenhagen Limestone large size plate load tests, 0.5 m size laboratory tests and thin sections analysis of the limestone were performed. This finally led to the Updated Model and the Design Parameters for the Copenhagen Limestone. The process and the various activities within the process is presented schematically in Fig. 2., and described in further details below.
