### **Recycling Scrap** for Steelmaking

The case of the Danish Steel Rolling Mill

#### Jørgen Burchardt

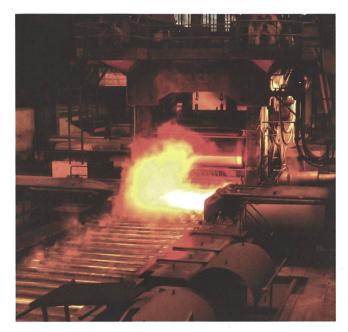
1 The 1922 steel rolling mill purchased by the Danish Steel Rolling Mill after World War II is still in operation today.

After the war, Danish shipyards could not buy enough steel sheets from foreign steelworks, so it was decided at Det danske Stålvalseværk to acquire a second-hand sheet metal mill from the United States. In 1949 a sheet metal mill, originally constructed in 1922, began service at the plant. In the first years, only bar steel was manufactured, which did not have strict requirements regarding the quality. That changed when the company began to produce plates, which were required to have both a high and a uniform quality. Shipyards bought many of the plates, and a certification body such as Det Norske Veritas (DNV) or Lloyds, who also insured the ships they were made of, was required to approve them.

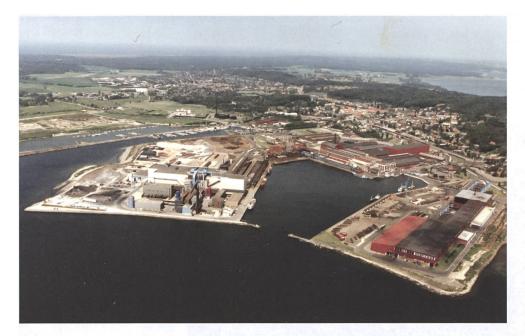
3 The Danish Steel Rolling Mill, Frederiksværk. The oldest part of the steelworks is in the middle. Built on the landfill from the furnaces is a rolling mill for long products (right), and the 1975 electric arc furnace from 1975 (left).

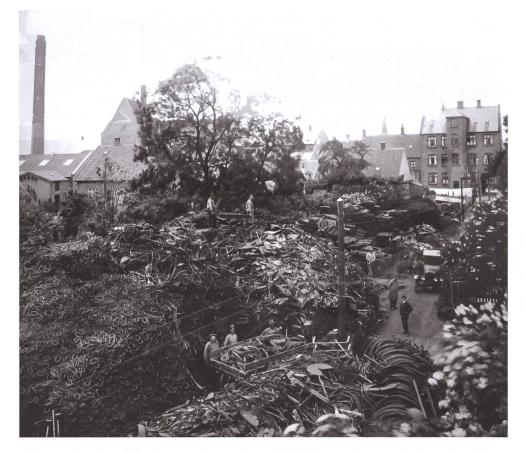
4 The yard of one of Denmark's largest scrap companies in the mid-1920s. Even then, the scrap had to be sorted carefully. For example, the pile on the left consists exclusively of horseshoes.

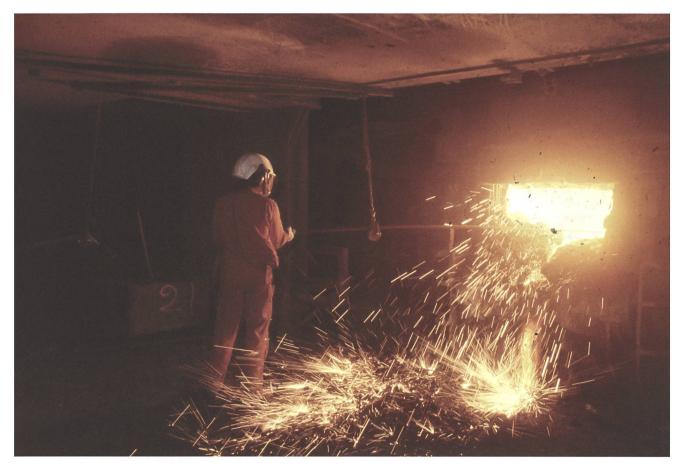
6 Samples are taken from the electric arc furnace, 1990.

New analysis methods could determine the composition of a charge in a short time. The analysis was no longer done by a chemical process but by a so-called electrospectrometer, which analyzed the composition of the emitted light from an arc lit between a sample of the steel and a platinum electrode. Whereas the old chemical analysis took twenty minutes, the spectrometer needed only twenty seconds.
