A problem at Erstfeld

Autor(en): **Adams, David**

Zeitschrift: **Swiss express : the Swiss Railways Society journal**

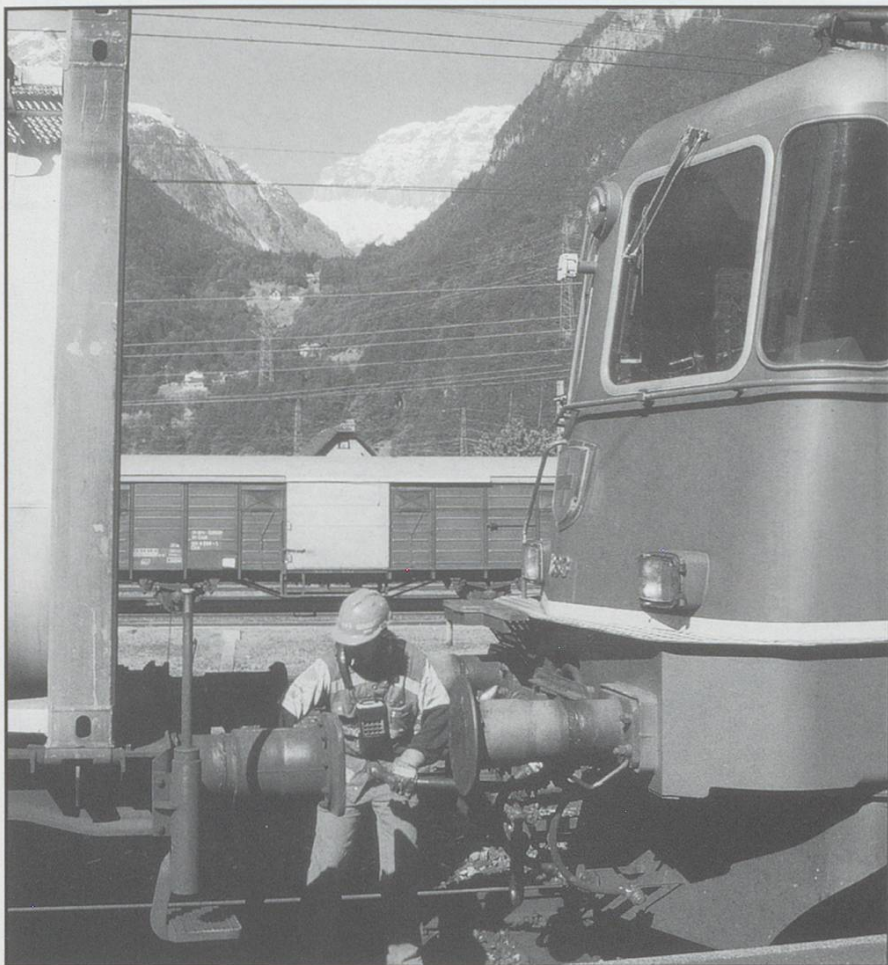
Erstfeld 30/05/02 - Banking loco, Re4/4^{II} 11383, is about to be coupled to the rear of the S/B intermodal train when the problem is spotted. Photo: David Adams

The problem was one that I had never encountered before despite having a life-long interest in railway operations spanning over 50 years. At 09.33 a southbound intermodal arrived in the main southbound platform with Re10/10 formation, 11151/11662, at the head. A careful study of the picture showing the shunter about to couple up the banking loco, Re4/4^{II} 11383, to the rear of this train, will reveal the actual problem. How are your observational skills, usually very good, but maybe not quite that good at the moment? Or perhaps the spectacular backdrop is putting you off?

Well the clue is in the buffers, those on the rear wagon being half a buffer lower than those on 11383 which could have had serious consequences once the Re4/4^{II} was exerting full power at the rear of the train on the 1 in 38 climb to Göschenen. The shunter arrived on the shunters' station bicycle, completed coupling up but radioed for assistance. Very shortly three personnel arrived, one carrying a long ruler. He measured the height of the loco buffers from the rail surface and then walked back checking the heights of other wagon buffers further along the train.

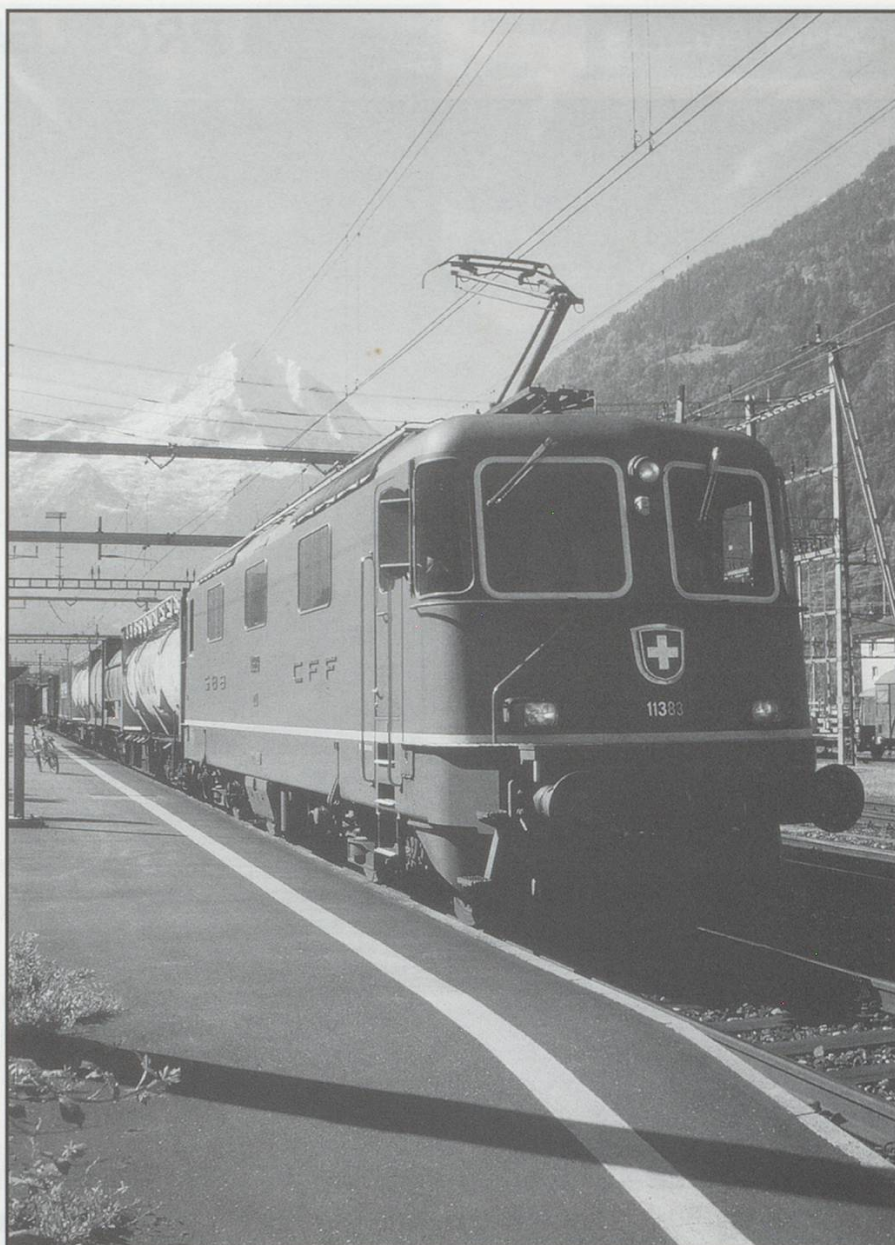
Erstfeld 30/05/02 - Re4/4¹ 11383 waits to draw forward with the rear four vehicles of the S/B intermodal to start the re-marshalling move.

A plan of action was then formulated and carried out with the usual unflappable Swiss efficiency. Relevant instructions were relayed by radio to those concerned and the red tail lights on the rear of 11383 were changed to headlights. At 09.43 the loco drew forward with the

last four wagons of the train and crossed to the west side of the main line. Here the fourth from last wagon was re-marshalled as the last wagon and the ensemble then reversed back onto the main part of the train. By 10.00 the train was ready to depart, a very smart piece of work, the operational versatility of the layout at Erstfeld being used to best advantage in preventing delays to other services.

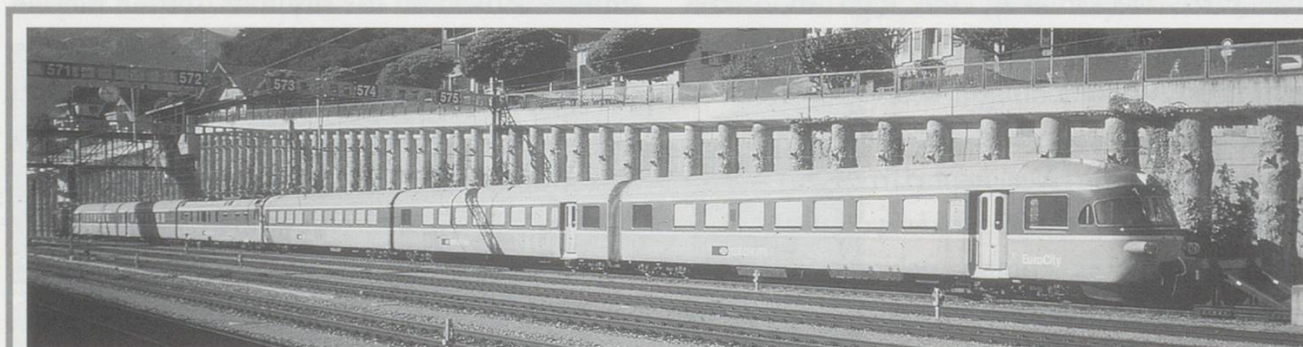
The "Grey Mouse", ex - RAe-TEE set No 1053, now owned by the "SBB Historic" trust, is seen here in Spiez in June 2002. It is awaiting restoration and painting into the old TEE livery of burgundy and cream by the BLS carriage Works in Bönigen. The engines will be treated at the BLS Depot in Spiez. The BLS won the restoration contract on the open market, but it did raise some eyebrows within the SBB...

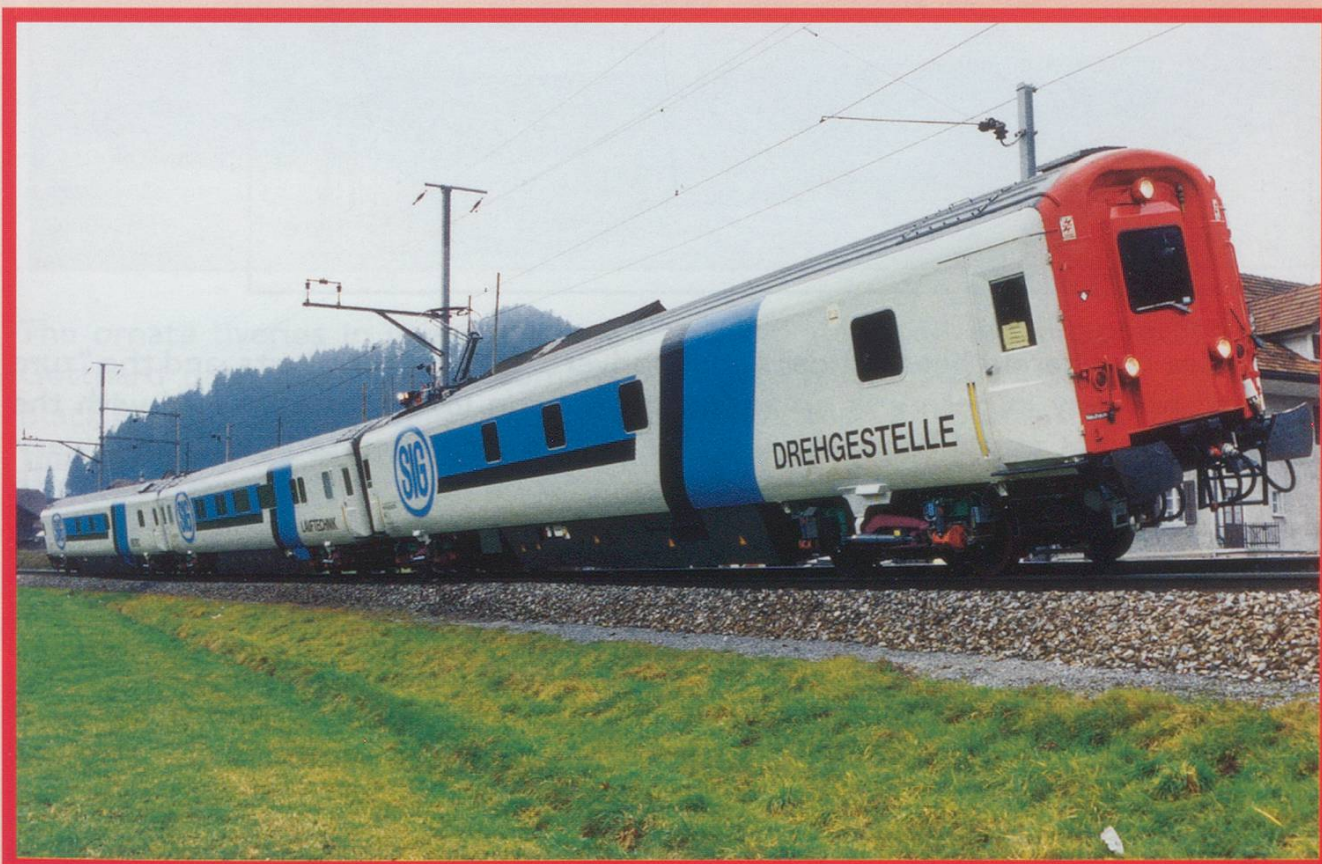
Recently I (George Hoekstra) spent a lovely afternoon with your Editor, David and his wife Debra, walking around the Rhine-Falls in Neuhausen. He might tell you how to get there. We then walked round the back of the SIG (Schweizerische Industrie-Gesellschaft) complex. Their famous bogie construction department now is part of the Alstom group. In 1995, together with SLM, ABB and Schindler Waggon (all since gobbled up by others), the group ran a specially constructed train set to test the tilting technology to be used in the ICN sets. Three ex - BR Mark III sleepers were bought, converted and crammed full of measuring equipment. With their much smaller BR loading gauge, the Mark IIIs could be tilted without fouling the SBB loading gauge. Photo: Neitec-Trains.
