# The Simplon Tunnel. Part 2, The second bore

Zeitschrift: **Swiss express : the Swiss Railways Society journal**

# The Simplon Tunnel

## Part 2 - The second bore

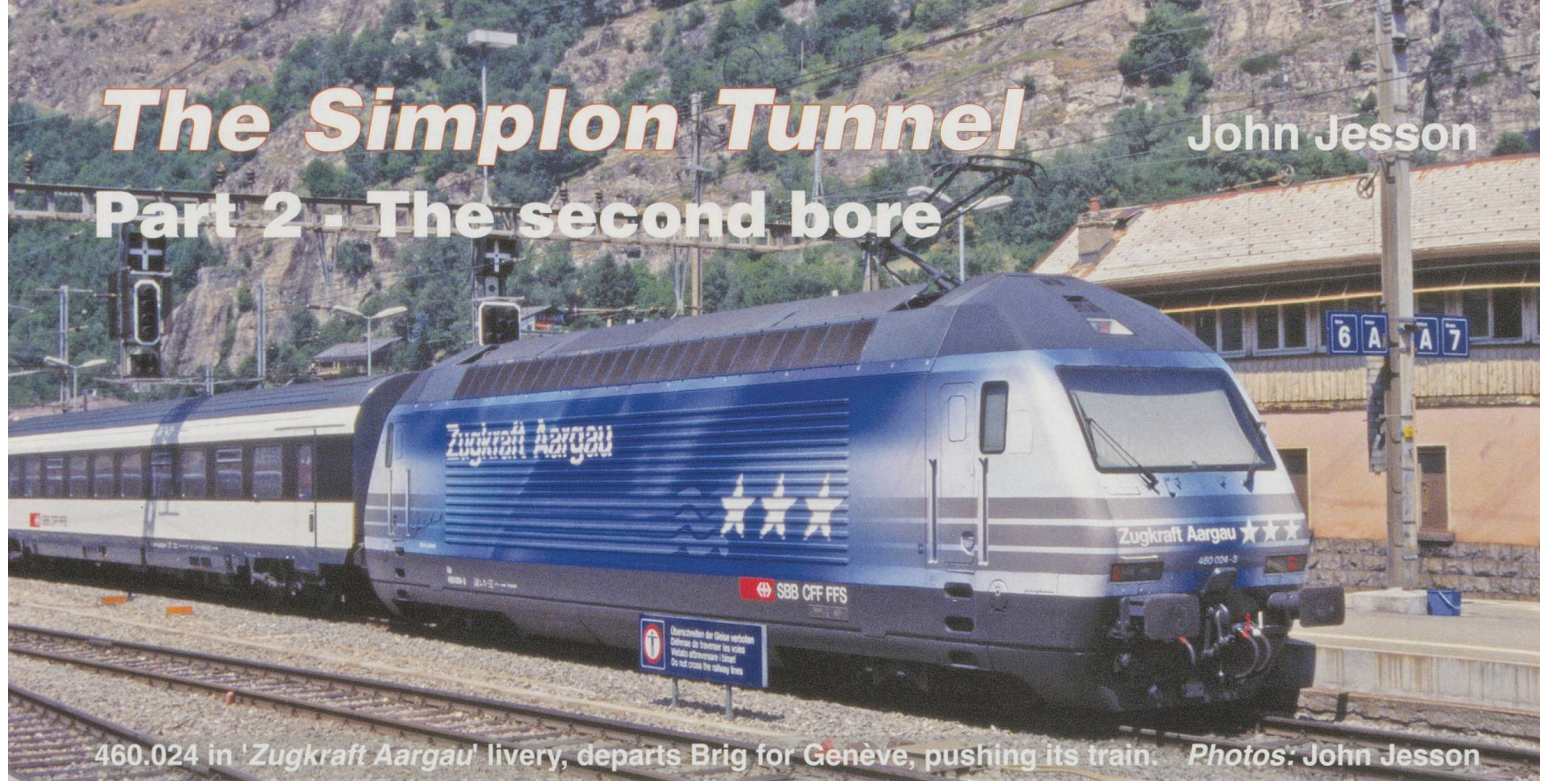
460.024 in 'Zugkraft Aargau' livery, departs Brig for Genève, pushing its train. Photos: John Jesson

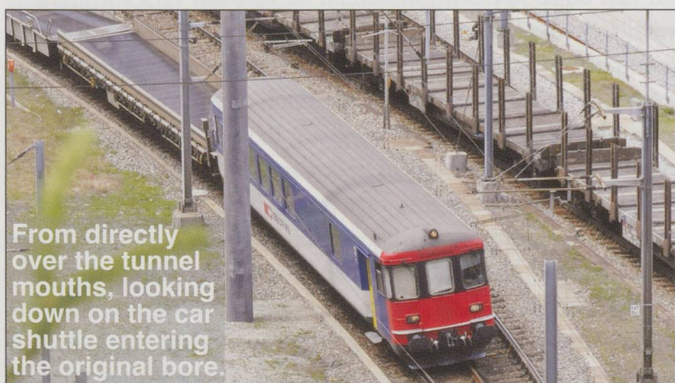
From directly over the tunnel mouths, looking down on the car shuttle entering the original bore.

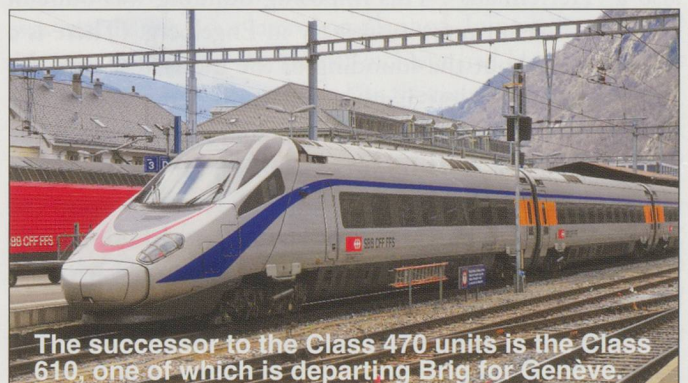
The successor to the Class 470 units is the Class 610, one of which is departing Brig for Genève.
